Executive summary

Acting for the South Shore Regional School Board, SP Dumaresq Architect (SPDA) examined four primary schools in Hebbville, Pentz, Petit Riviere, and Newcombeville. The study recorded the current physical condition of each school and its related systems, determined what remedial actions would be required to permit it to continue to function for another five years and what would be needed to extend its useful life for another 25 years.

Pentz Elementary

**Building Audit
Pentz Elementary School**

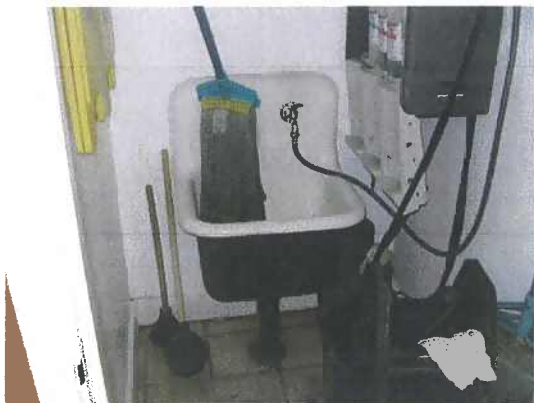
Water closets are flush tank, 6.0 Liters per flush (LPF) manufactured by Crane Canada and were installed approximately 4 years ago. Lavatories are stainless steel in counter basins with commercial grade 4" centre set double handle faucets and were installed when the water closets were replaced. Several faucets were dripping at the time of the review and had to be tourqued tight to stop the flow. Urinals are original cast in place units and are equipped with a flush tank. There is one cast iron custodial sink with separate hot and cold faucets located in a dedicated room off of the corridor. The cold water faucet was noted to be connected to a chemical cleaner dispensing unit with no noted means of backflow prevention installed.

Mechanical Picture #1
Custodial Sink with chemical dispenser

1. The faucets on the custodial sink should be replaced with trim that is equipped with a vacuum breaker suitable for continuous pressure service to comply with the requirements of the current National Plumbing Code of Canada. This upgrade should be undertaken within the next year.
2. The lavatory faucets which drip should be rebuilt or replaced within the next year.
3. The urinals are nearing the end of their expected service life and should be considered for replacement within the next 5-10 years.

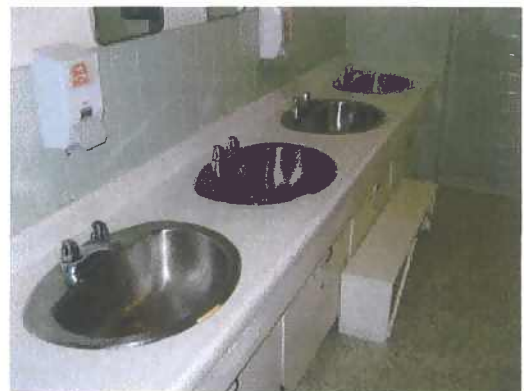
Mechanical Picture #2
Lavatories stained from dripping faucets

D2010	Replacement of custodial sink trim	\$2,000.00
	Repair of dripping faucets	\$500.00

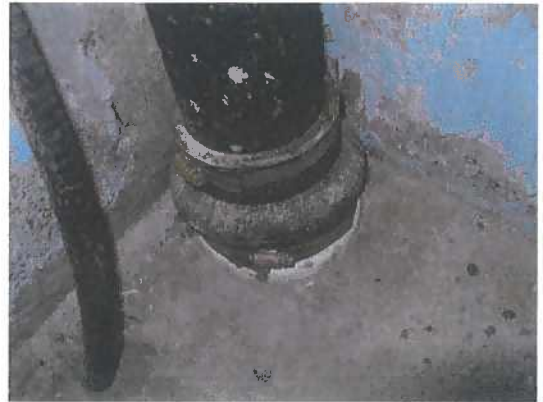
The rain water drainage system for the building is limited to the boiler room flat roof area. The rainwater drainage extends to an unknown location. Sections of the rainwater leader in the boiler room were reportedly replaced due to an obstruction. Again, the exact condition of the piping should be determined by video inspection.

Mechanical Picture #4
Repaired rain water leader

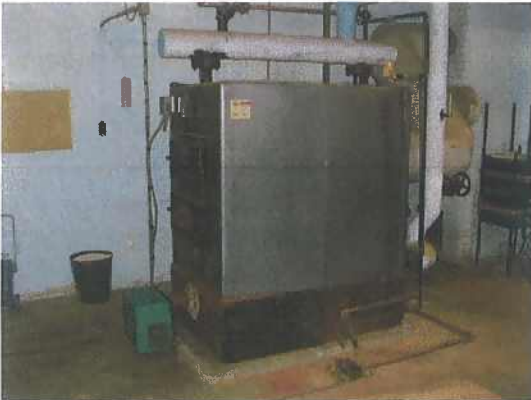
Hot water for space heating is generated by a Weil McLain Model B-882 cast iron sectional boiler with a retrofit Riello M-15 oil burner. The boiler is original equipment with no reported operational issues. The capacity of the boiler plant is reportedly capable of meeting the heating requirement of the building.

Mechanical Picture #5
Hot water heating boiler

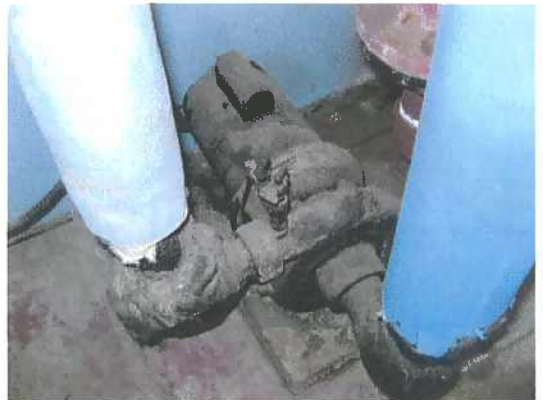
There are two circulator pumps which feed the hydronic distribution system; one operates as the lead pump with the other as standby. One circulator is an original close coupled centrifugal manufactured by the Arthur S. Lietch Company; the other is a Grundfos in line circulator. The original expansion tank has been replaced with a hydro pneumatic unit.

Mechanical Picture #6
Original circulator pump

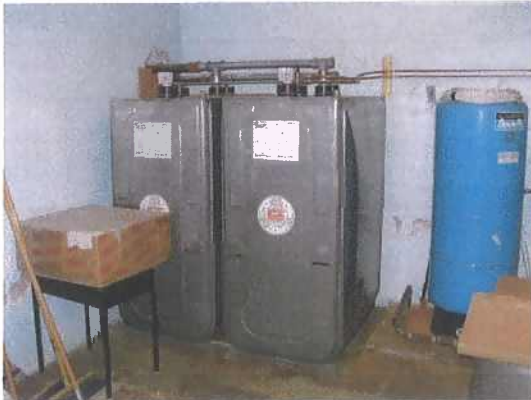
Mechanical Picture #7
Furnace oil tanks

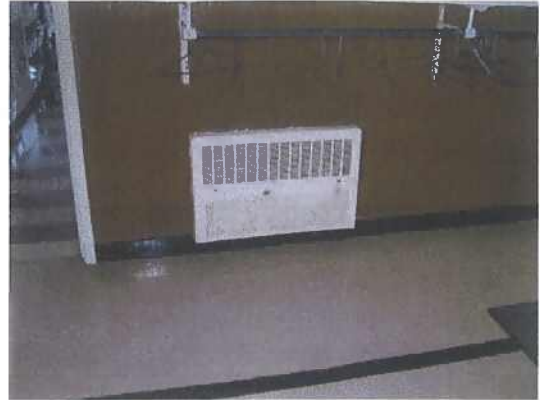
Mechanical Picture #8
Original force flow heater

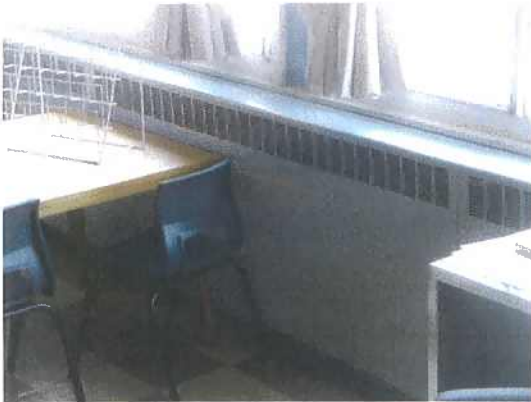
Mechanical Picture #9
Typical wall fin radiation

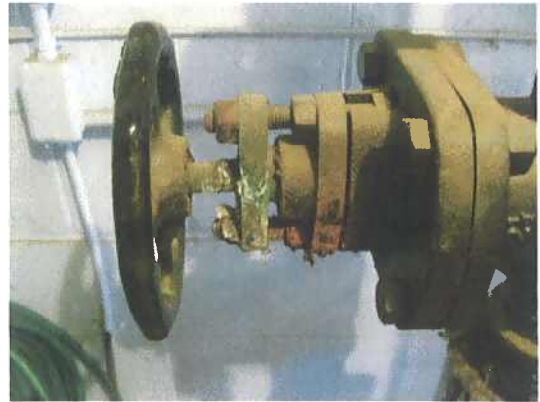
Heating distribution for the building is steel piping with gate and ground key stop valves for isolation and radiator valves at each heating terminal. Many of the valves are original and may not hold, and valve stems may break when closed. The condition of heating mains is difficult to determine without removing and examining several sections of piping. We estimate the heating mains have been in service for over 40 years with no noted means of water treatment; however, there have been no reported leaks in the system.

Mechanical Picture #10
Original gate valve (boiler room)

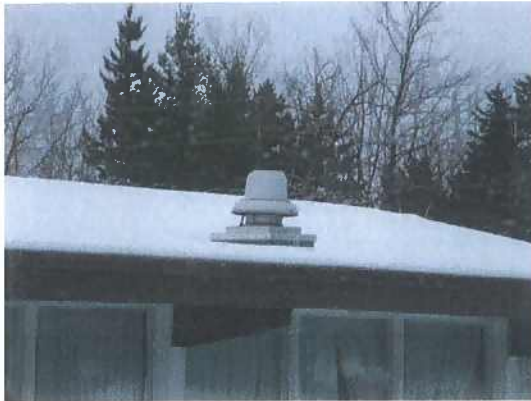
Mechanical Picture #11
Typical roof top exhaust fan.

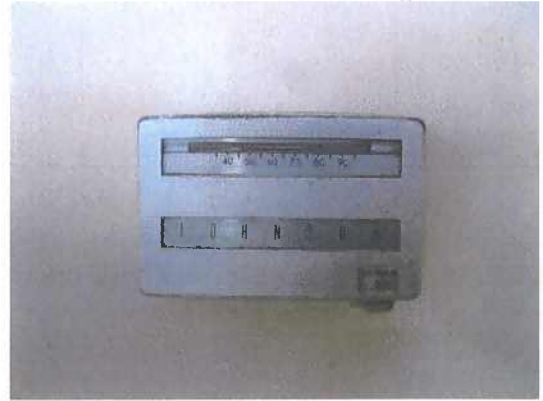
Mechanical Picture #12
Original pneumatic thermostat

D3040	<ul style="list-style-type: none">• Replacement of remaining original pneumatic valves and Thermostats	\$5,500.00
HVAC Equipment and Distribution	<ul style="list-style-type: none">• DDC control system as described above.	\$47,000.00
	<ul style="list-style-type: none">• Replacement of Air Compressor Pressure Tank	\$1000.00

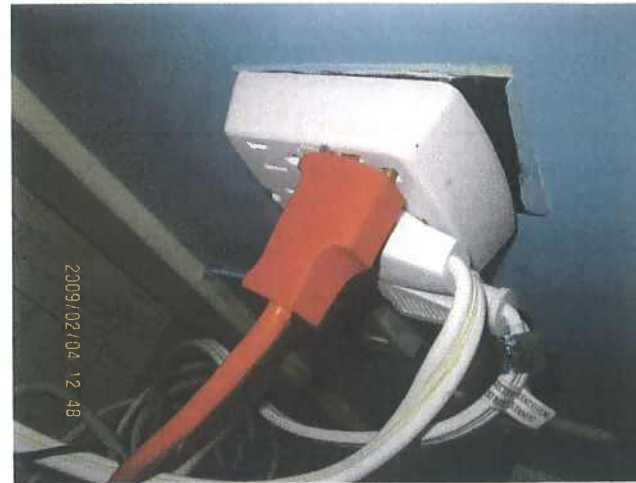
**Electrical Picture #8
Typical Classroom Extension Cords**

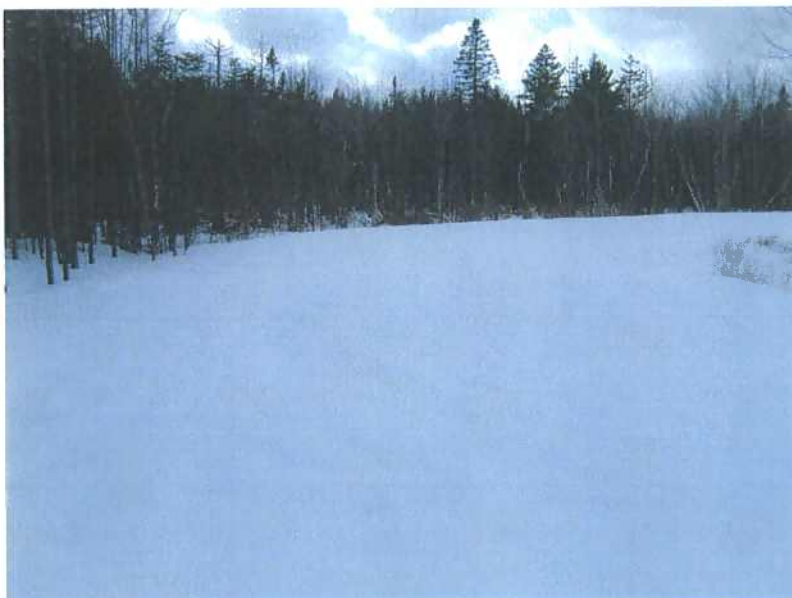
This school has a large on-site sewage raised bed disposal field as shown in figures 7 and 8. It is probably a C-3 but may be a higher C2-R. The system was installed 7 years ago and the bed has not been showing signs of malfunction (smells, breakout, etc.) The system is pump fed and it all seems to be working correctly. There was no record of when the septic tanks were pumped out last, or if the pumps have been checked and serviced.

Figure 8 - Pentz School sewage disposal field bed

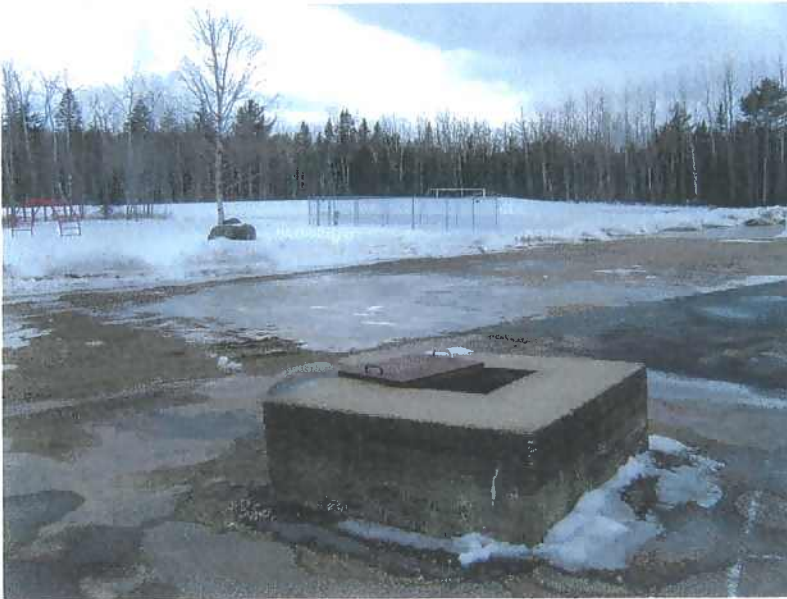
The water supply for this school is a well about 100' from the tanks and pump chamber. The well has a steel hatch that isn't locked and is easy to remove. **This represents a significant risk to child safety and should be addressed immediately (see figure 9).**

Figure 9 – Well at Pentz School. Septic tanks and pump chamber shown in background (fenced area)

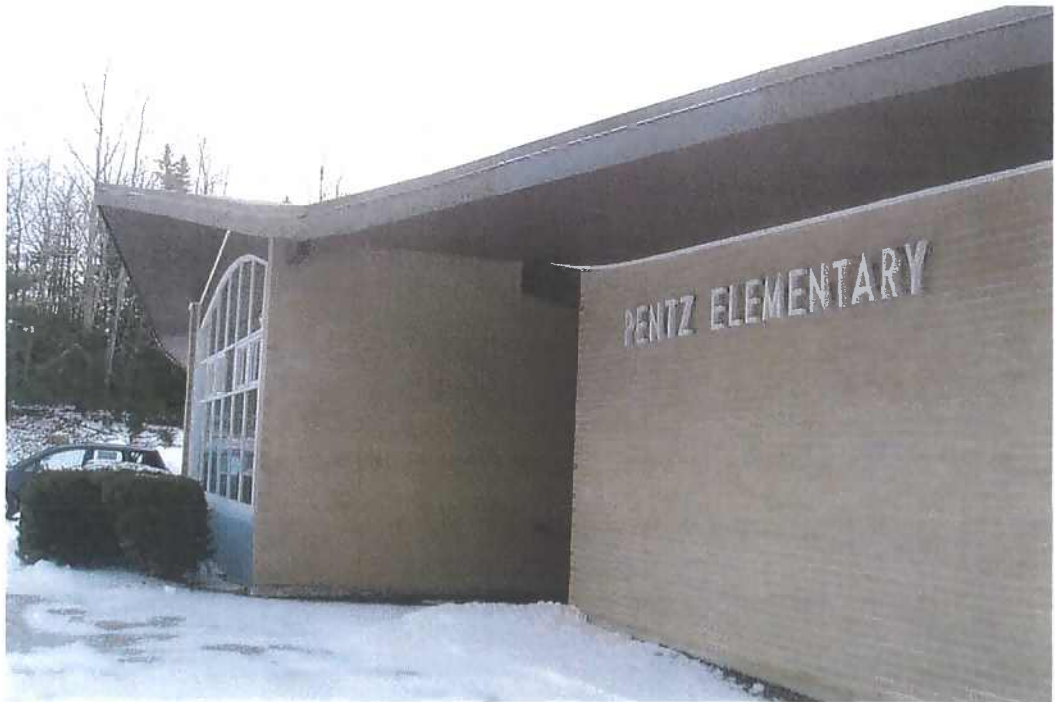
Figure 1 Pentz Elementary. Masonry is in very good condition.

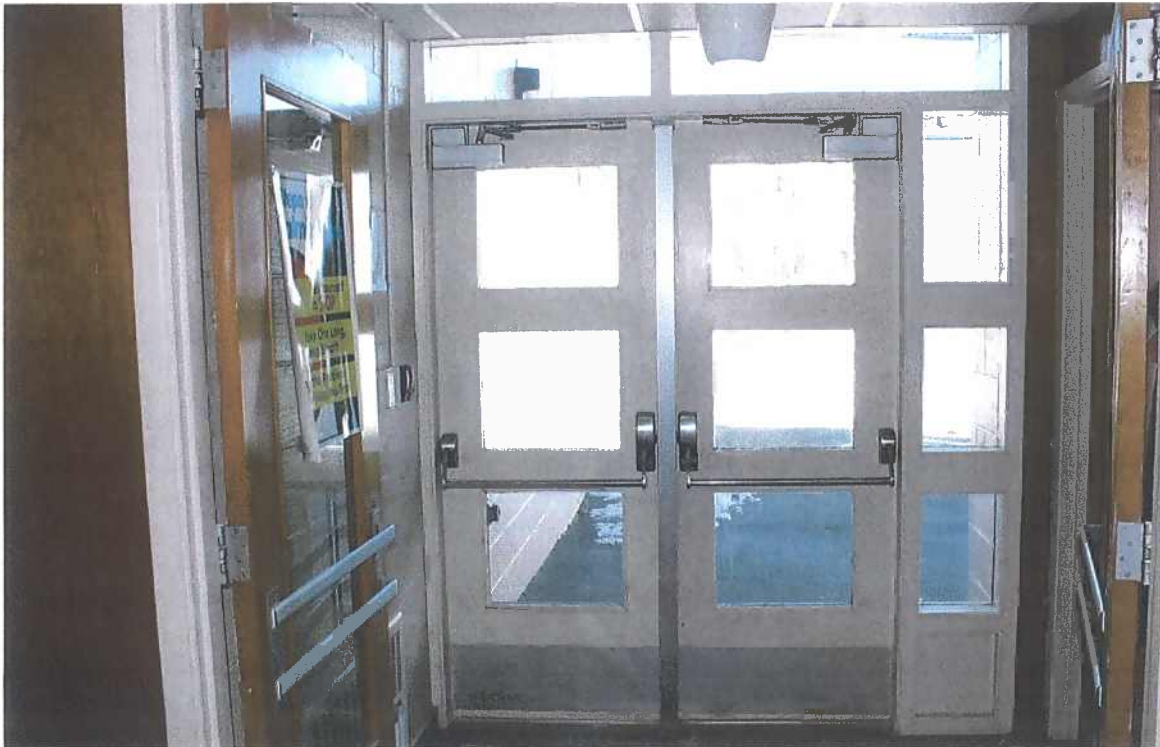
Figure 3 Inside Front Door – Original Doors.

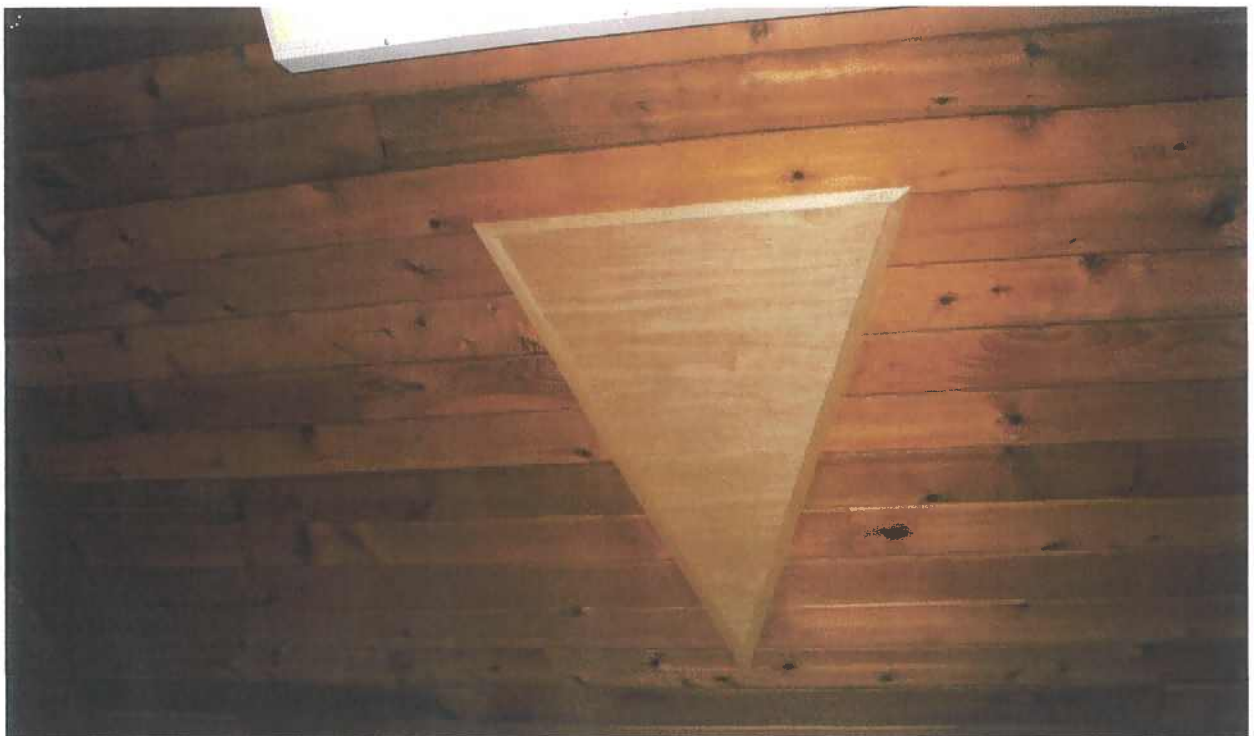
Figure 4 Exposed wood offers a lovely warm feeling. The plywood covers an original sky light, removed when the roof was replaced.

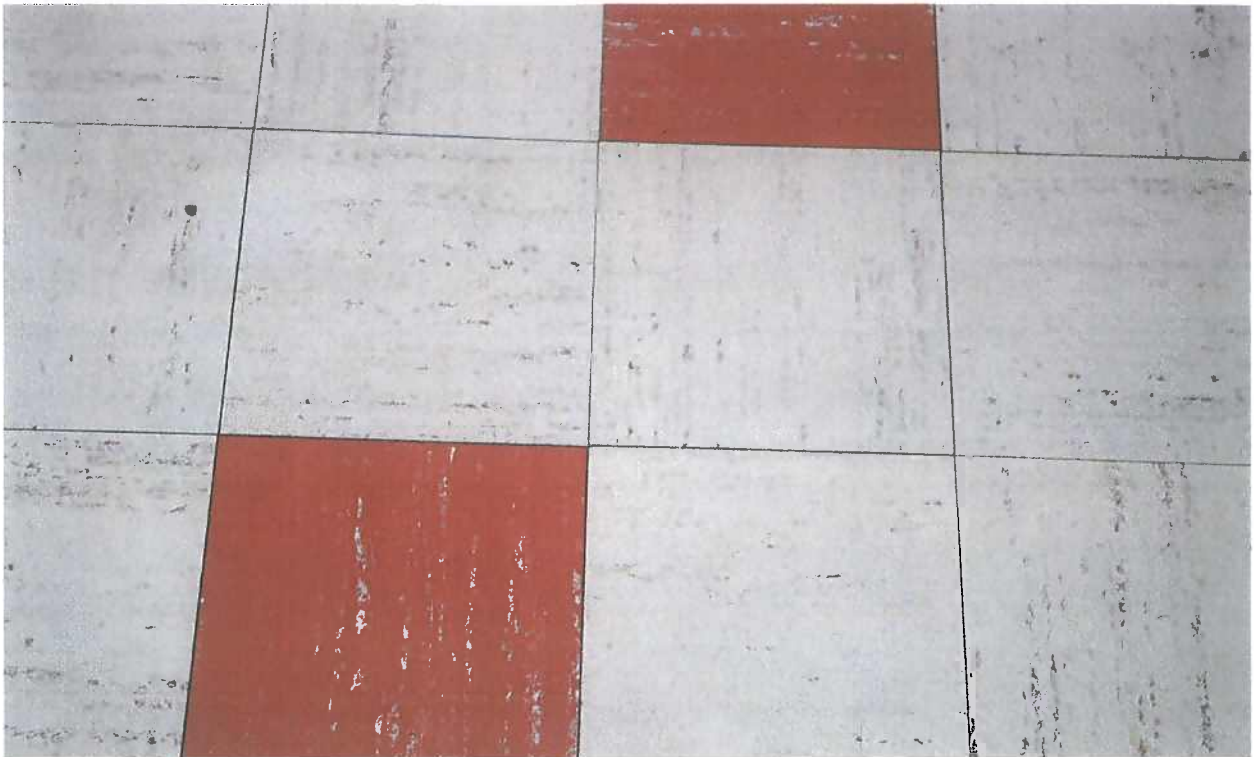
- 5.1 Floor tile – Some classrooms have the original 9"x9" VAT tiles which are being replaced by the Board as time and money allow.
- 5.2 The terrazzo in the entrance vestibules and washrooms is in very good condition.

Figure 6 Original VAT tiles – replacement plan is on-going.

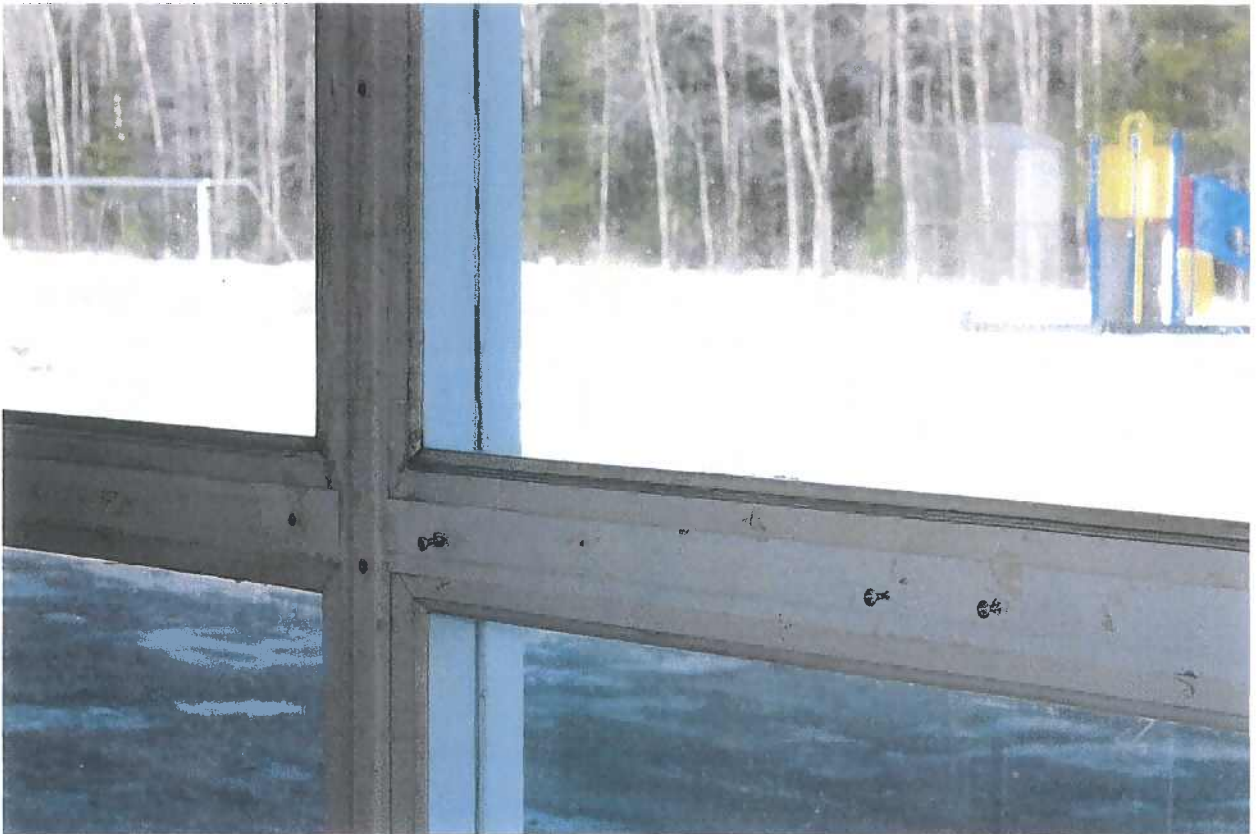
Figure 14 Original windows

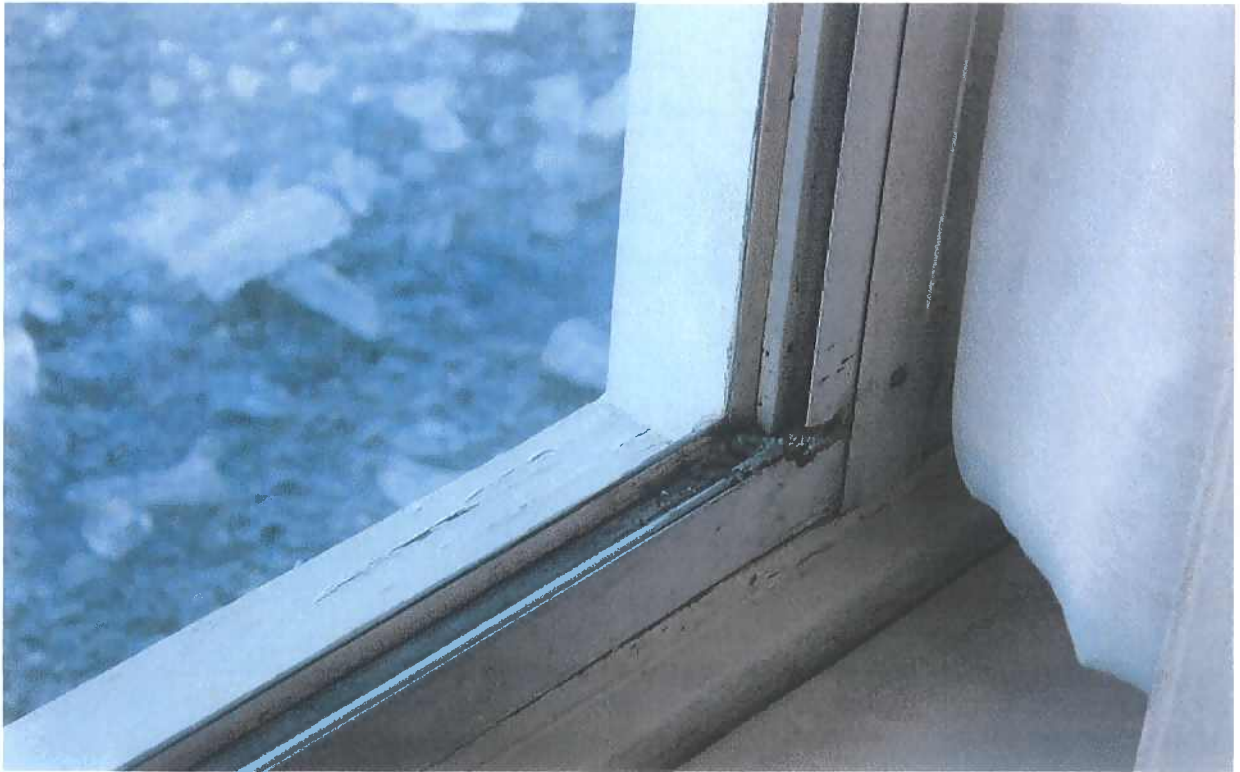
- 4.4 The windows and doors are original and are therefore 44 years old. Some of the operable windows are single glazed. All the windows and doors need to be replaced.

Figure 15 Windows are 44 years old.

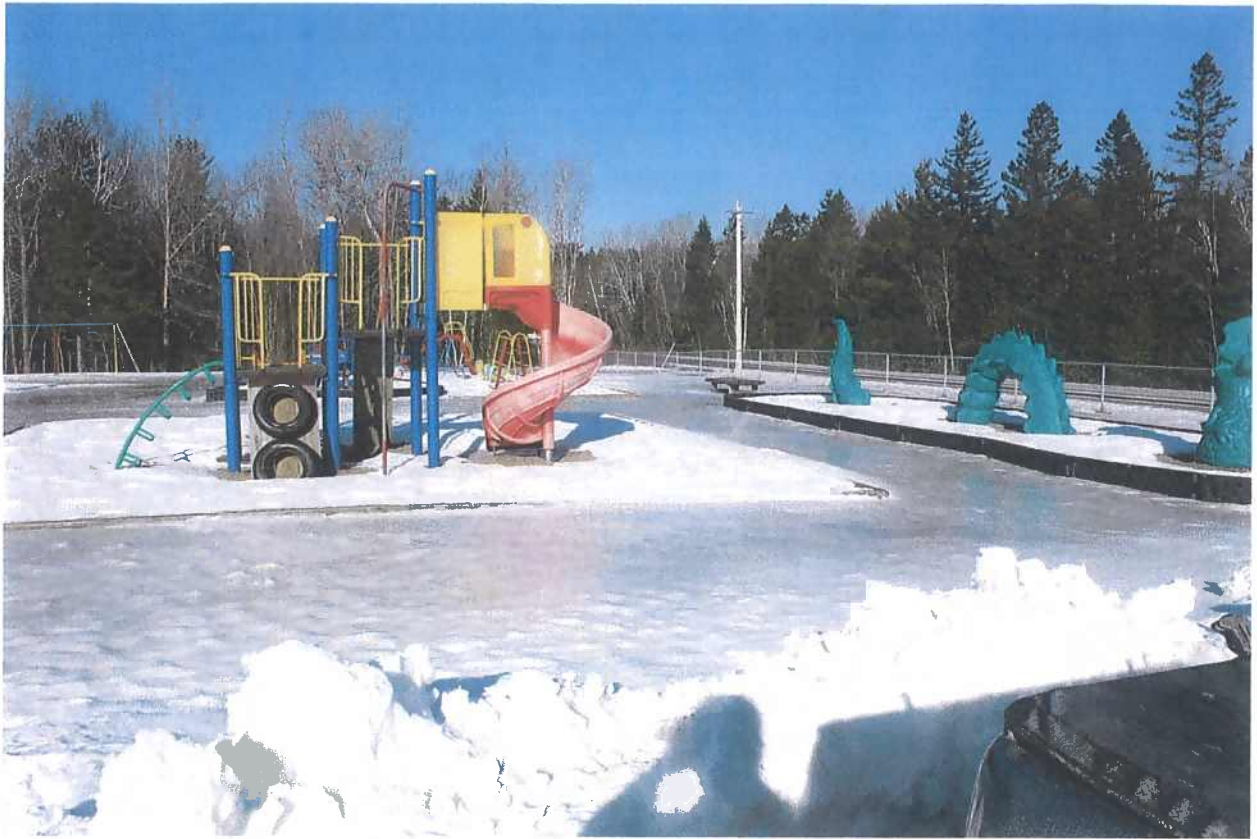
Figure 19 Playground Equipment is in excellent condition

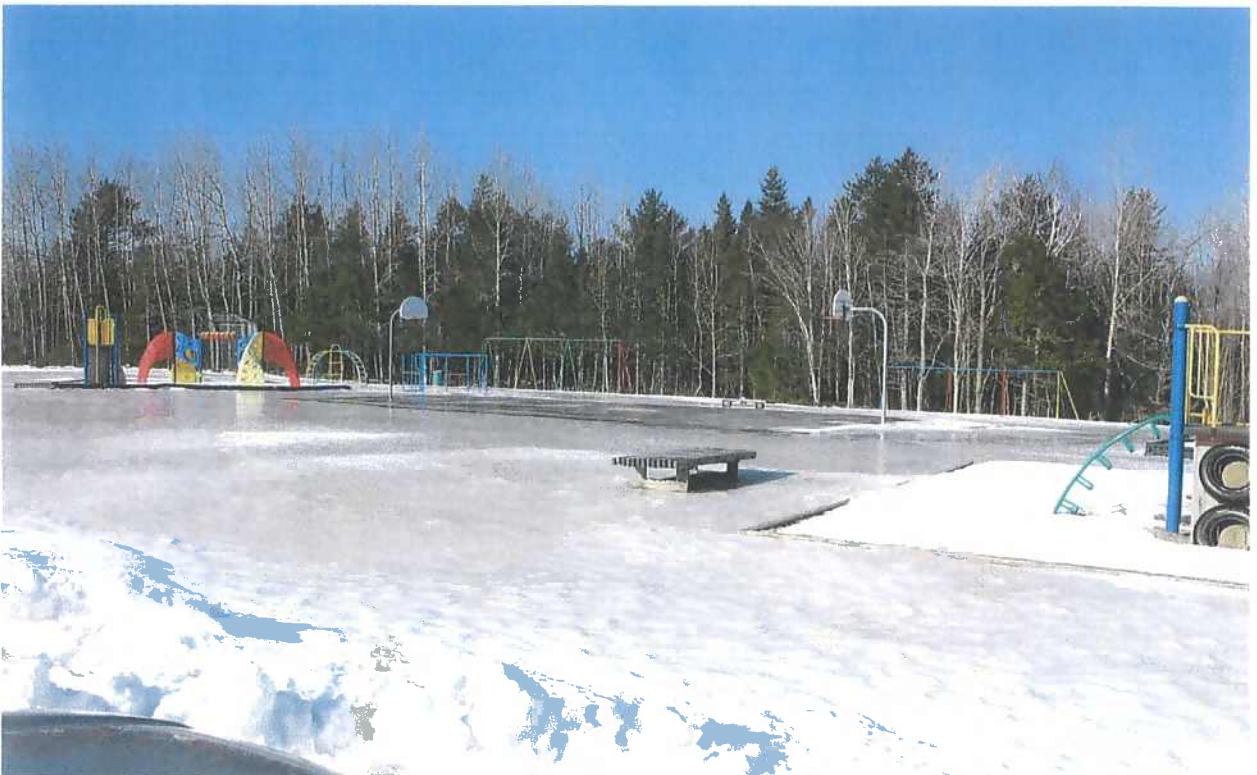
Figure 20 Sports field is in good condition.
