South Shore Regional School Board

Elementary Schools Assessment March 2009

Building Audit
Petite Riviere Elementary School

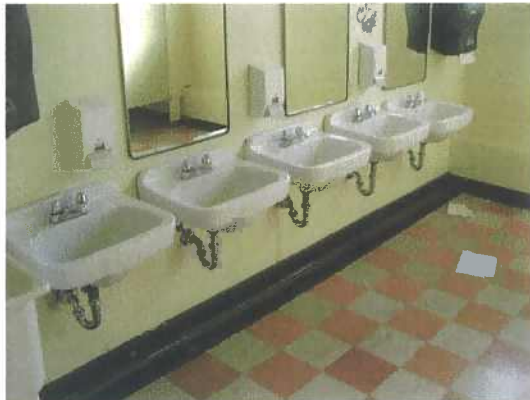
1. The faucet on the custodial sink is original and should be replaced with trim that is equipped with a vacuum breaker.
2. The two remaining original water closets should be replaced.
3. The original urinals are near the end of their expected service life and should be replaced within the next 5 to 10 years.
4. The original lavatories are near the end of their expected service life should be replaced within the next 5 to 10 years.

Mechanical Picture #1
Existing lavatories

D2010	Replacement of custodial sink trim	\$2,000.00
	Upgrade of lavatories	\$8,000.00
Plumbing Fixtures	Upgrade of urinals	\$5,000.00

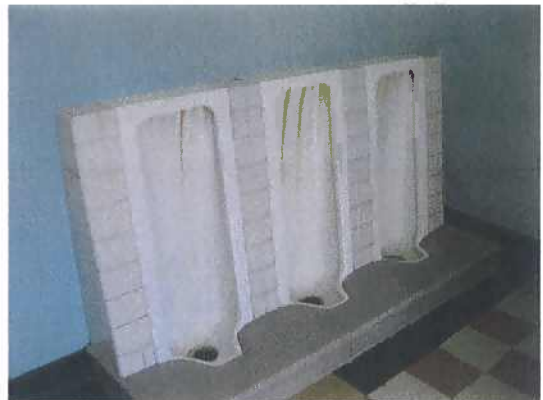
Mechanical Picture #2
Existing urinals

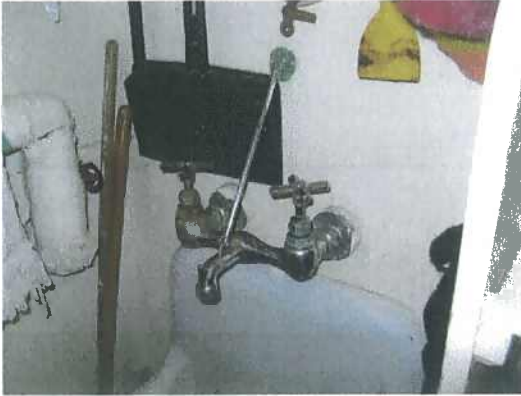
Mechanical Picture #3
Custodial sink trim

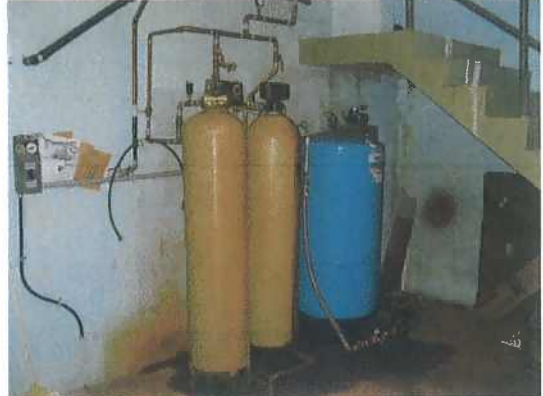
The water treatment system currently installed consists of an air injection pump and two iron removal filters manufactured by Water Conditioning Canada. Although the equipment is functioning, iron removal systems of this nature are typically not reliable, as it is difficult to manage air removal, and automatic air vents can fail.

A chemical analysis of the treated water (raw water sample not available) was provided by the School Board. The analysis report provided covers samples taken in 2006, 2007 and 2008. The results indicate turbidity and manganese exceed the recommended limit as set by the Canadian drinking water quality guide. The limit set for manganese is based on aesthetic objectives; therefore, the guideline does not consider it to have a health based impact. Turbidity however, must be maintained below the maximum acceptable concentration (MAC) as set by the guideline. Because the results provided are for treated water, it is unclear if high turbidity is a source issue or if it is being generated by the plumbing system in the building. The report indicates the levels of turbidity have steadily increased from 2006.

Mechanical Picture #4
Water system

1. Provide additional filtration measures to reduce turbidity level below the MAC. The existing water treatment equipment should be replaced with a modern system for iron and manganese removal. The new system would include an air injection compressor pump and aeration and precipitation tank and iron removal filters. Further treatment would include the addition of chlorine or ultra violet light as a means of disinfection.
2. The existing well is susceptible to contamination should a floor or oil leak occur in the boiler room. In addition, the use of sanitary well seals is no longer permitted to cap a well. We recommend a new supply well be drilled outside the building complete with a new pump, pitless adapter and vermin proof vented pitless well cap.

We recommend immediate action be taken to provide a treatment system to supply water that meets the requirements of the Guideline for Canadian drinking water quality. These recommendations are based on the treated water; a more accurate recommendation could only be provided based on a raw water sample from the supply.

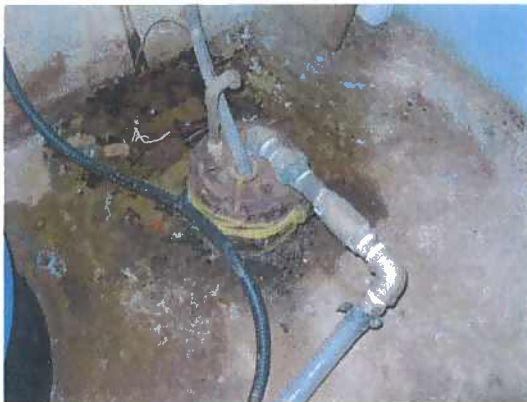
Mechanical Picture #5
Existing well in boiler room

The school is served by a drilled well, located in the basement of the school. This would not meet current well drilling regulations.

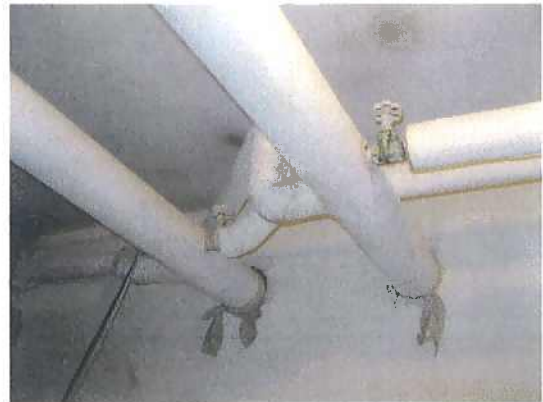
The domestic water distribution system is primarily copper piping with soldered joints. The mains originate in the boiler room and are then piped under the floor of the multi purpose room before exiting above grade. The majority of the isolation valves are gate style; many have been replaced with ball valves on an "as required" basis. The life expectancy of a copper plumbing system is typically 40+ years depending on the water quality. The condition of the domestic water distribution is difficult to discern without examining sections of the piping; however, the water supply at this facility has a high iron content which is evident from stains on the plumbing fixtures. Based on past experience, distribution piping of this age supplying water with high iron content would require replacement. We recommend the system be reviewed for replacement within the next 5 years if the building is to remain in use.

Mechanical Picture #6
Original gate valves (domestic water)

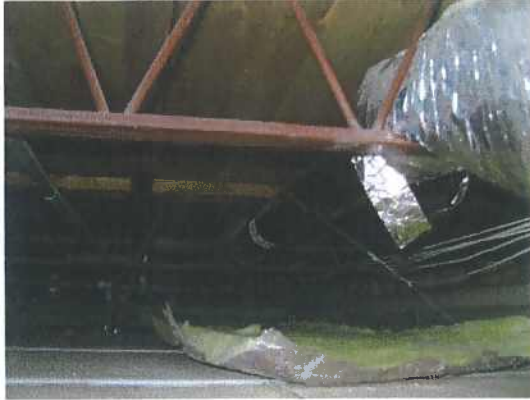
The rain water drainage system for the building consists of roof drains and cast iron rainwater leaders although repairs to the system have been completed with ABS pipe. Sections of insulation have fallen off the pipe. A clean-out cap in the rainwater leader piping in the boiler room has been removed for use as an indirect drain for the boiler relief valve. This is a concern as the boiler room could be flooded in the event of a back-up.

Mechanical Picture #7
ABS rain water leader with damaged insulation

Again, the exact condition of the existing rainwater drainage system should be determined using video inspection before a decision is made as to whether replacement is necessary. Further recommendations include repairing any un-insulated sections of piping and replacement of any ABS piping with PVC. These recommendations should be undertaken within the next 5 years.

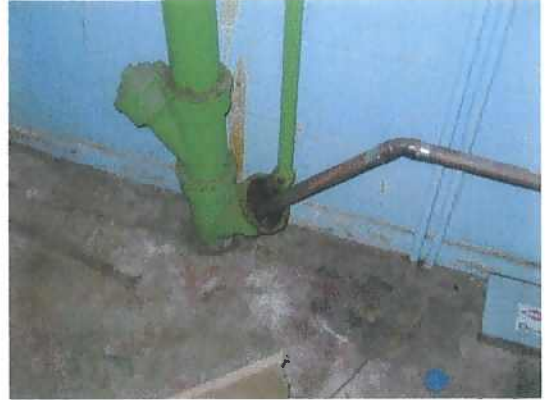
Mechanical Picture #8
Open cleanout on rainwater leader

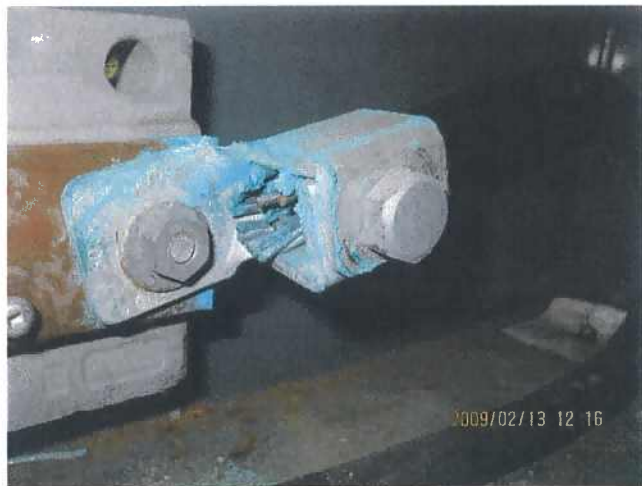
**Electrical Picture #3
Electrical Basement Splitter
Terminal Corrosion.**

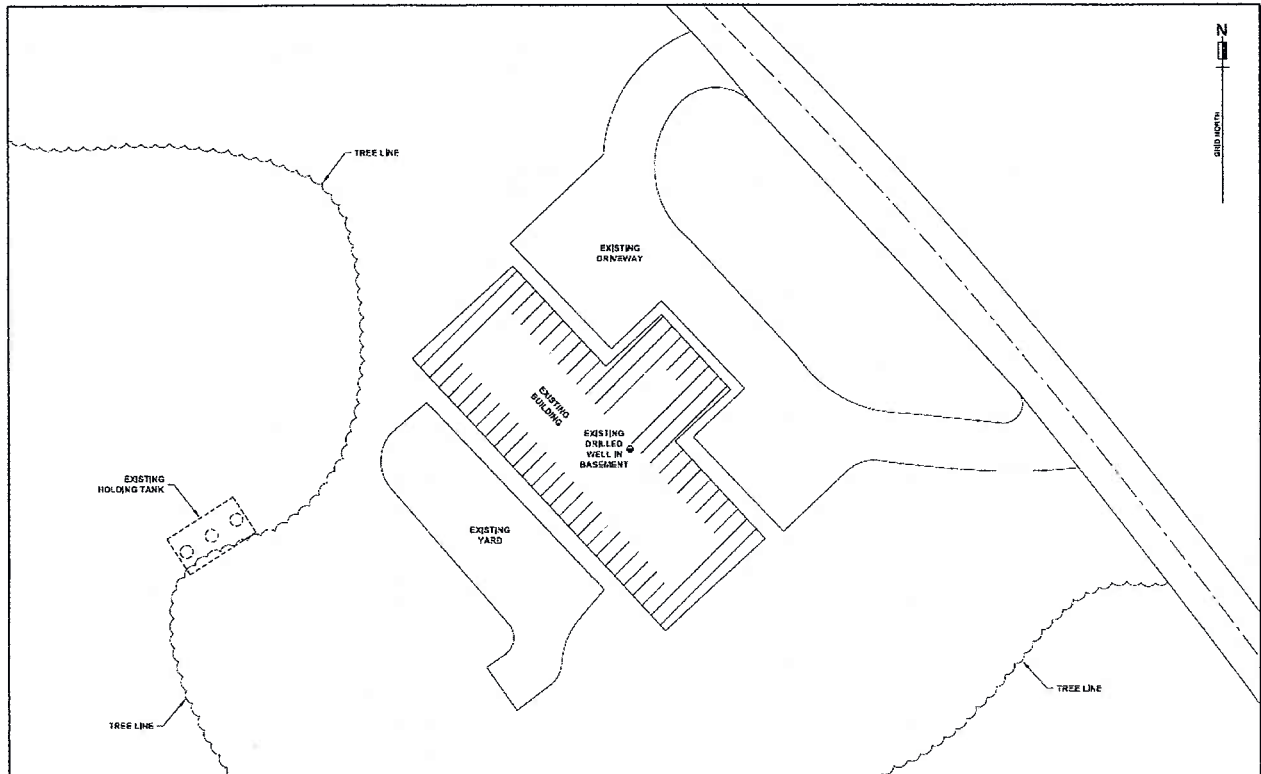
Sewage Management at this school is accomplished, or attempted, by means of a 13,650 gallon holding tank (see figure 10). The tank is located behind school and has large trees growing over it (figure 11). In addition, it has not been pumped out since 1989. It therefore is not functioning as a holding tank anymore. Signs of malfunction were looked for, but with the snow cover, none were found. The tank is located at the crest of a steep slope towards the river, and is almost certainly leaching partly treated effluent to the river via shallow groundwater flow, and possibly overland flow in the spring.

Figure 10 - Site sketch showing location of holding tank for Petite Riviere school

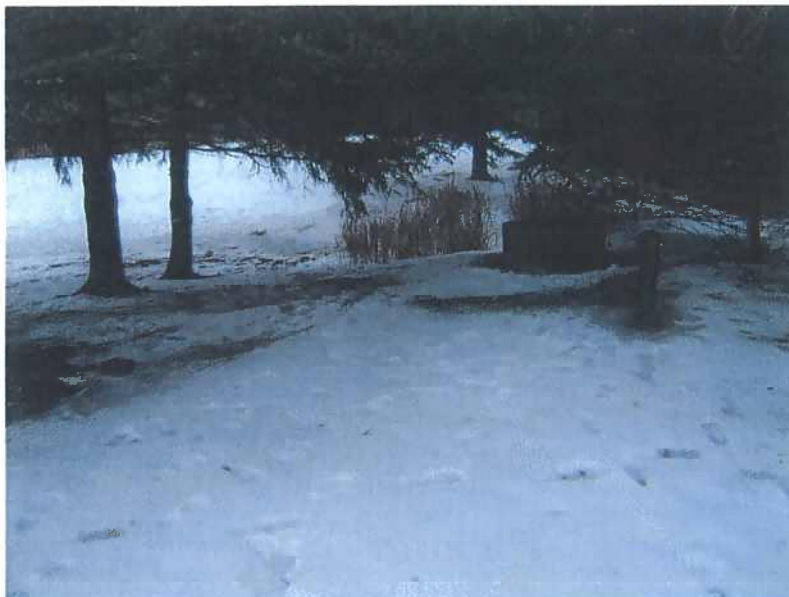
Figure 11 – Holding tank at Petite Riviere School

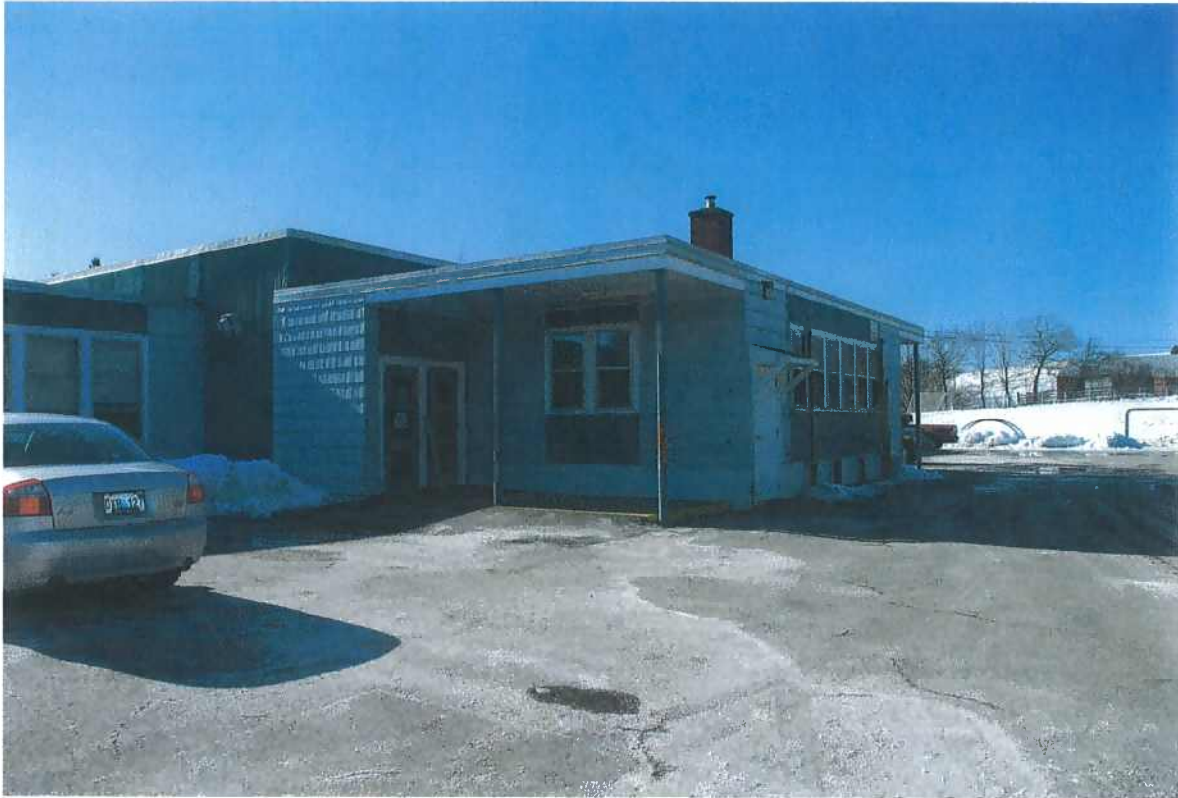
- 1.1 **The underground coal bunker is located below the school bus driveway (see item 2.6). This condition of this structure is unknown. We recommend no further vehicular traffic over this area, especially school busses, until this bunker can be removed.**
- 1.2 **The sewage disposal system is not functioning and may be leaching into the surrounding area, including the Petit Riviere River. This situation should be addressed immediately.-see also site services section of this report.**

Figure 1 Front Entrance – Underground coal bunker is below the driveway, directly in front of the school.

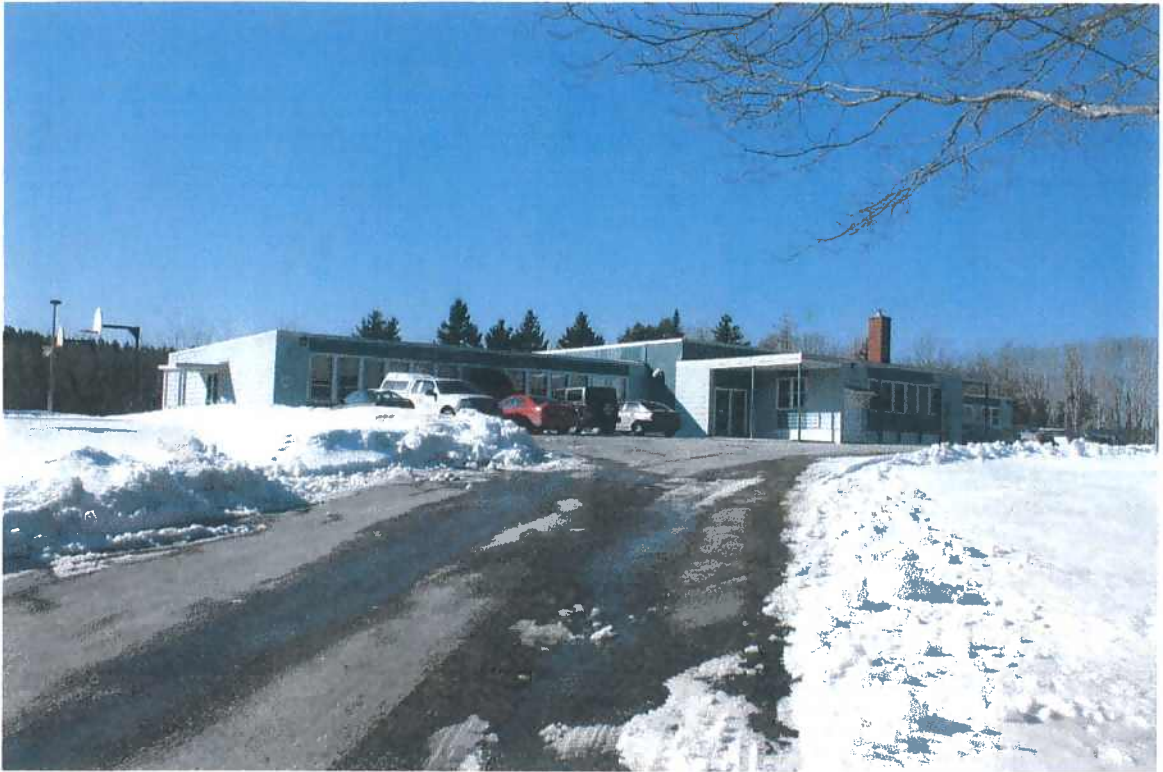
- 3.1 Paving: The paving in front of the school is in poor condition, does not drain properly and needs replacing. This should be done in conjunction with the removal of the coal vault. The gravel areas behind the school should also be paved.
- 3.2 Playground equipment – all new and in excellent condition.
- 3.3 The basketball courts are in good condition.
- 3.4 The sports field is in good condition but prone to poor drainage in the spring.
- 3.5 Site drainage – good.

Figure 3 Pavement is in poor condition

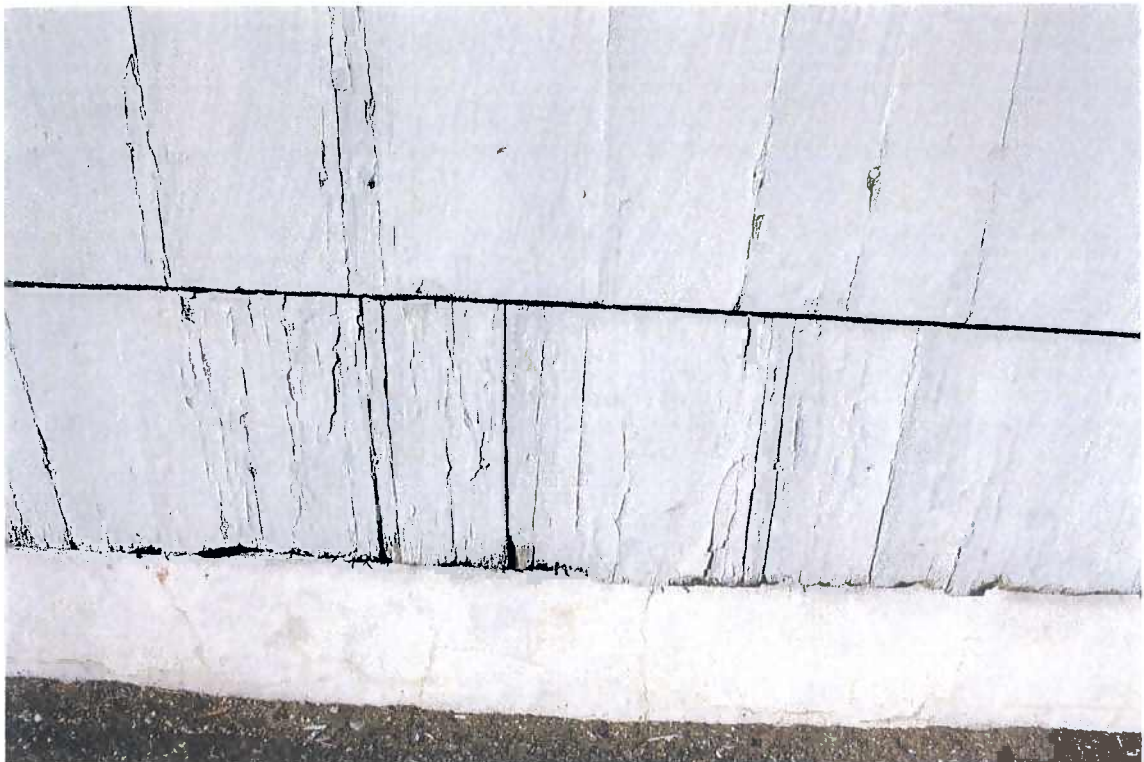
Figures 6 The lower courses of shingles should be replaced and the sheathing checked for rot. All remaining shingles should be scraped and painted.

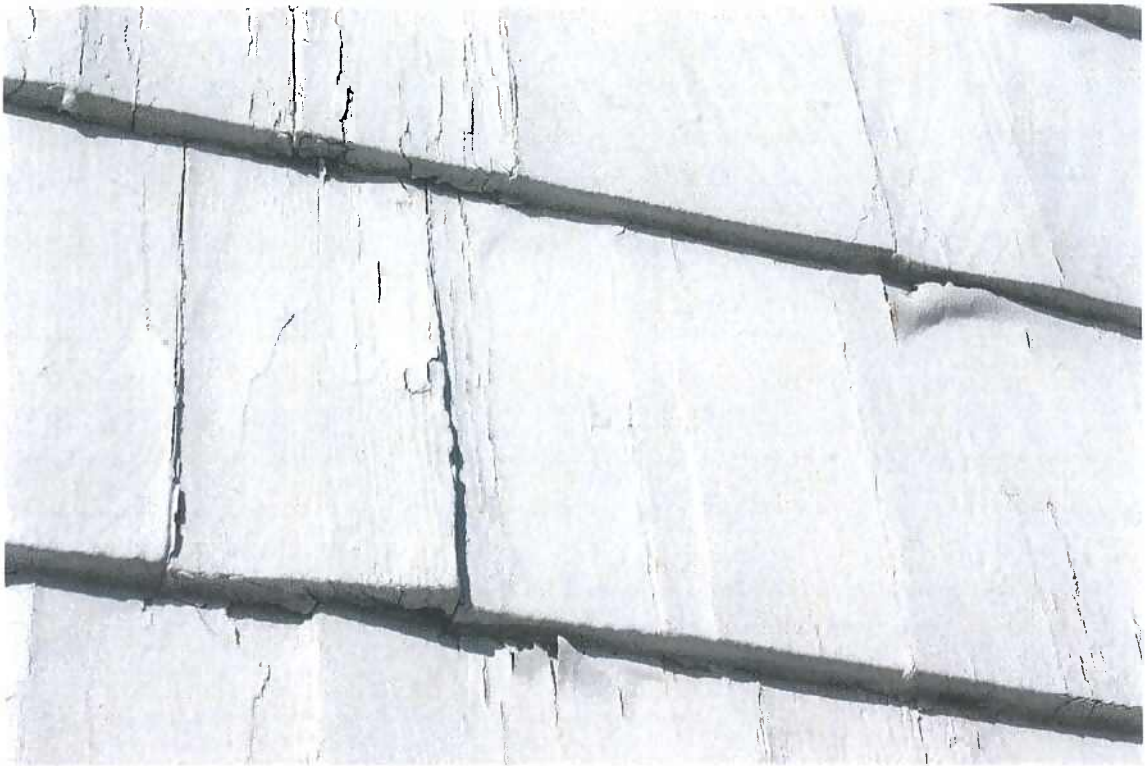
Figure 7 Shingles need attention.

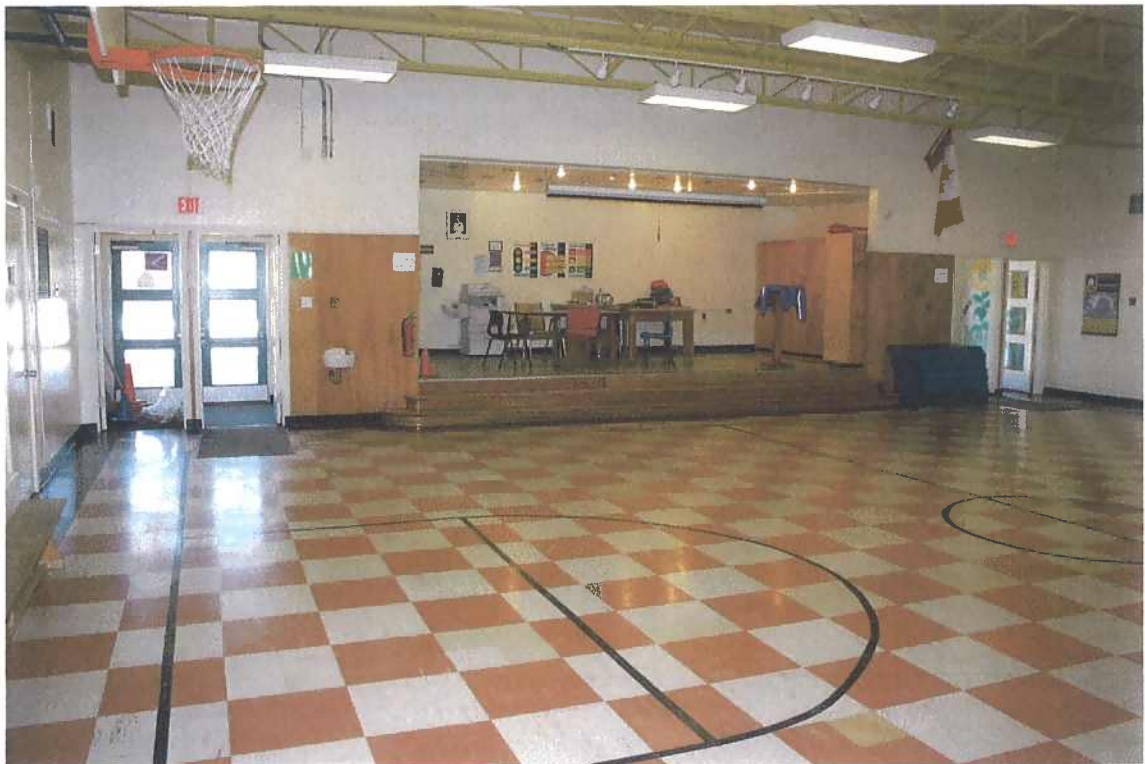
Figure 8 Gym / Multi purpose room. Note: lack of accessible access to stage. Principal's office and Administrative office are accessed from stage.

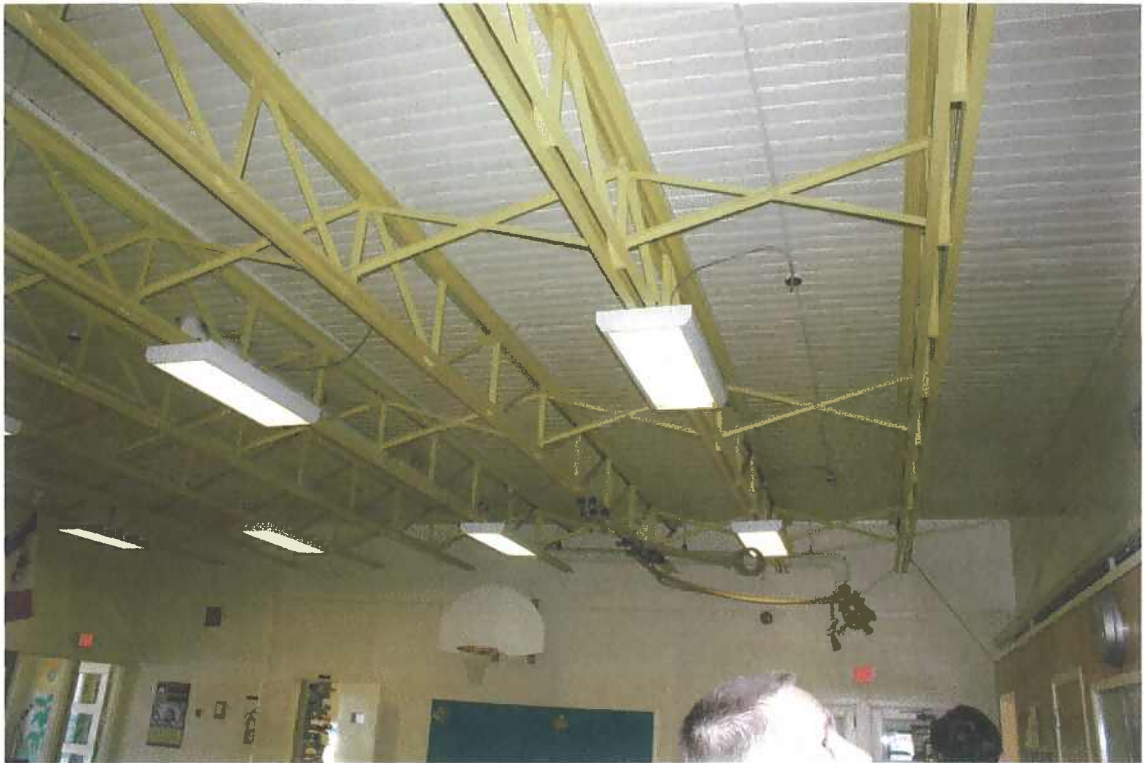
Figure 9 Exposed steel joints could be replaced with suspended acoustic tile ceiling to reduce noise.

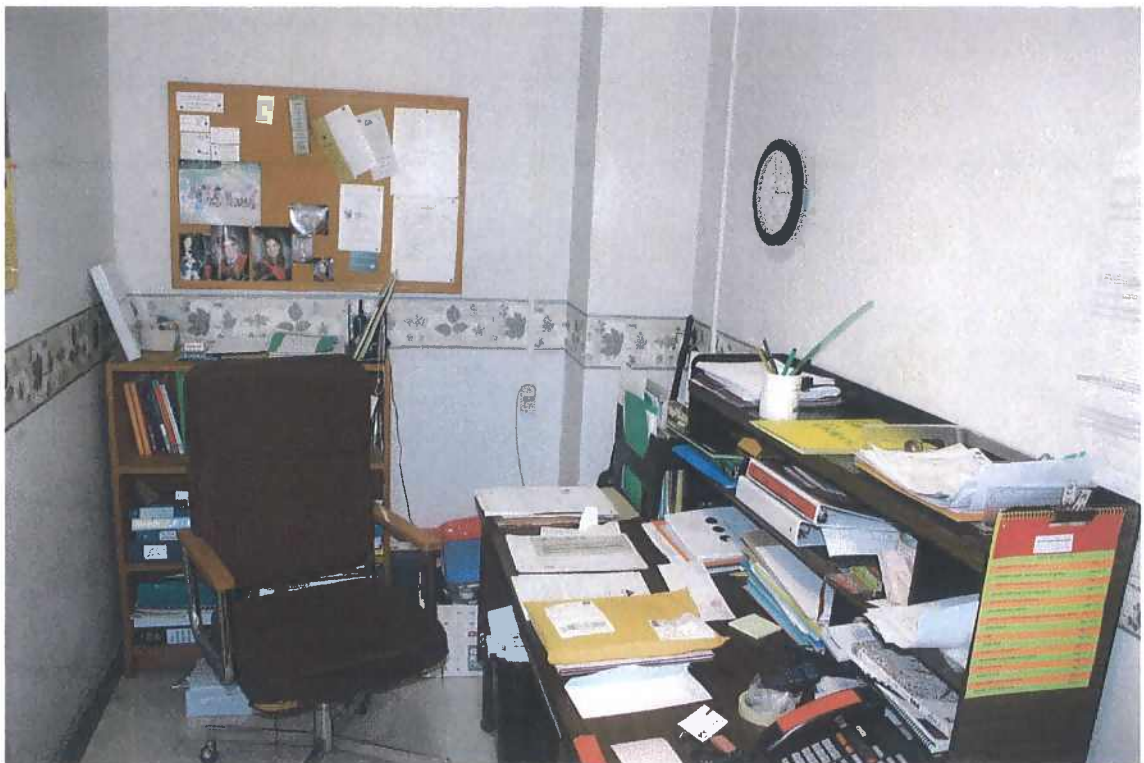
Figures 10 Administrative space and staff space is very limited. This is the Principal's office.

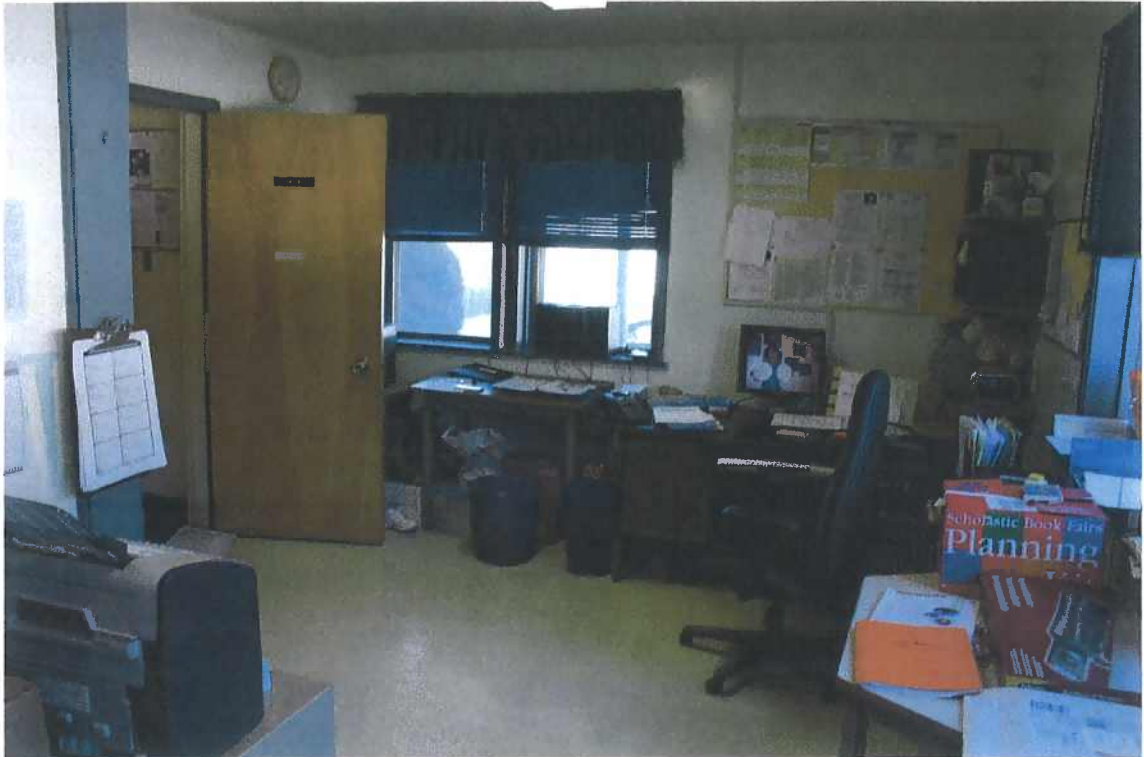
Figure 11 Administration area, accessed via the stage.

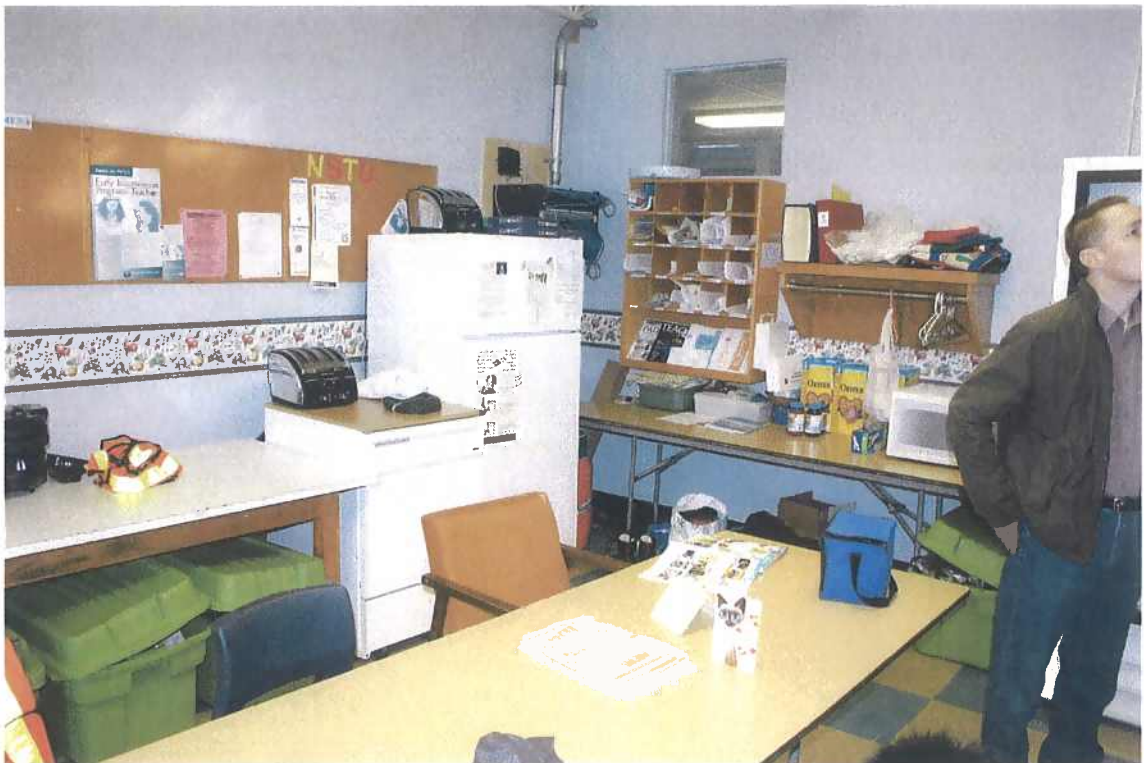
Figure 12 Limited storage space.

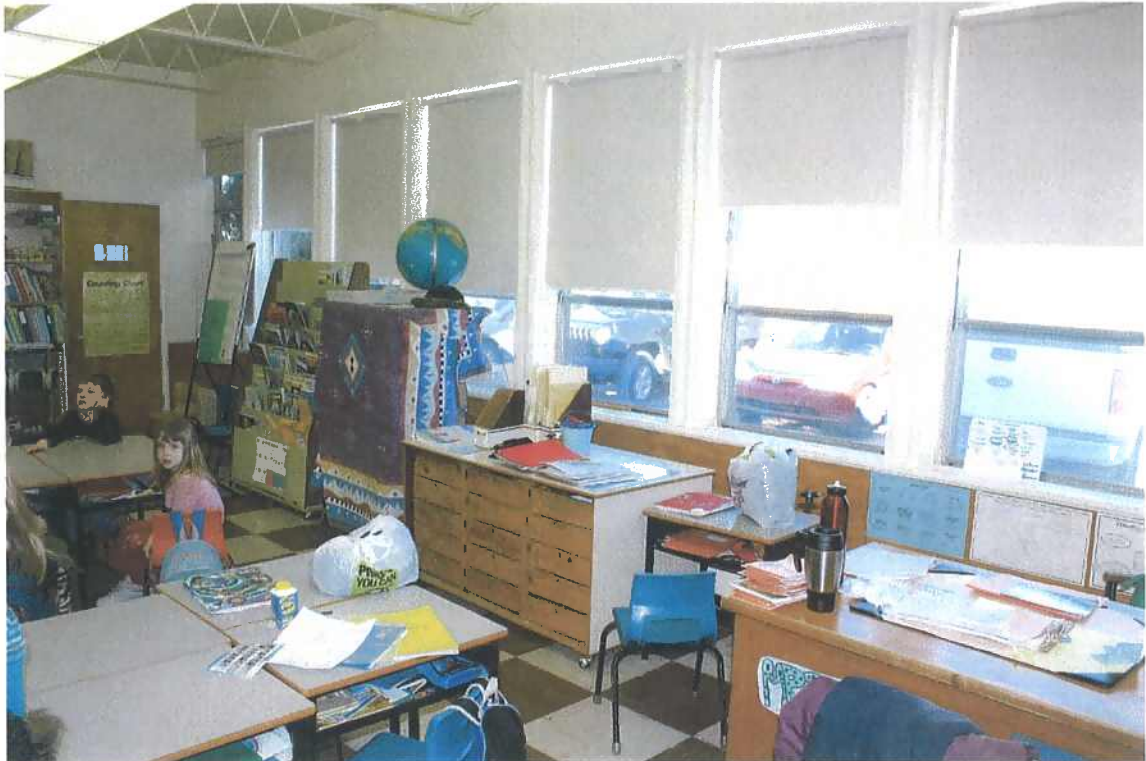
- 5.3 The wall around the gym, where the gym is higher than the classroom block, is prone to leaking which should be addressed. This could be done in conjunction with the roof improvements recommended in 4.1 above.
- 5.4 The windows and doors are the original and are therefore 48 years old. There is evidence of rot in the wood window frames. Some windows are difficult to open. All the windows and doors need to be replaced. The wood panels above and below the windows have been replaced in the past and could be left in place and repainted. Note: One pair of doors at the end of the south corridor is new and does not need replacing.

Figures 13 Windows and doors are 48 years old and need to be replaced.
