**Property Condition Assessment
(PCA) For Pentz Elementary School,
2680 331 Hwy, Pentz, NS**

FINAL REPORT

Project No: 133430692

February 23, 2016

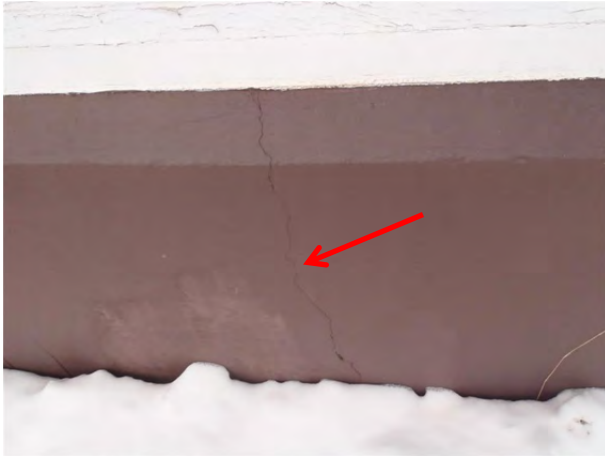
Hairline to 1/32" wide foundation cracks were noted on the exposed poured concrete below the windows on the north and south sides of the school (Photo 4.1.1). These cracks appear

approximately every 8 feet along these two walls. Hairline cracks were also noted on the small exposed area of concrete below the block on the southeast side of the building. For all foundation cracks from hairline to $\frac{1}{4}$ " it is recommended that repair be completed by chemical injection. For cracks greater than $\frac{1}{4}$ " and larger areas of concrete loss, the damaged concrete is to be chipped away, if rebar is exposed a corrosion inhibitor is to be applied and then new concrete or mortar is to be applied. Crack repairs are to be done to prevent water infiltration.

Photo 4.1.1 – Cracking below windows on north and south sides

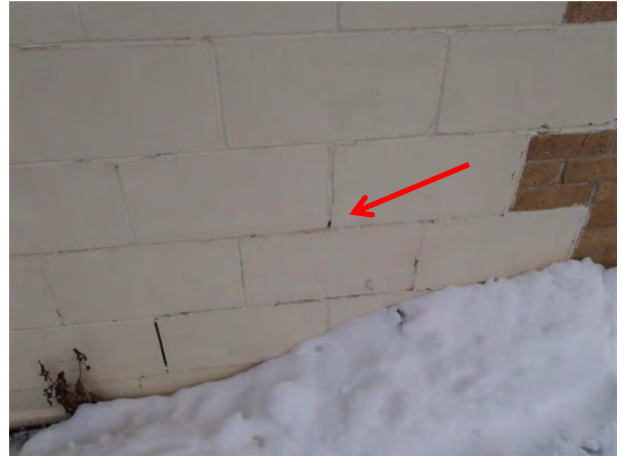
Deterioration of the concrete block mortar and fine step shaped cracking was noted on the northeast corner of the building (Photo 4.1.2), southeast side near the door (Photo 4.1.3) and an area of material loss was noted on the southeast corner of the Mechanical Room (Photo 4.1.4). These areas should be repointed and repainted to ensure no water infiltration. A step crack was also noted in the region between the Mechanical Room and the stage on the south side (Photo 4.1.5) which should also be repointed.

Photo 4.1.2 – Cracks and deteriorated mortar on northeast corner

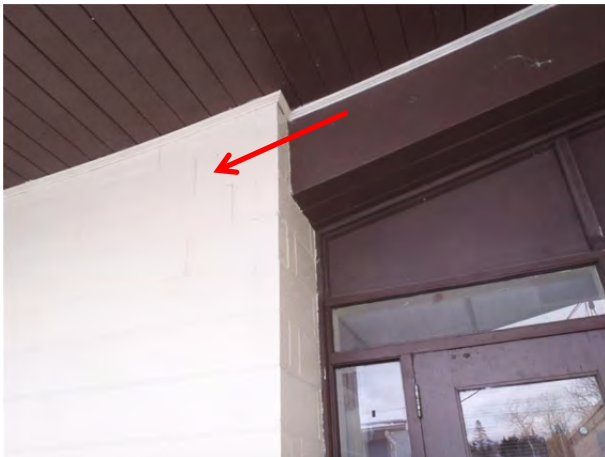
Photo 4.1.3 – Step crack in block mortar on southeast side

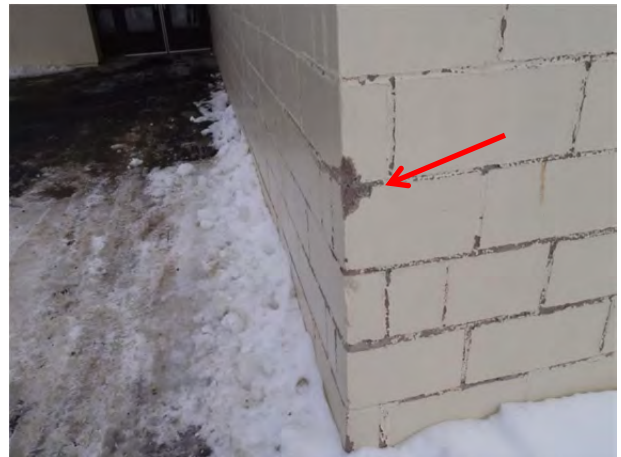
Photo 4.1.4 – Exposed grout and area of material loss. Southeast corner of mechanical room

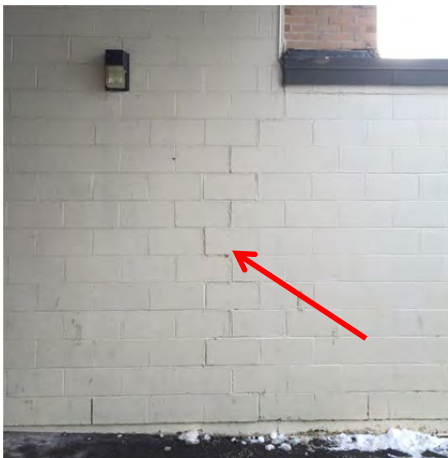
Photo 4.1.5 – Cracks in block mortar at area between the mechanical room and stage

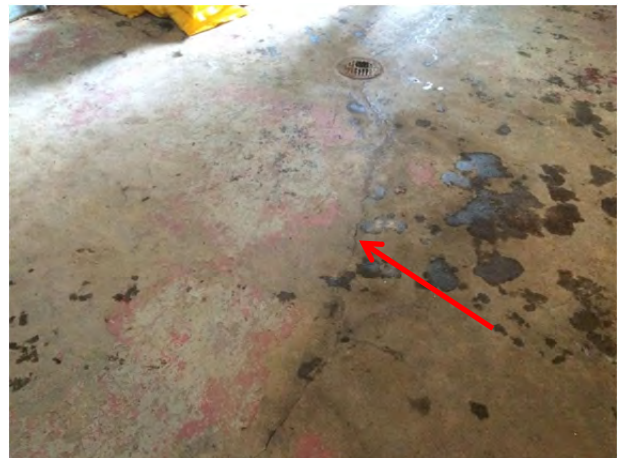
In the Mechanical Room cracks were noted in the floor slab which should be repaired to prevent water infiltration (Photo 4.1.6). Concrete spalling was noted in several areas, which should be repaired to prevent further loss of material (Photo 4.1.7). The housekeeping pad below the boiler on the south side of the room showed significant deterioration and exposed rebar and should be repaired to provide a stable support for the boiler (Photo 4.1.8). Corrosion was also noted on the steel stairs inside the boiler room (Photo 4.1.9). The corrosion should be removed, any loss of material reported and repaired followed by the application of primer and paint to prevent further damage.

Photo 4.1.6 – Crack in mechanical room floor

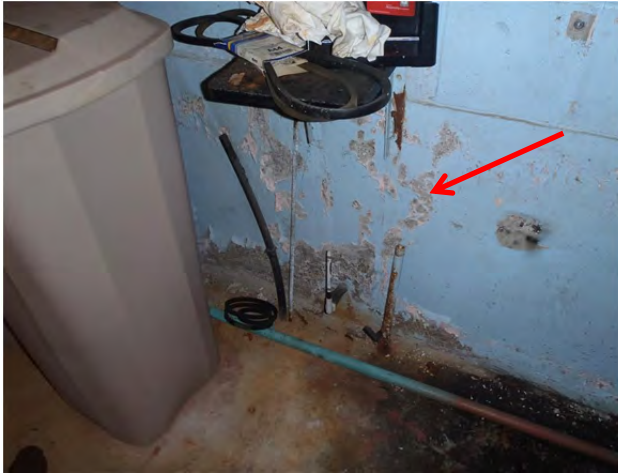
Photo 4.1.7 – Concrete spalling on interior of mechanical room foundation

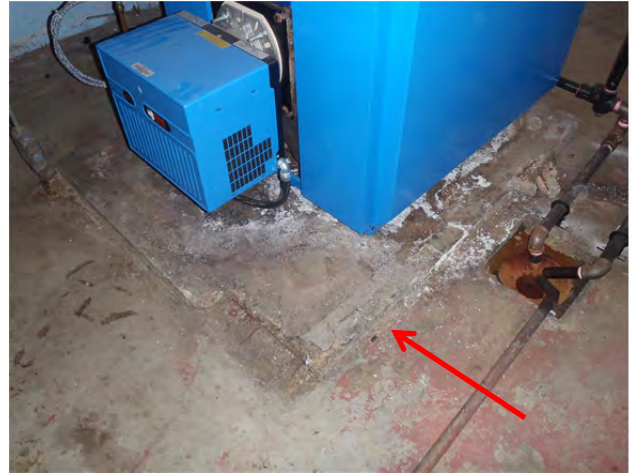
Photo 4.1.8 – Deteriorated housekeeping pad below boiler

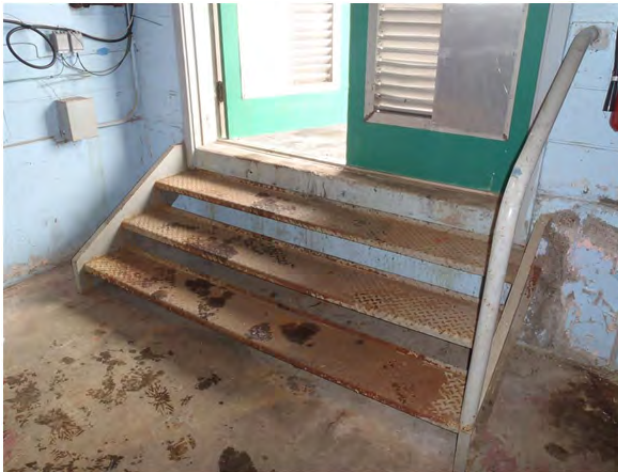
Photo 4.1.9 – Corroded stair into mechanical room

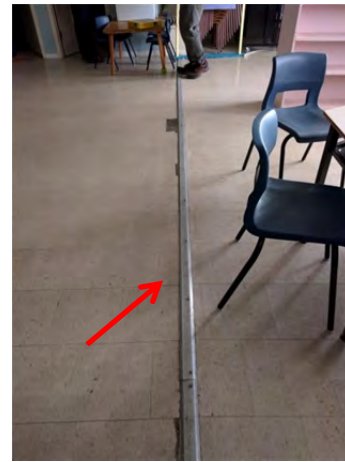
The portable classroom showed signs of structural concern. There was a significant high point in the floor running along the centerline joint of the building (Photo 4.1.10). Also, there was a corresponding ceiling crack in the drywall running down the centerline of the building (Photo 4.1.11). Further structural investigation via the underside of the structure is required to determine whether the foundations and frost protection are adequate. The cause of the movement will determine the extent of the repairs required. The structural assessment and determination of the remaining useful life should be performed prior to any other updates to the building.

Photo 4.1.10 – High point in classroom portable floor

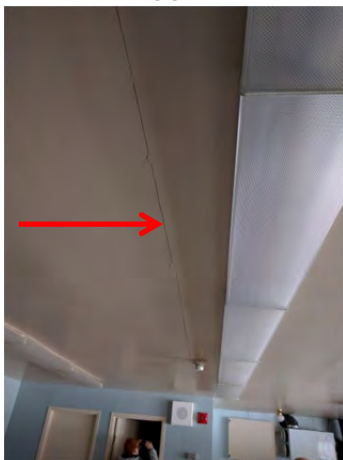
Photo 4.1.11 – Ceiling crack along centreline of classroom portable ceiling

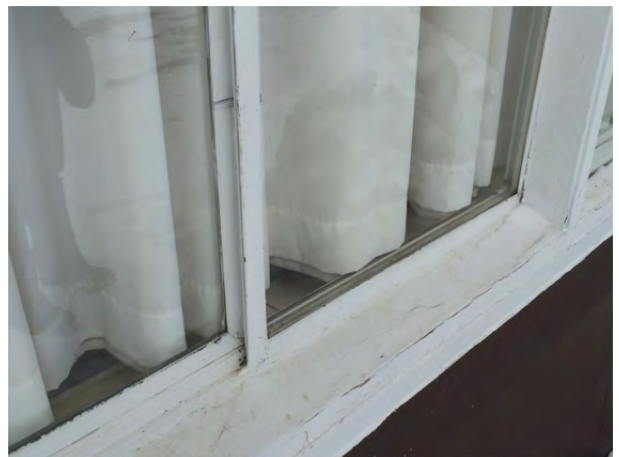
Photo 4.2.4 – Wood framed windows along the north face. Some paint peeling.

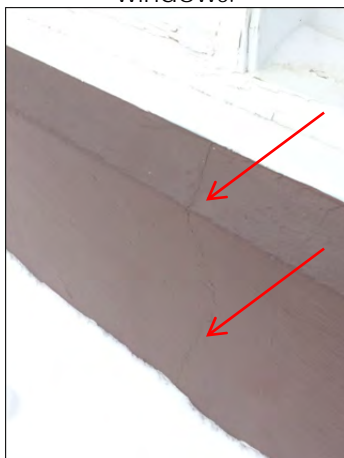
The poured concrete wall along the north and south sides of the building have some small vertical hair line cracks in many locations. Cost has been allocated in Section 4.1 Building Structure.

Photo 4.2.5 – Vertical crack in concrete wall. Smaller vertical cracks are typical along wall.

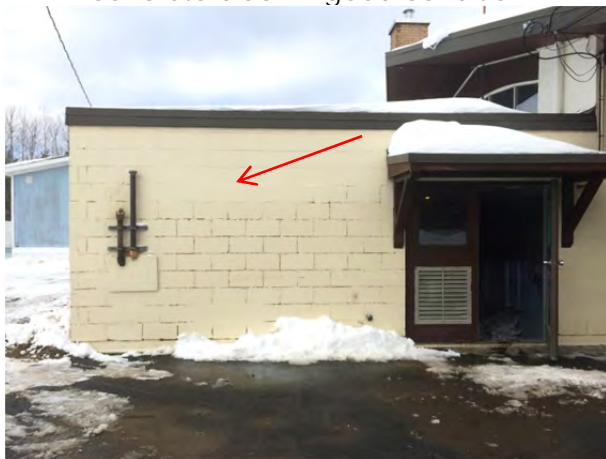
The exterior cladding is in overall fair condition, however the concrete block surrounding the boiler room at the east of the school was noted to have peeling paint between the blocks and damages to the block on the south wall. A vertical crack along the mortar seam of the south boiler room block wall was noted and costs have been allocated in the short term to repoint the mortar joints at this location. Costs are allocated in the short term to repaint the exterior of the boiler room block wall when the resealing of the crack is completed.

Photo 4.2.11 – North face of boiler room. Located at east side of school. Painted joints in concrete block peeling

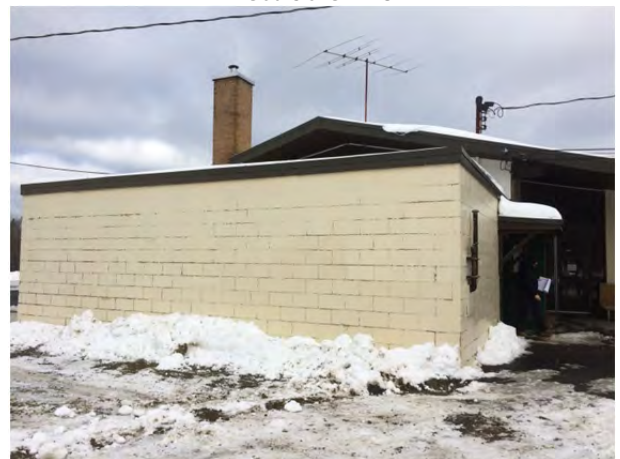
Photo 4.2.12 – East face of the boiler room. Painted joints in concrete block peeling

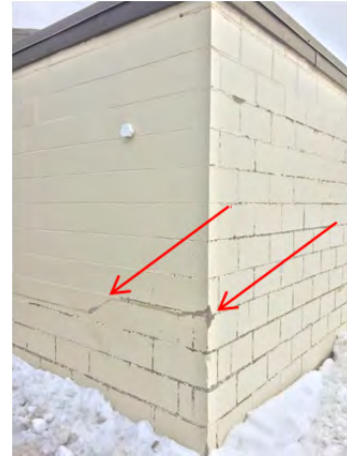
Photo 4.2.14 – South east corner of boiler room. Damages to surface paint and to the concrete block

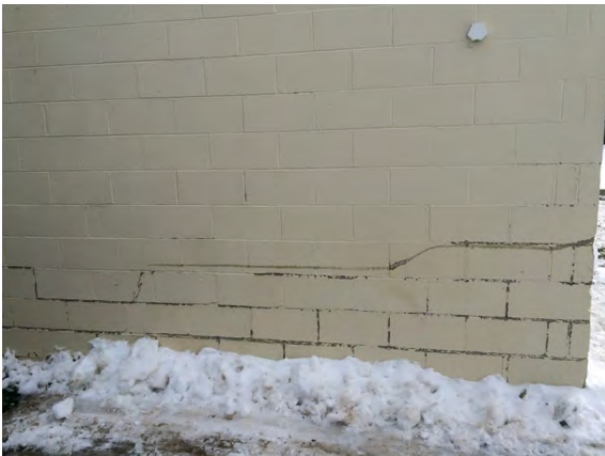
Photo 4.2.15 – South face of boiler room. Paint peeling between concrete block joints and damage to block

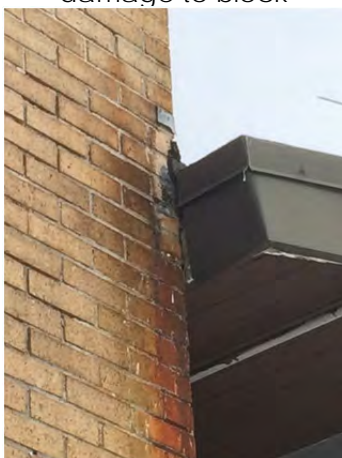
Photo 4.2.17 – Damage at connection between chimney and roof over stage area

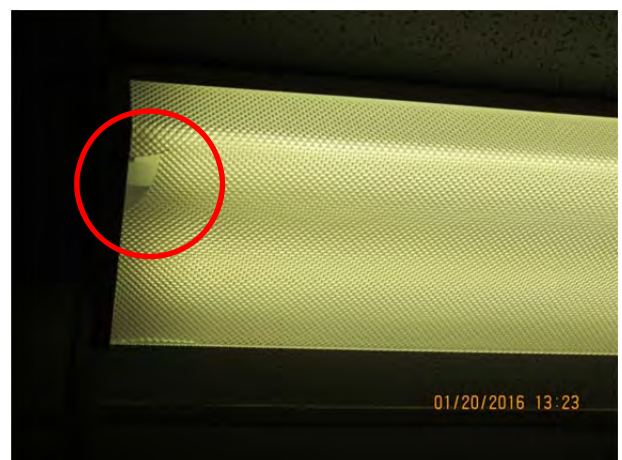
Photo 4.5.30 – Crack in lens of 1'x4' fluorescent luminaire in the boys washroom

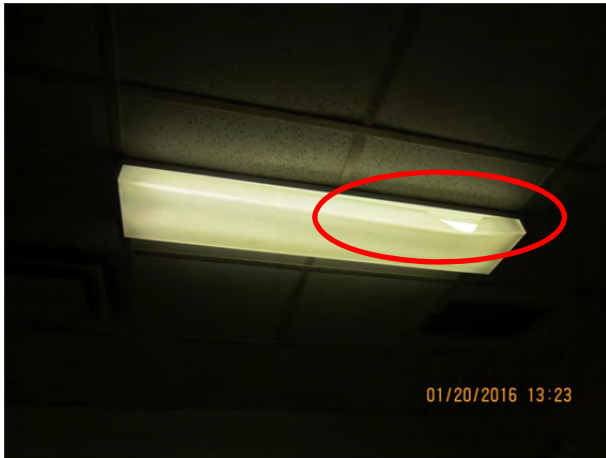
Photo 4.5.31 – Additional cracked lens on 1'x4' surface-mounted fluorescent luminaire in boys washroom

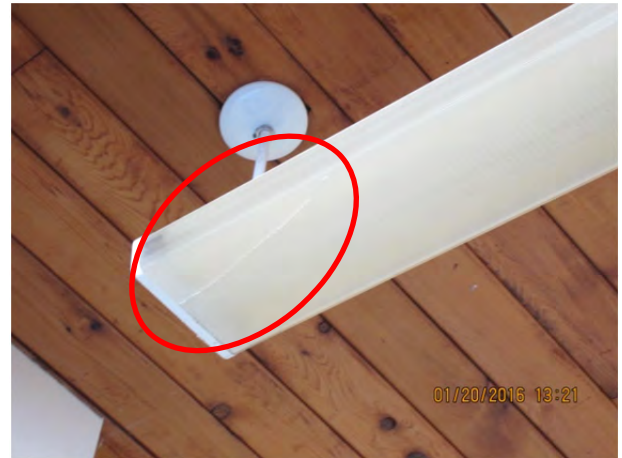
Photo 4.5.32 – Cracked lens of suspended 1'x4' luminaire in Principals office

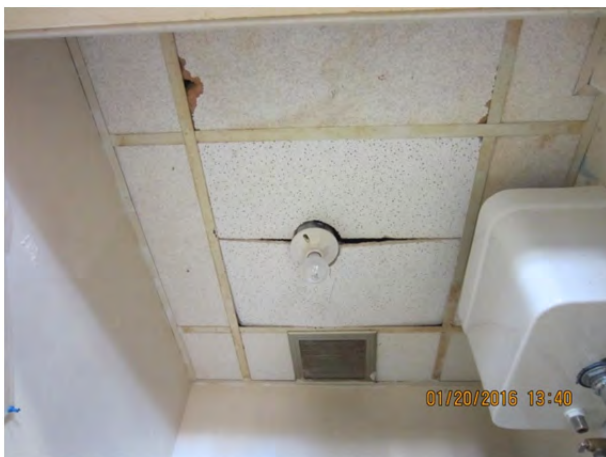
Photo 4.5.33 – Damaged ceiling tile in Janitor's Room

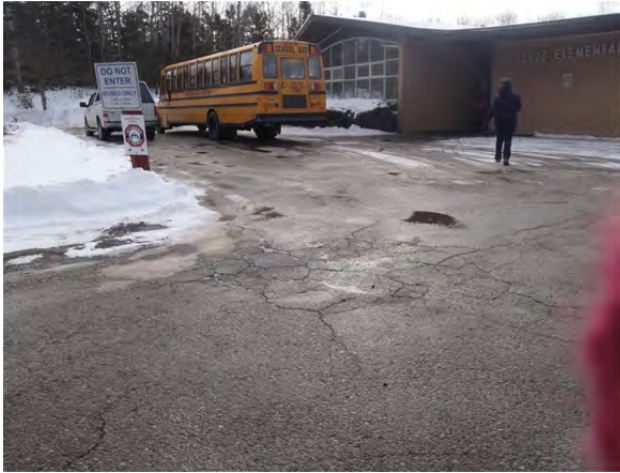
Photo 4.6.1 – Cracking in asphalt on bus loop

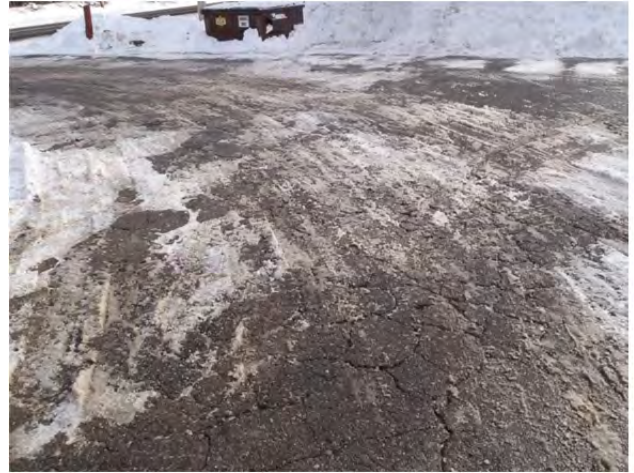
Photo 4.6.2 – Significant cracking in asphalt on bus loop

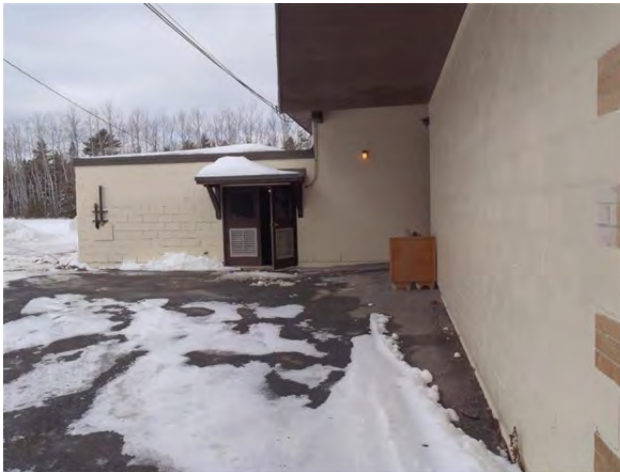
Photo 4.6.3 – Uneven asphalt on northeast side of school

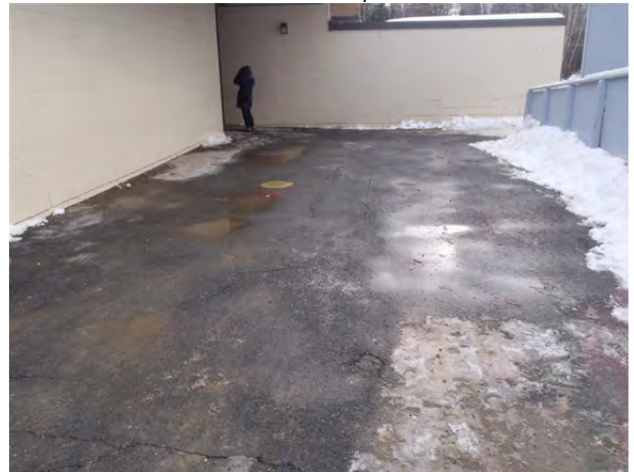
Photo 4.6.4 – Uneven asphalt on southeast side of school

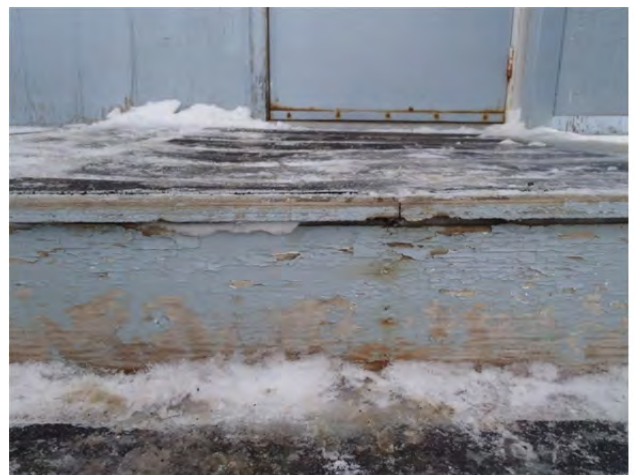
Photo 4.6.6 – Rotted area at top landing of portable classroom stair/ramp

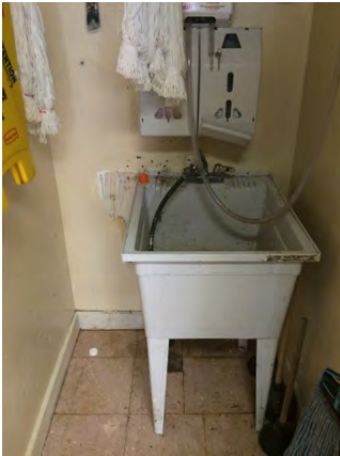
Photo 4.8.3 – Janitor Closet. Water damage to wall and floor.

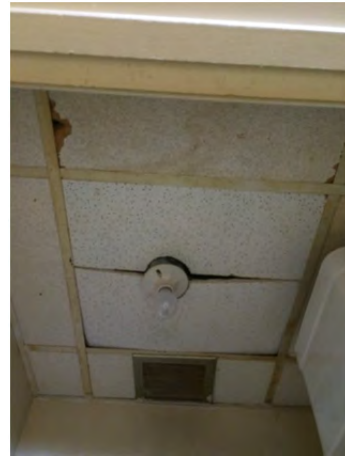
Photo 4.8.4 – Janitor Closet ceiling tile damaged and should be replaced.
