**Property Condition Assessment  
(PCA) For Petite Riviere Elementary  
School, 123 Wentzell Rd,  
Lunenburg, NS**

**FINAL REPORT**

Project No: 133430692

February 23, 2016

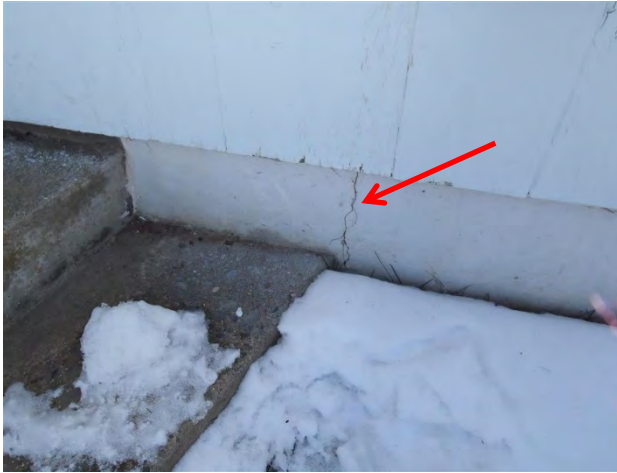
Hairline to 1/32" wide foundation cracks were noted on the exposed poured concrete around the perimeter of the school (Photo 4.1.1). These cracks appear approximately every five to six

feet around the building. Typically for all foundation cracks from hairline to ¼" it is recommended that repair be done by chemical injection. For cracks greater than ¼" and larger areas of concrete loss, the damaged concrete is to be chipped away, if rebar is exposed a corrosion inhibitor is to be applied and then new concrete or mortar is to be applied. Crack repairs are to be done to prevent water infiltration. Given that these cracks are below the slab it is recommended that they be monitored and only repaired if there are changes or issues arising from them.

Photo 4.1.1 – Crack in foundation on south side of school

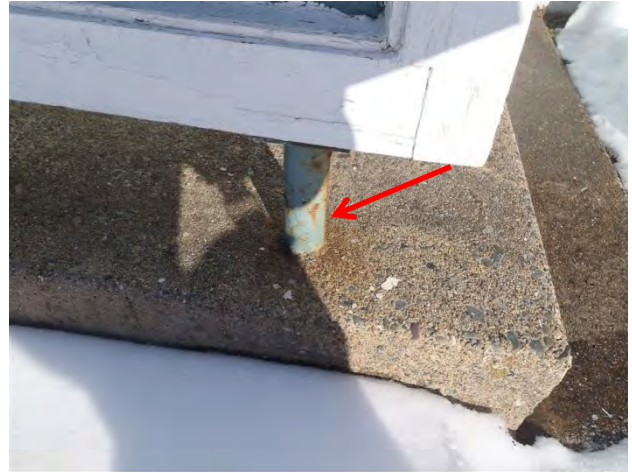
Corrosion was noted on the steel feet supporting the windscreens on the east side of the building (Photo 4.1.2) and the columns at the main entrances on the west side of the building (Photo 4.1.3). It is recommended that the corrosion be removed, any loss of material reported and repaired if required, and then the items be primed and repainted to prevent any further deterioration.

Photo 4.1.2 – Corrosion on windscreen support on east side of building

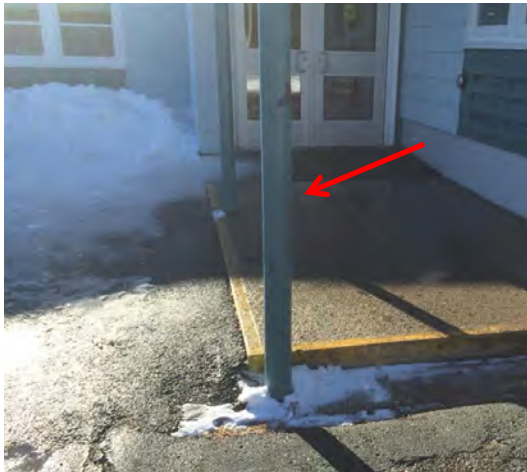
Photo 4.1.3 – Corrosion on column at northwest entry

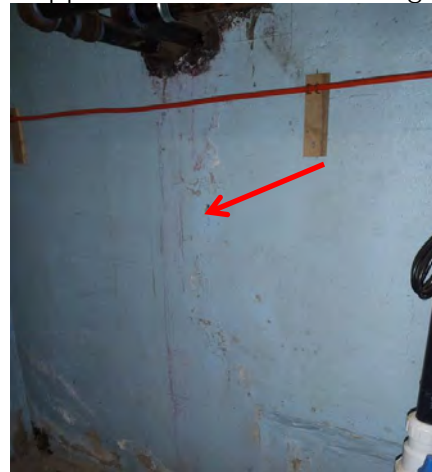
In the Mechanical Room a hairline crack was noted in the south end of the west concrete wall below piping which should be repaired to prevent water infiltration (Photo 4.1.4). Damage was noted on the nosing of several of the concrete stair treads leading to the basement which is a slipping and tripping hazard (Photo 4.1.5). Deterioration of the bottom stair was also present and it should be replaced (Photo 4.1.6). For all foundation cracks from hairline to ¼" it is recommended that repair be done by chemical injection. For cracks greater than ¼" and larger areas of concrete loss, the damaged concrete is to be chipped away, if rebar is exposed a corrosion inhibitor is to be applied and then new concrete or mortar is to be applied.

Photo 4.1.4 – Crack in west wall of mechanical room

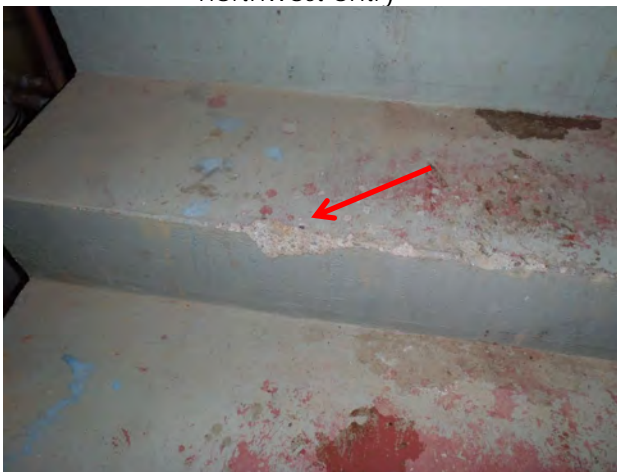
Photo 4.1.5 – Chip in stair nosing leading to mechanical room

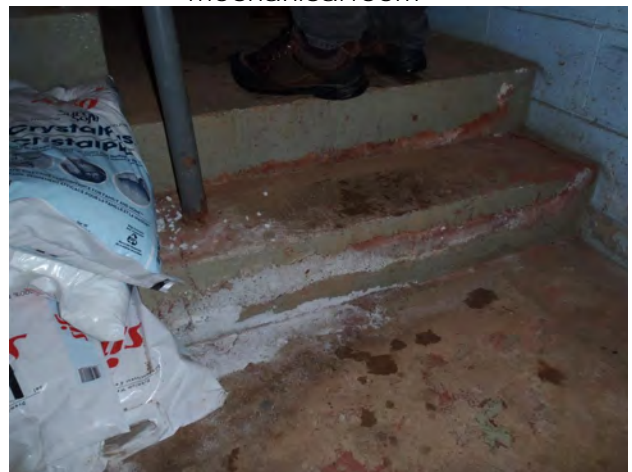
Photo 4.1.6 – Deteriorated bottom stair leading to mechanical room

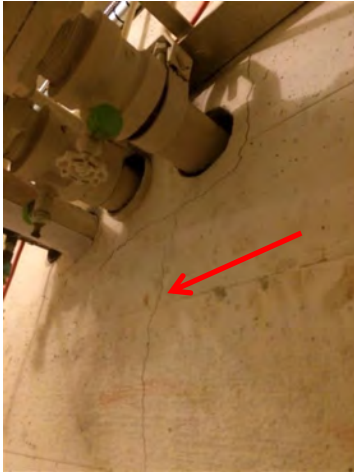
In the Electrical Room below the stage, fine cracks were noted in the walls and should be repaired, particularly in the east wall below and around the pipe penetrations (Photo 4.1.7). It is also recommended that the large gouge in the floor be infilled as it is a tripping hazard (Photo 4.1.8).

Photo 4.1.7 – Crack in east wall of electrical room

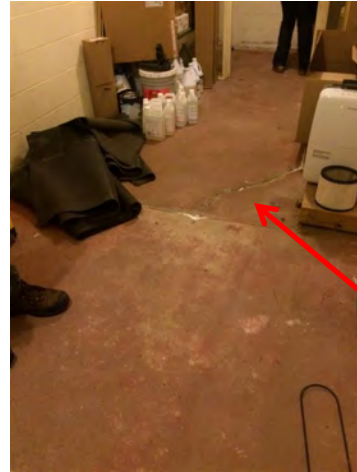
Photo 4.1.8 – Gouge in electrical room floor to be repaired.

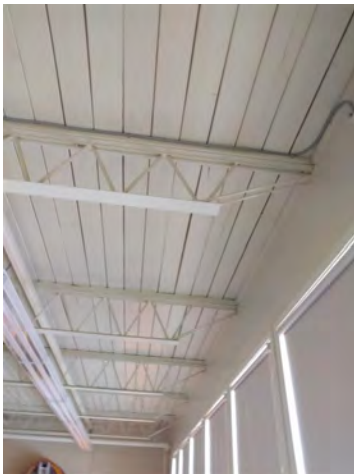
Throughout the school larger gaps between the tongue and groove roof/ceiling planks were present in some areas, however; no areas of complete separation between the members were noted (Photo 4.1.9). Also, some tongue and groove ceiling planks were noted to be split (cracked) longitudinally although they still appear to be structurally intact (Photo 4.1.10). These items should be monitored to ensure no further changes occur. Complete separation of the tongue and groove planks or complete cracking of the plank could cause a reduction in the structural strength of the roof. The following rooms outline where the issues were more prevalent, however this is not a comprehensive list of all areas. Splitting was noted in: Room 111 (Library), Room 114 (Primary), Room 120 (Resource) and Room 127 (Boys Washroom). Room 114 (Primary) also had one plank cracked transversely which should be repaired (Photo 4.1.11). Larger gaps between the planks were noted in: Room 111 (Library), Room 119, Room 120 (Teachers Room), and Room 120 (Resource).

Photo 4.1.9 – Gaps in ceiling planks in room 111 (library)

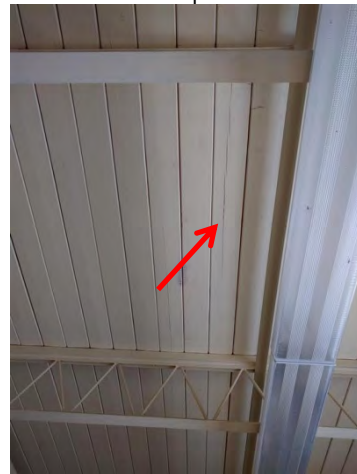
Photo 4.1.10 – Cracks in ceiling planks in room 120 (resource)

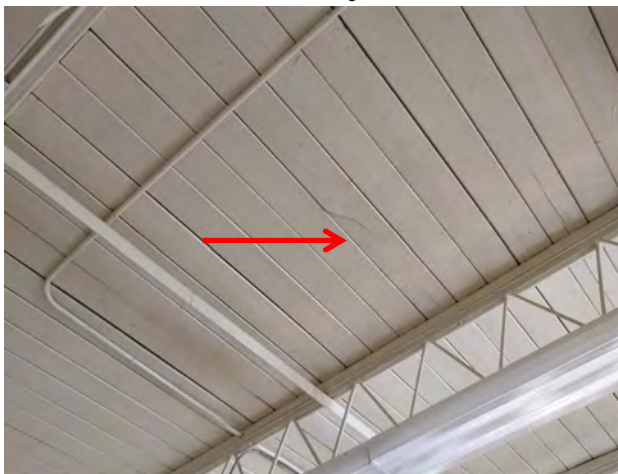
Photo 4.1.11 – Transverse crack in ceiling plank in room 114 (primary)

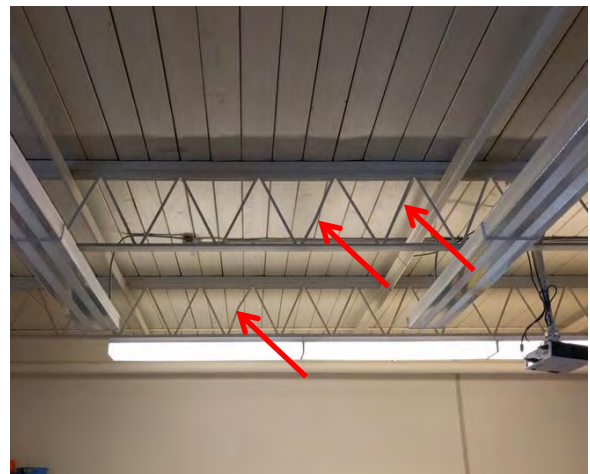
OWSJ were noted to have bent web members (Photo 4.1.12) in Rooms 112 and Room 127 (Boys Washroom) and lateral deflection of the bottom chord (Photo 4.1.13) was also noted in Room 114 (Primary), Room 118, Room 119, Room 123 (Girls Washroom), and Room 127 (Boys Washroom). Further investigation is required to determine the cause of bending in this joist and should be performed immediately. The opinion of cost provided in this report is an allowance for a detailed inspection of the bent joists and design of a structural reinforcement. The capital cost of the repair shall be determined after the inspection and engineering have been completed.

photo 4.1.12 – Bent web members in OWSJ in room 112

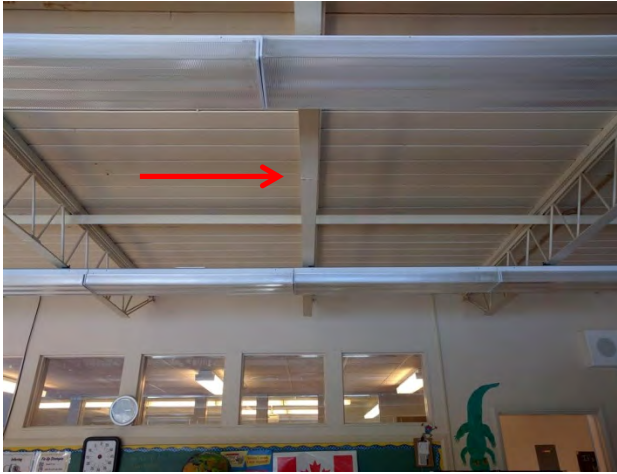
Photo 4.1.13 – OWSJ with bottom chord laterally deflected in room 119

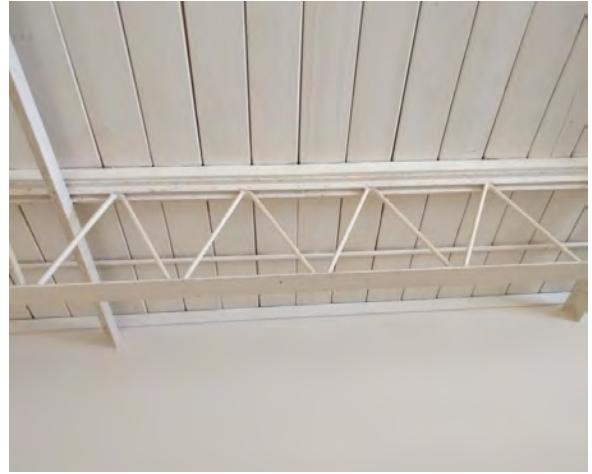
Corrosion was noted on the OWSJ and the lateral bracing in Room 127 (Boys Washroom) (Photo 4.1.14). It is recommended that the corrosion be removed, any loss of material reported and repaired if required, and then the joist and bracing be primed and repainted to prevent any further deterioration.

photo 4.1.14 – Corrosion on OWSJ and bracing in room 127 (boys washroom)

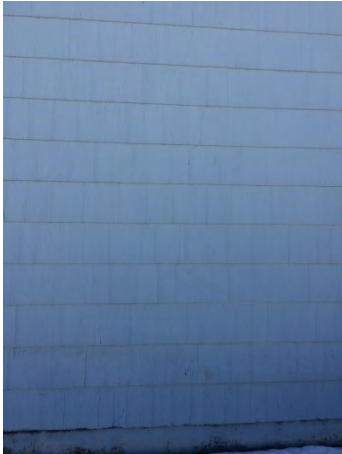
The exterior cladding is in overall good condition. Repainting of the wood shingles and siding is typically recommended every 5-7 years. Some wear of the paint was noted on each elevation. Costs have been allocated in the short term of the evaluation period to repaint the exterior of the building.

Photo 4.2.7 – Example of painted wood shingle wall cladding in fair condition overall

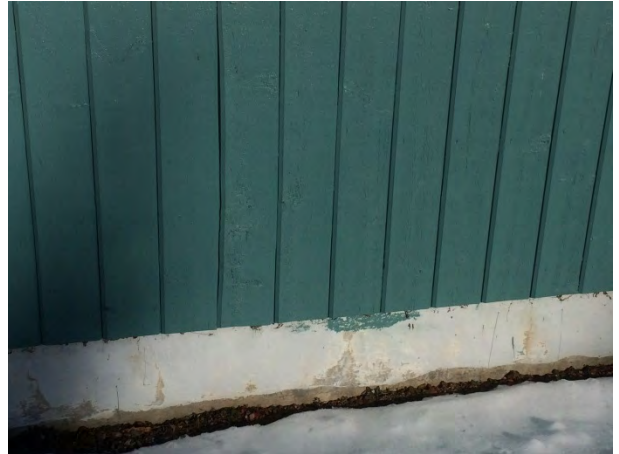
Photo 4.2.8 – Example of painted wood siding in fair condition overall

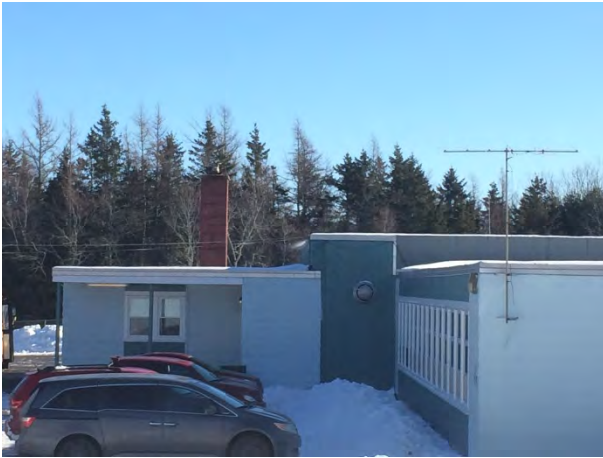
At the time of the site visit, the roof was covered in snow/ice and a full visual review could not be completed. A modified bitumen roof has an expected useful life of twenty years. Due to the suspected age of the roof (around 20 years old) a full replacement of the roof is recommended in year 5 with allocated repairs in the long term. When the roof is free of snow, a roof assessment is recommended to determine if a roof repair is required in the short term or can be deferred to the intermediate or long term.

Photo 4.3.1 – Example of roof (snow covered)  
looking north

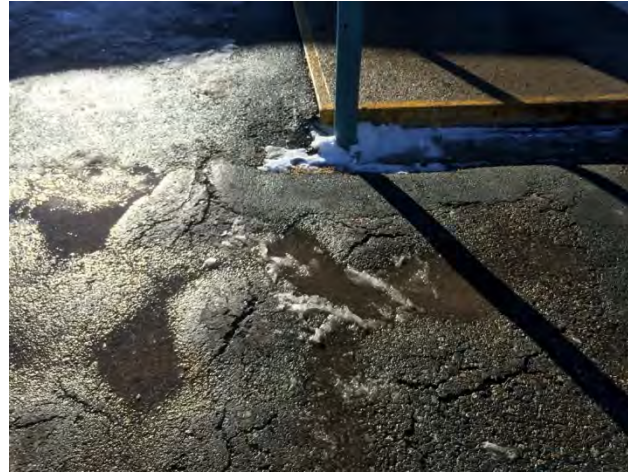
Photo 4.6.2 – Deteriorated asphalt at northwest entrance

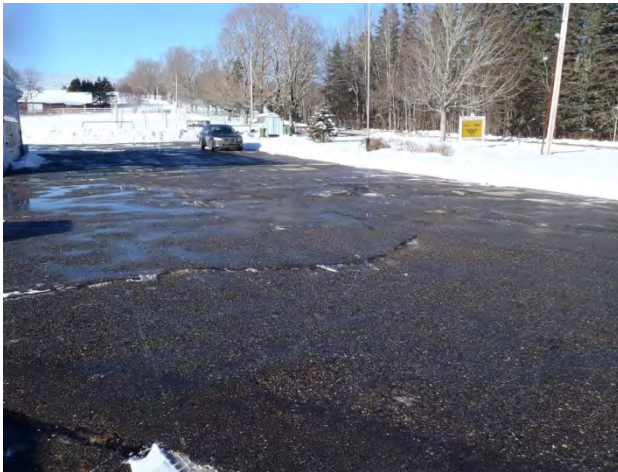
Photo 4.6.3 – Front asphalt driveway showing areas of deterioration

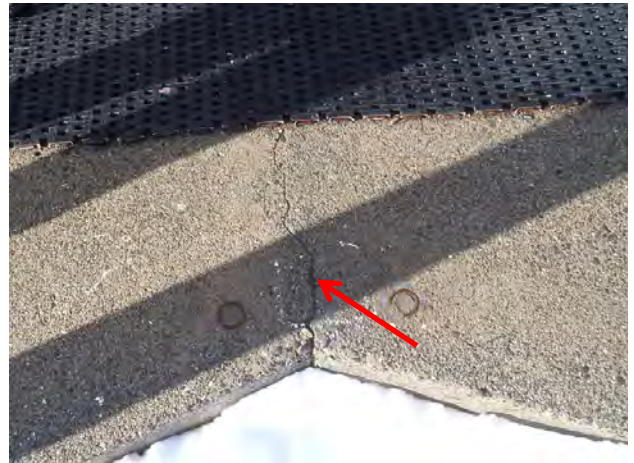
Photo 4.6.4 – Crack in concrete pad at north exit

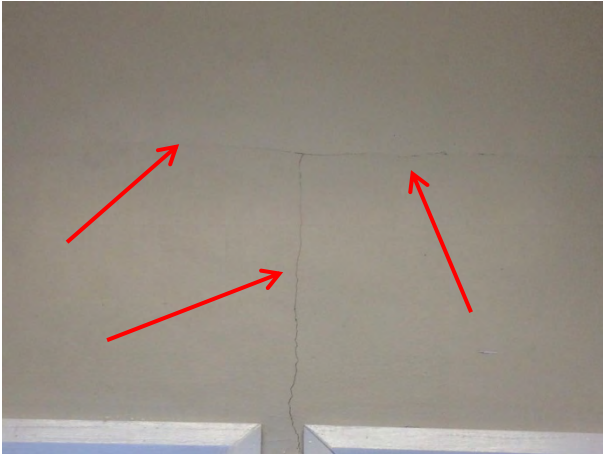
Horizontal and vertical drywall cracks were noted over the southwest interior vestibule door and the north exit door. These cracks are to be repaired as part of the interior finishes, however if reoccurrence occurs, further investigation should be performed to determine if they are structural in nature.

Photo 4.8.7 – Large vertical and horizontal cracks on wall above vestibule 102 doors. Looking east from inside vestibule.

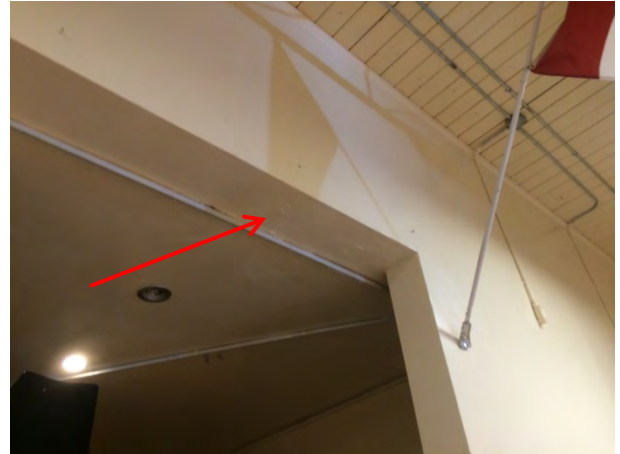
Water damage was observed in the northeast corner of the stage. Water damaged areas should be investigated for structural damage when the repairs are performed to fix the leak and repair the interior finishes. No costs for the structural investigation related to leaks have been considered as it would be incidental to the other repair work.

Photo 4.8.8 – Old water damage at north east corner of platform area

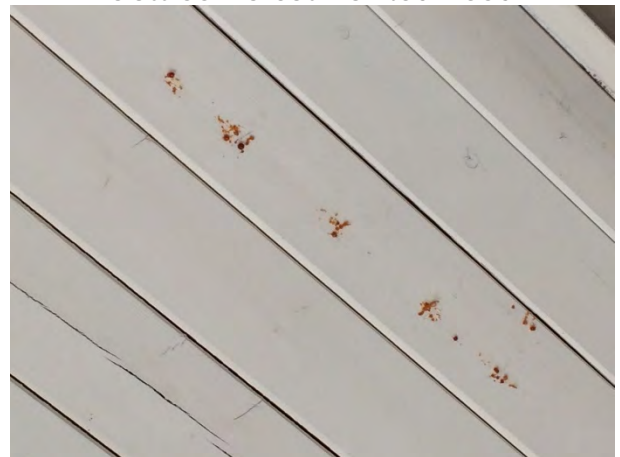
Photo 4.8.12 – Sap appears to be seeping from the roof boards. Noticed in several classrooms

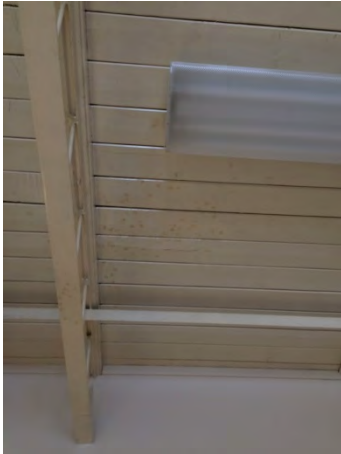
Photo 4.8.13 – Discoloration / staining noted on the roof joists and roof boards. Moisture buildup in the washrooms / humidity suspected.

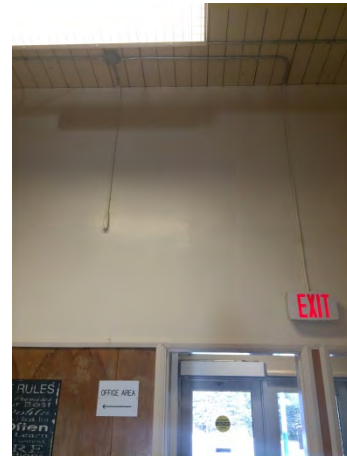
Photo 4.8.16 – Vertical and horizontal cracking noted above doors to vestibule 101. Image is looking west from assembly hall
