**Property Condition Assessment
(PCA) For Pentz Elementary School,
2680 331 Hwy, Pentz, NS**

FINAL REPORT

Project No: 133430692

February 23, 2016

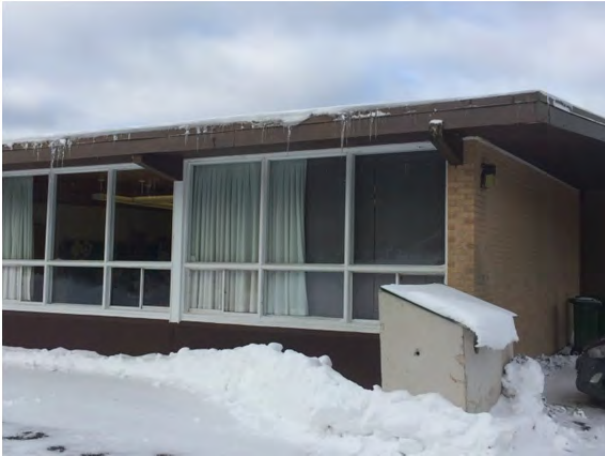
Photo 4.2.1 – North face at west corner. Cladding consists of brick, concrete and glazing.

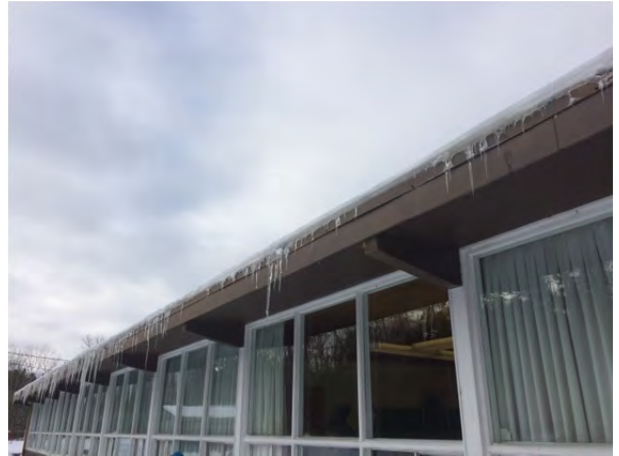
Photo 4.2.2 – North face, roof edge. Underside of roof overhang finished with wood

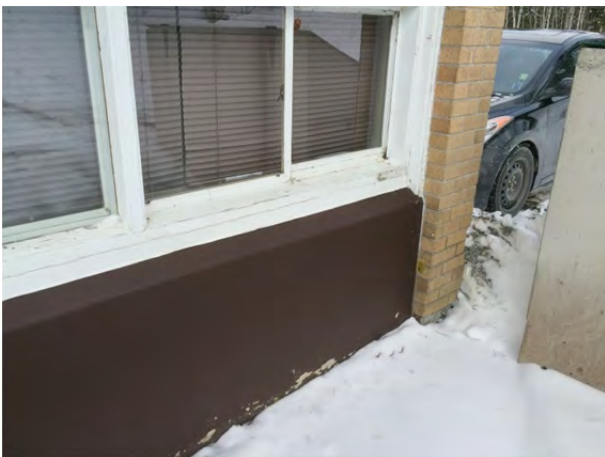
Photo 4.2.3 – North face, concrete wall under windows.

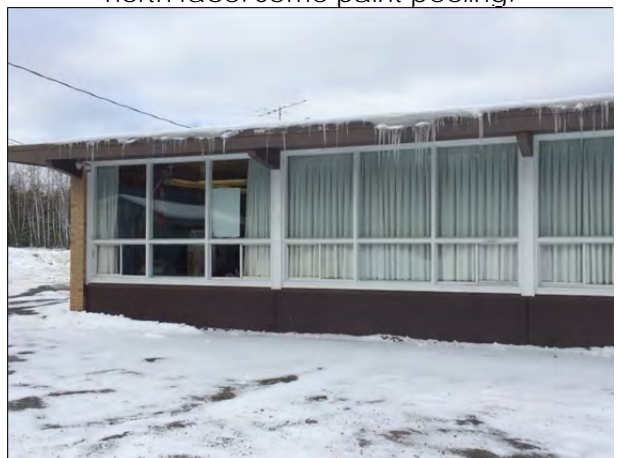
Photo 4.2.6 – North face at east corner.

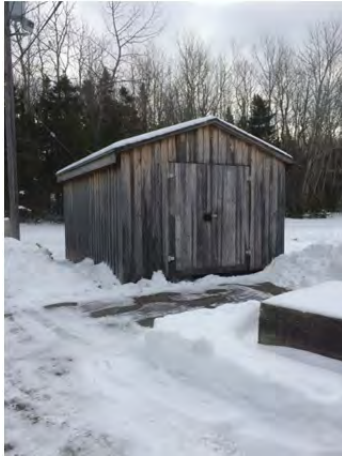
Photo 4.2.7 – Small wooden shed located at the north east corner of the school

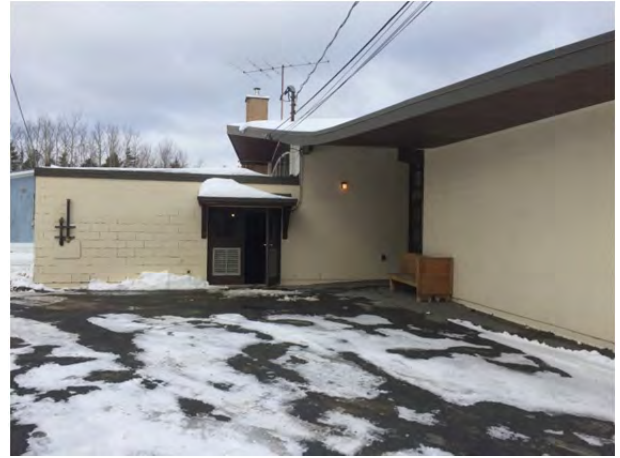
Photo 4.2.8 – East face of the building, looking towards vestibule 118. Concrete block cladding.

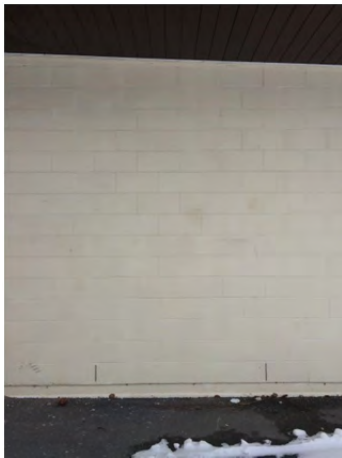
Photo 4.2.9 – East face at north side. Painted concrete block in good condition

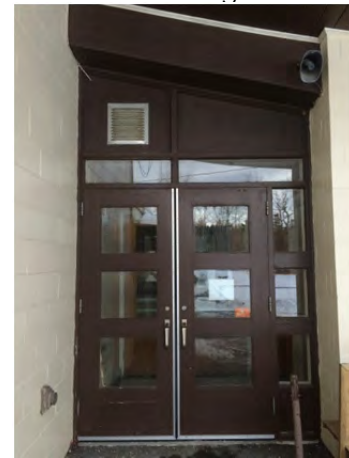
Photo 4.2.10 – East entrance at north side, vestibule 118

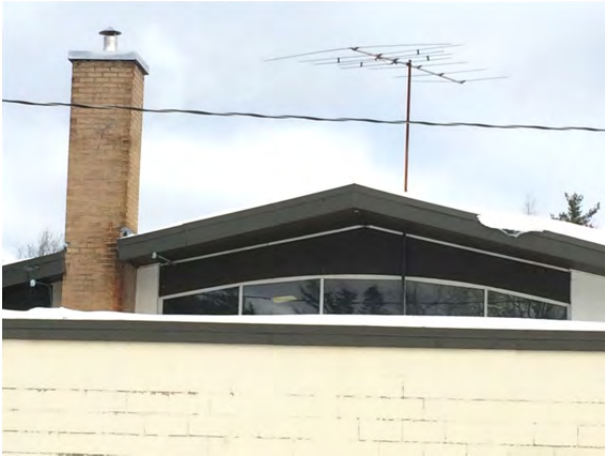
Photo 4.2.13 – East face of school. Above the stage

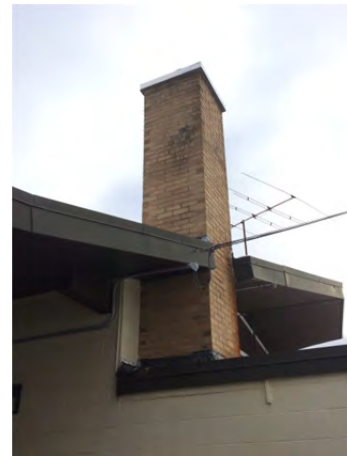
Photo 4.2.16 – Chimney at south east corner over stage area

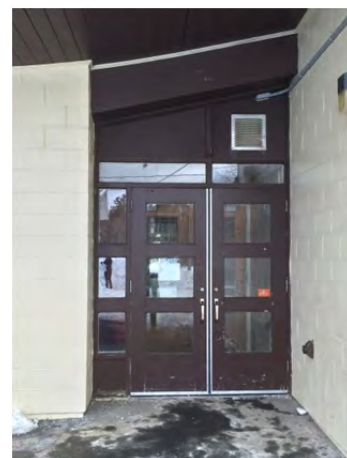
Photo 4.2.18 – East entrance at south corner, vestibule 121

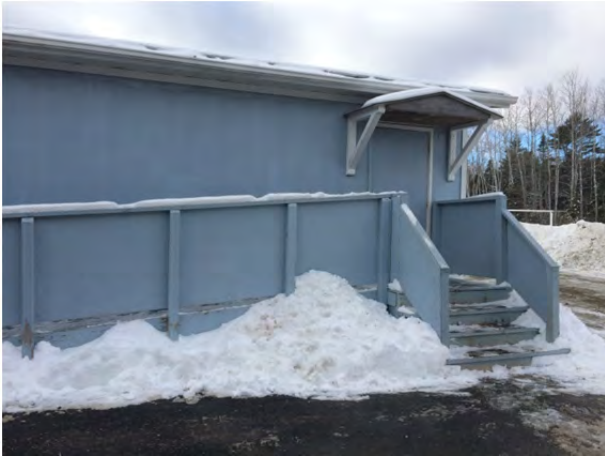
Photo 4.2.19 – West elevation of portable building

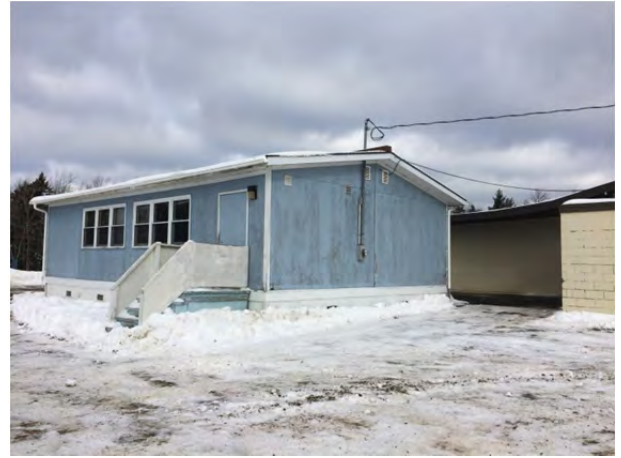
Photo 4.2.20 – East elevation of portable building

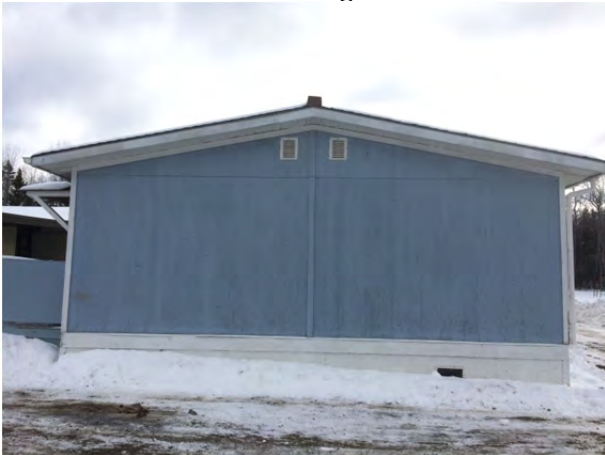
Photo 4.2.21 – South elevation of portable building

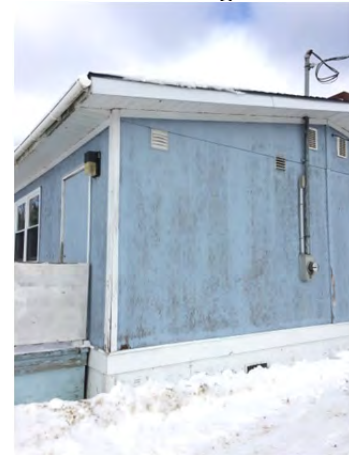
Photo 4.2.22 – North elevation of portable building.

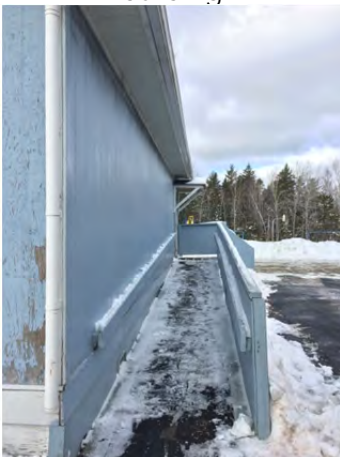
Photo 4.2.23 – west entry ramp for portable building

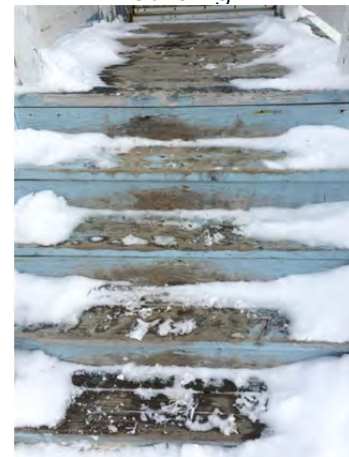
Photo 4.2.24 – East stair entry for portable building

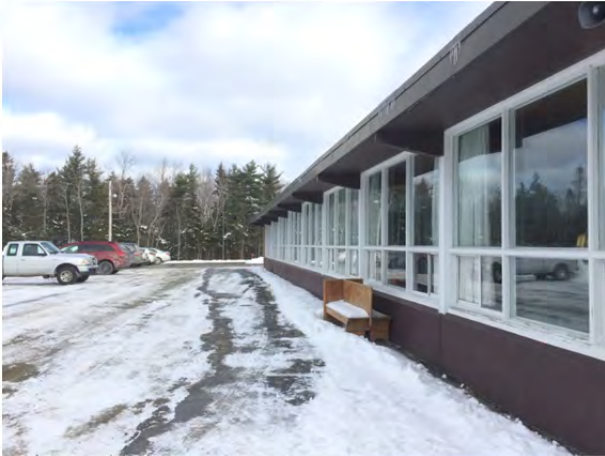
Photo 4.2.25 – South elevation school

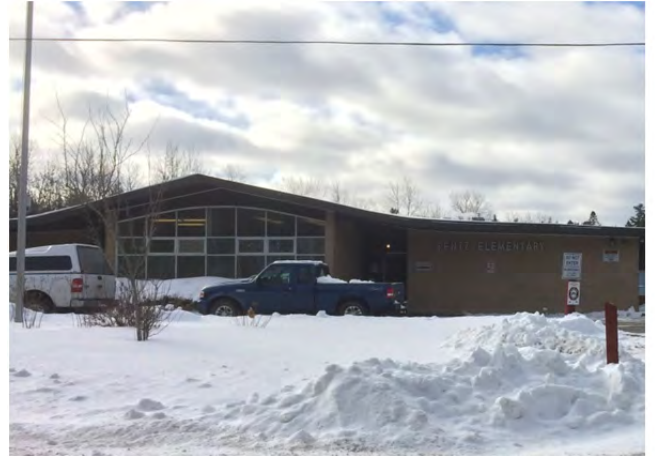
Photo 4.2.26 – West elevation school

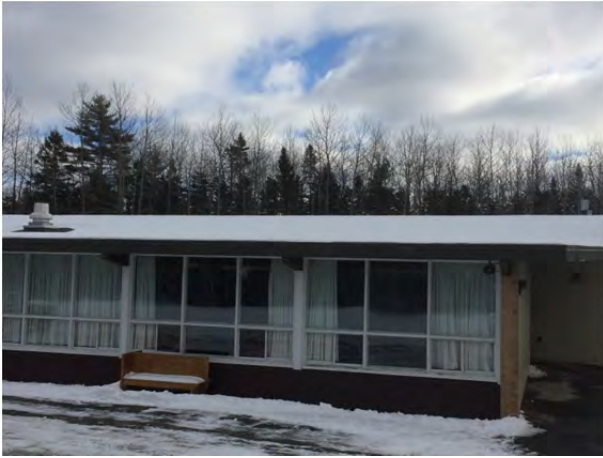
Photo 4.3.1 – View of roof facing North. Access to roof was not available

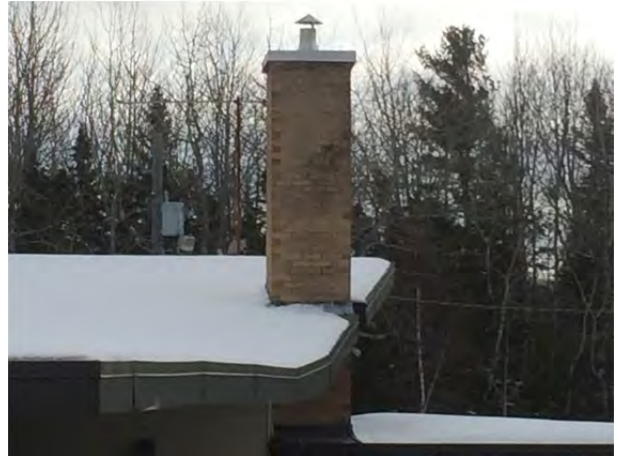
Photo 4.3.2 – View of roof at East end.

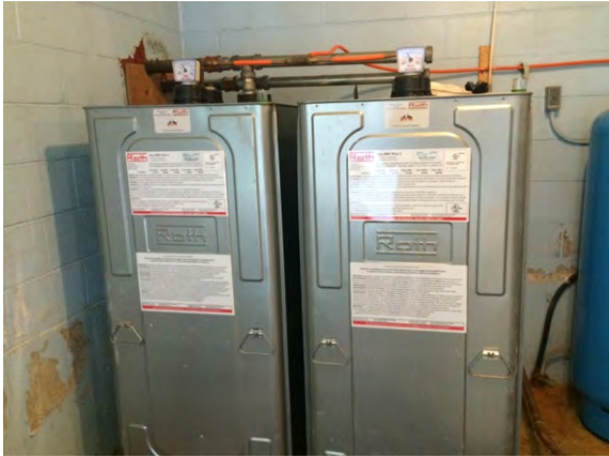
Photo 4.4.1 – Roth fuel storage tank for the building's heating system.

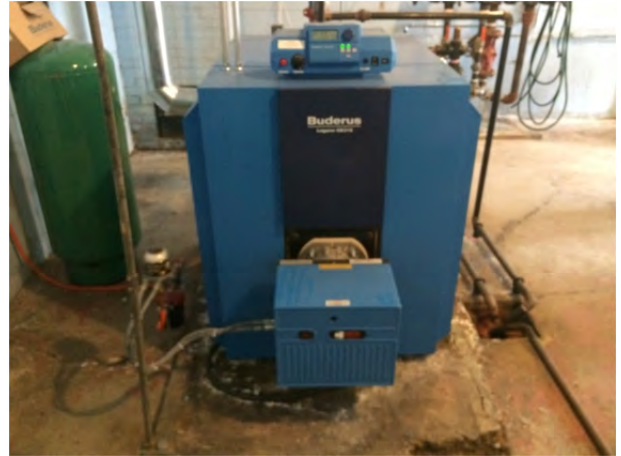
Photo 4.4.2 – Buderus oil fired boiler

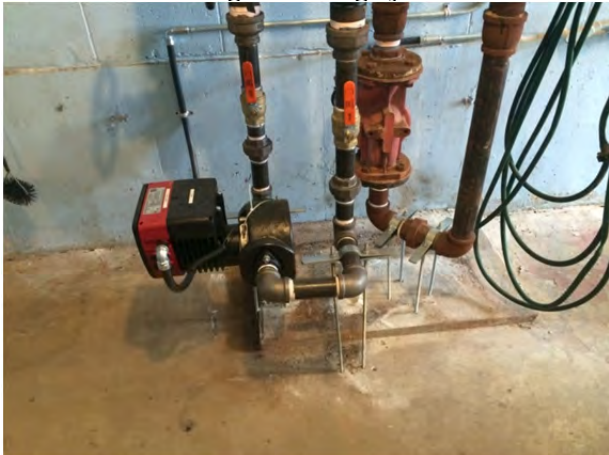
Photo 4.4.3 – Heating circulation pumps

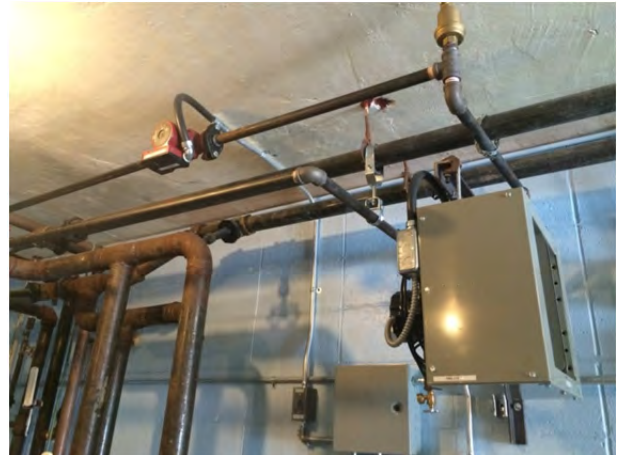
Photo 4.4.4 – Mechanical room unit heater

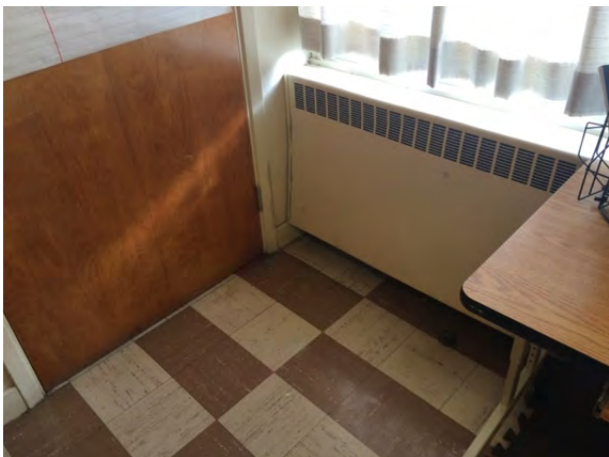
Photo 4.4.5 – Typical hot water baseboard heater

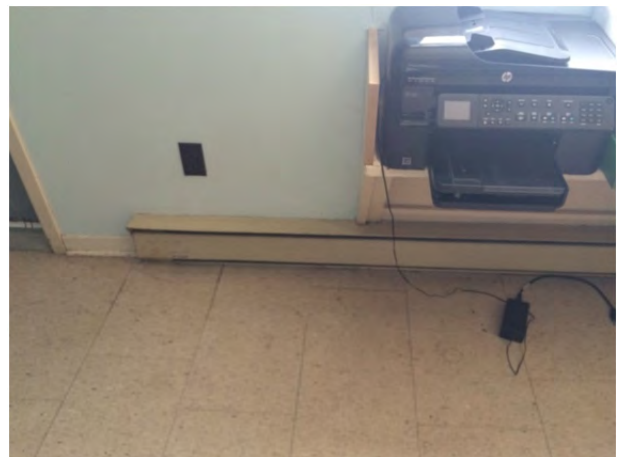
Photo 4.4.6 – Out building electric baseboard heaters

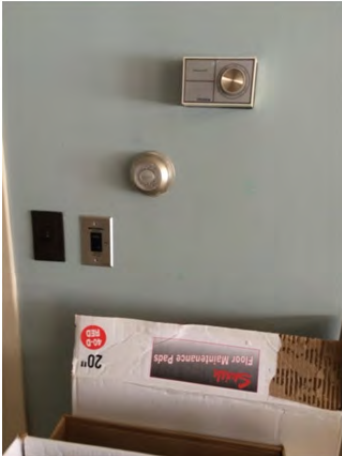
Photo 4.4.7 – Out building Thermostat and humidistat controls

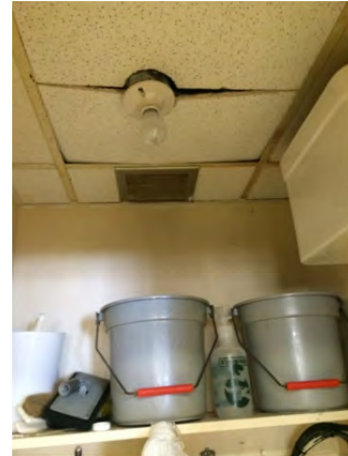
Photo 4.4.8 – Typical exhaust grill for exhaust fans

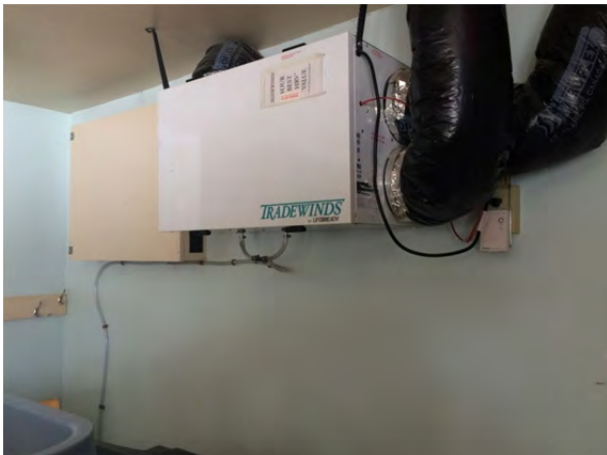
Photo 4.4.9 – Out building heat recovery ventilator (HRV)

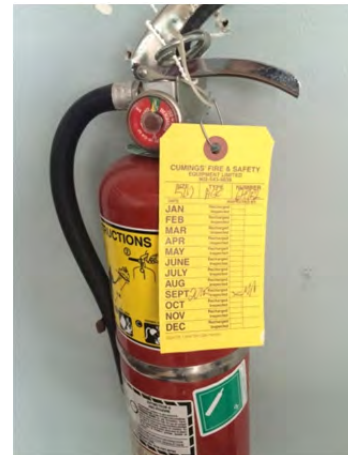
Photo 4.4.10 – Typical fire extinguisher throughout the buildings

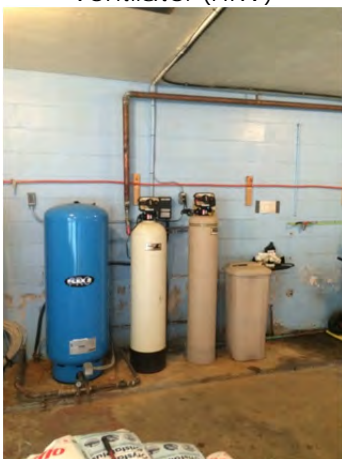
Photo 4.4.11 – Domestic water entrance equipment included pressure tank and water conditioners

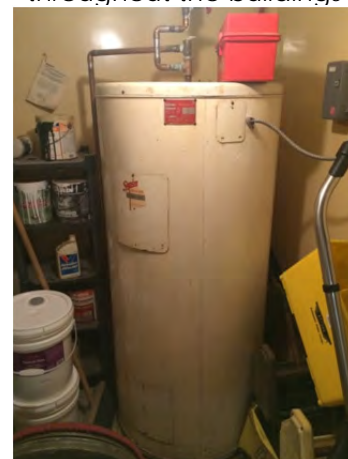
Photo 4.4.12 – Domestic hot water tank

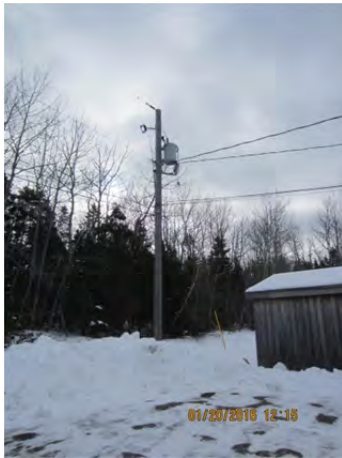
Photo 4.5.1 – 50 kVA single-phase pole mounted utility transformer

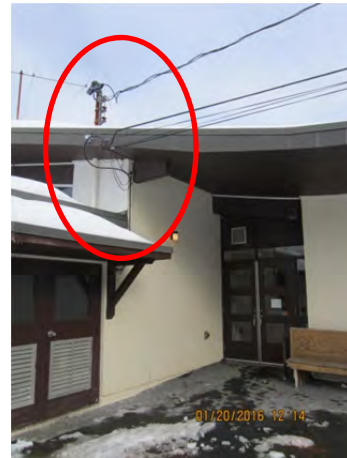
Photo 4.5.2 – Overhead power lines for school service into boiler room

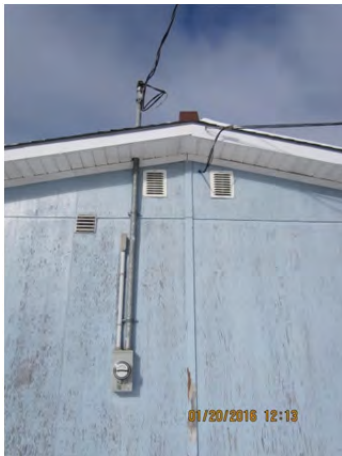
Photo 4.5.3 – Overhead power lines for portable classroom service

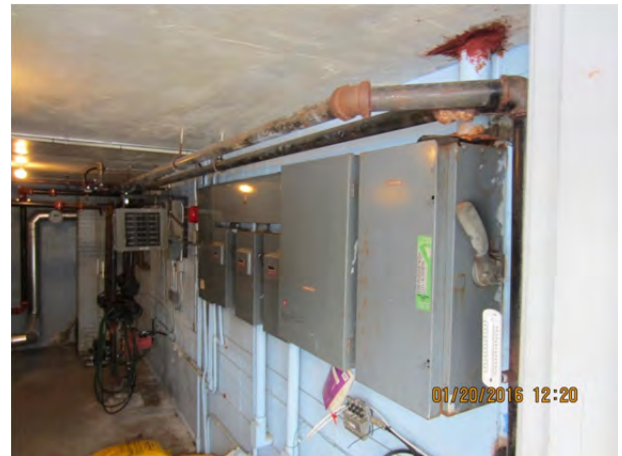
Photo 4.5.4 – Main distribution equipment

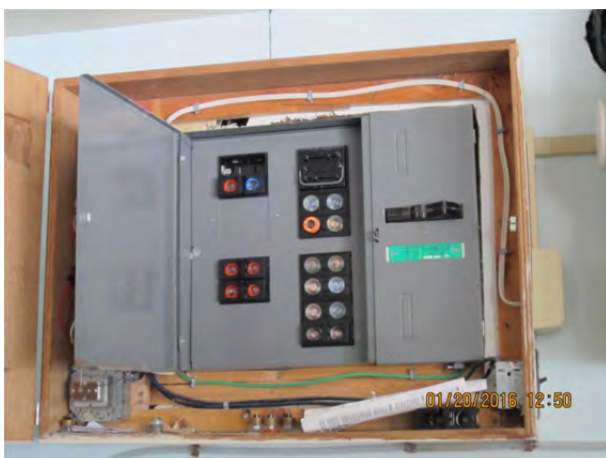
Photo 4.5.5 – 100A, 120/240V, 1-phase main fuse panel located in Portable Classroom

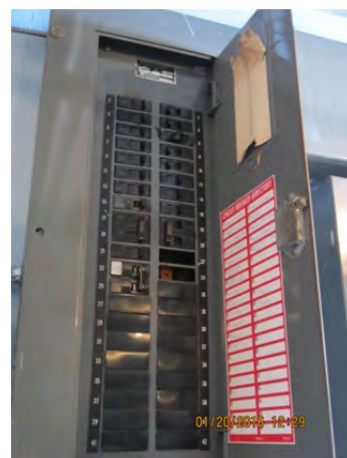
Photo 4.5.6 – 200A, 120/240V, 1-phase, 3-wire panel located in the Boiler Room

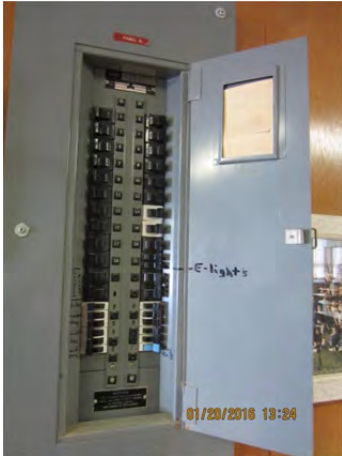
Photo 4.5.7 – Typical 100A, 120/240V, 1-phase, 3-wire Federal Pioneer distribution panel located in the school corridor

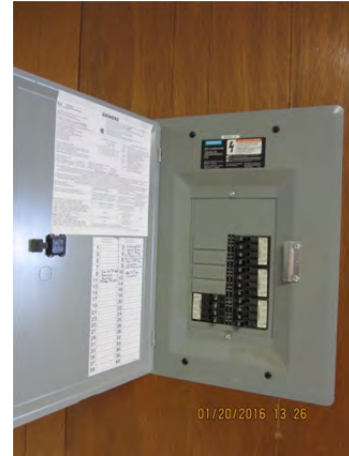
Photo 4.5.8 – 100A, 120/240V, 1-phase, 3-wire Siemens panel

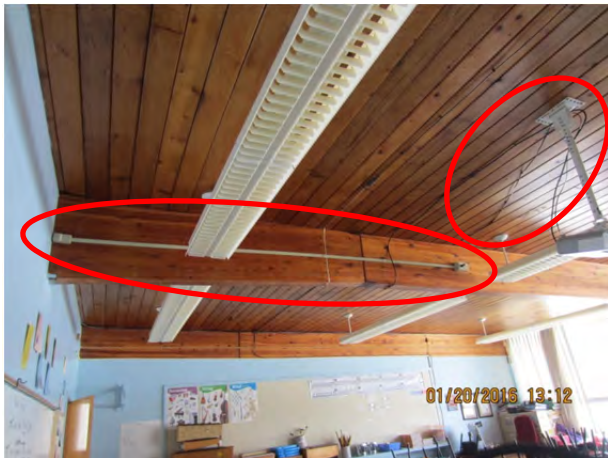
Photo 4.5.9 – Typical wiremold and wiring for ceiling suspended projectors

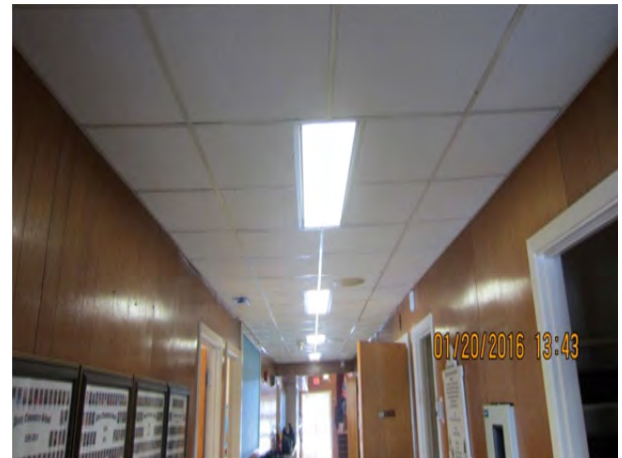
Photo 4.5.10 – Typical 1'x4' recessed fluorescent corridor luminaires

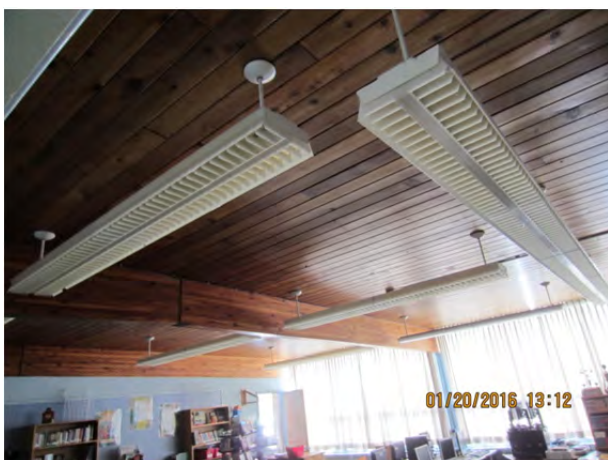
Photo 4.5.11 – Typical suspended 1'x4' fluorescent luminaires in the classrooms

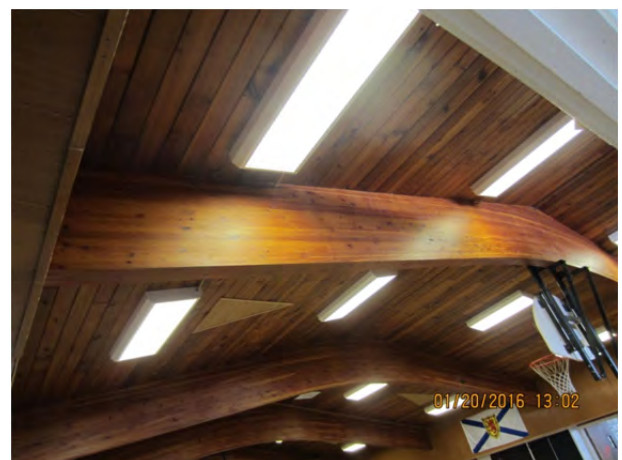
Photo 4.5.12 – 2'x4', 4-lamp fluorescent surface-mounted luminaires in gymnasium

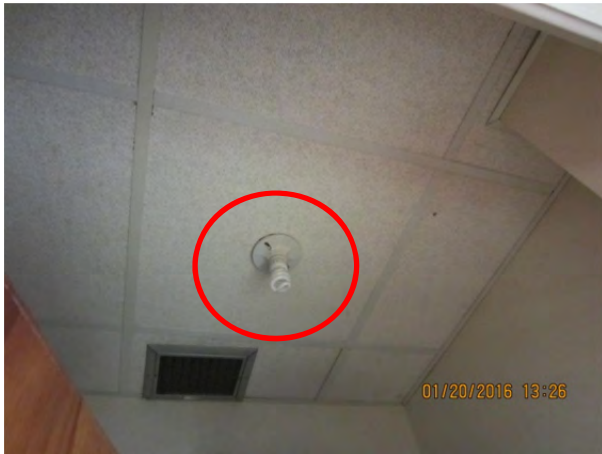
Photo 4.5.13 – Typical A19 luminaires in Janitor, storage and small washrooms

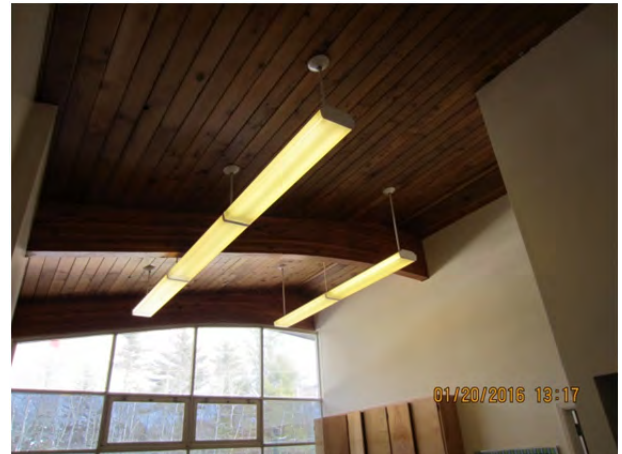
Photo 4.5.14 – Typical 1'x4' suspended fluorescent luminaires in office area

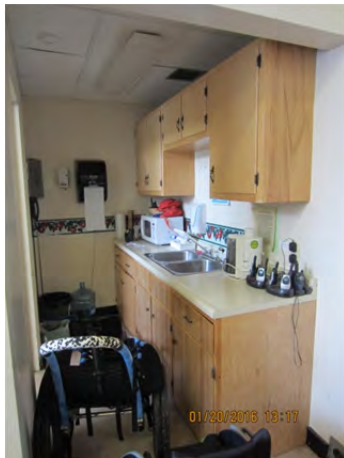
Photo 4.5.15 – Surface-mounted 1'x4' luminaire in the office kitchenette

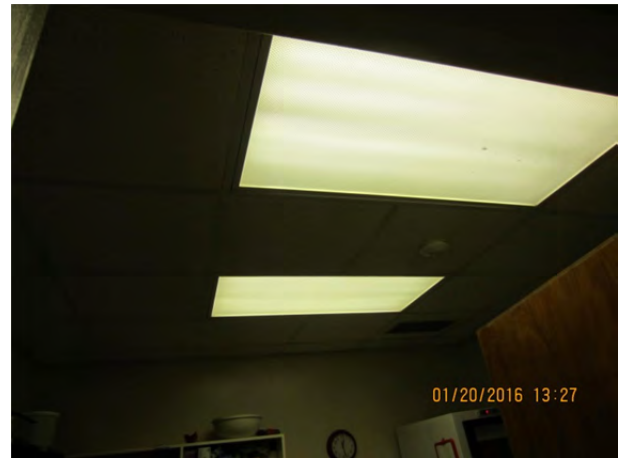
Photo 4.5.16 – Typical 2'x4' recessed fluorescent luminaires in the kitchen

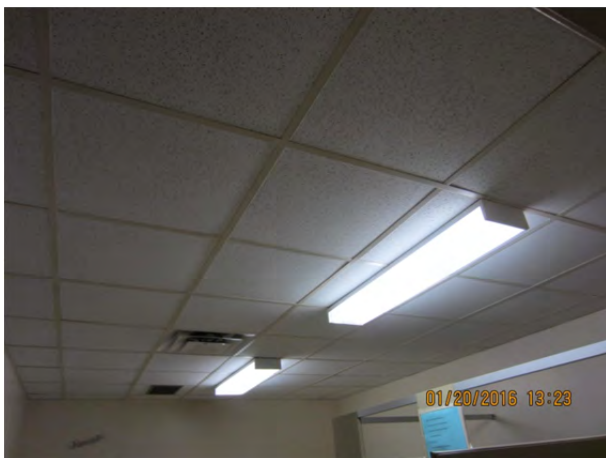
Photo 4.5.17 – Typical surface-mounted 1'x4' fluorescent luminaires in the washrooms

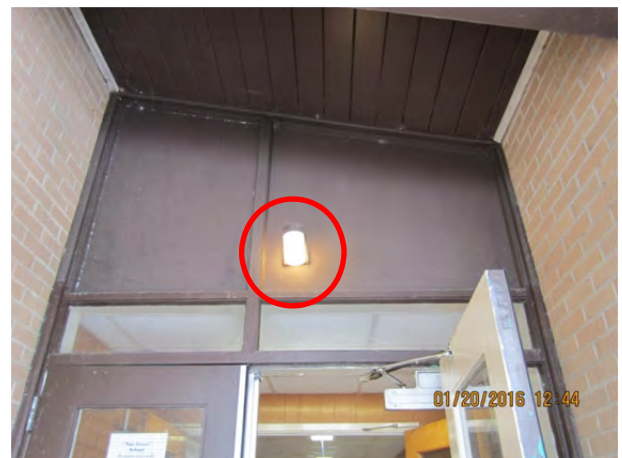
Photo 4.5.18 – Typical wall-mounted luminaires at the school entrances

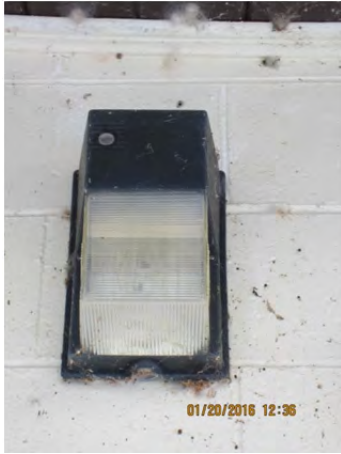
Photo 4.5.19 – Typical wall-mounted HID luminaires mounted on school perimeter

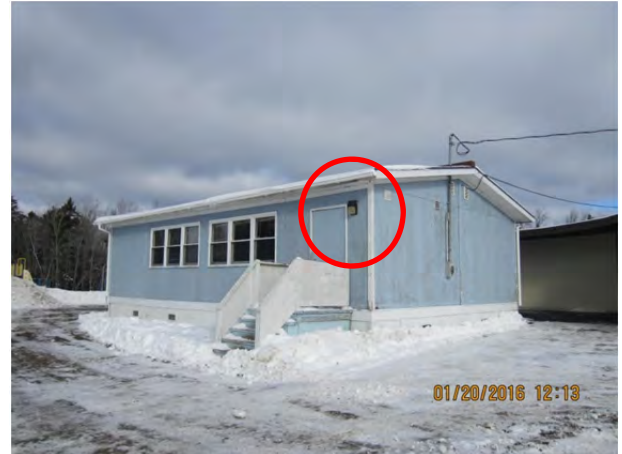
Photo 4.5.20 – Wall-mounted HID luminaire mounted at portable classroom entrance

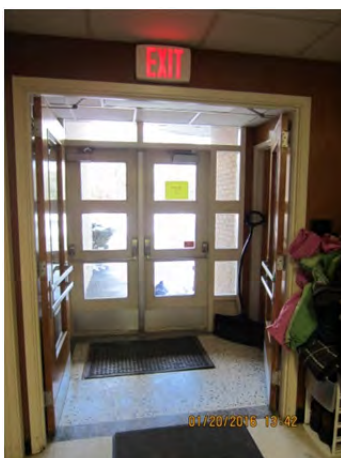
Photo 4.5.23 – Typical LED exit sign

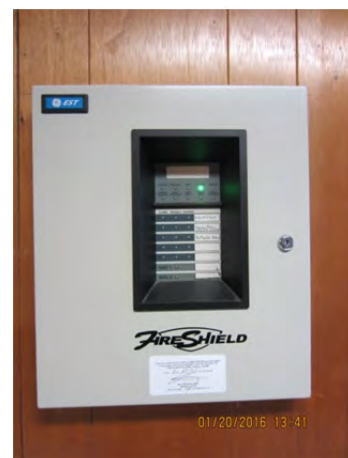
Photo 4.5.24 – GE EST – Fireshield Fire Alarm Control Panel

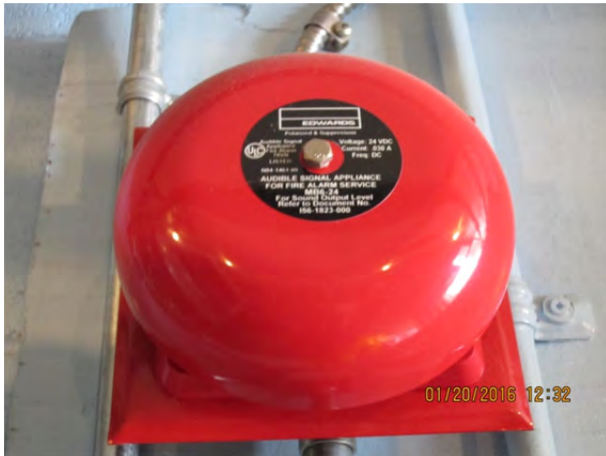
Photo 4.5.25 – Typical fire alarm bell

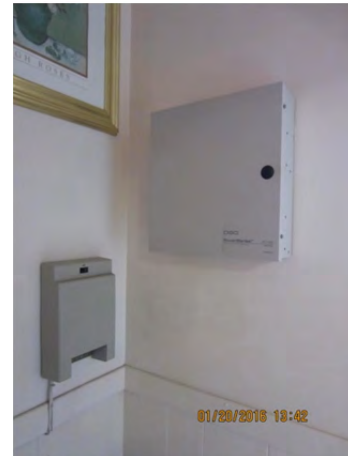
Photo 4.5.26 – Security system control panel

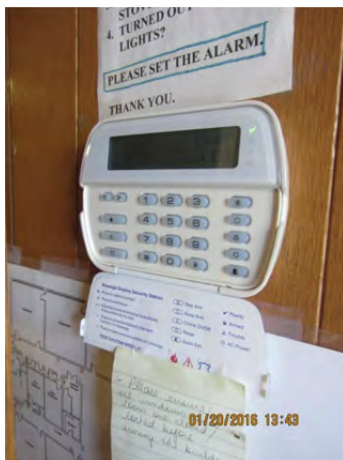
Photo 4.5.27 – Security keypad at main entrance

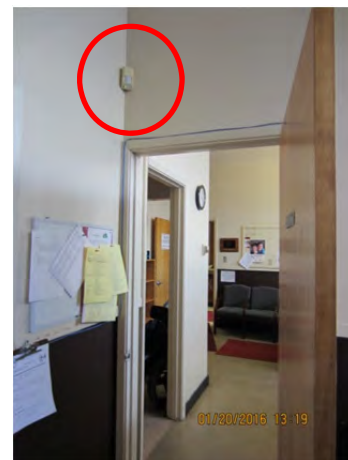
Photo 4.5.28 – Typical wall mounted motion sensor

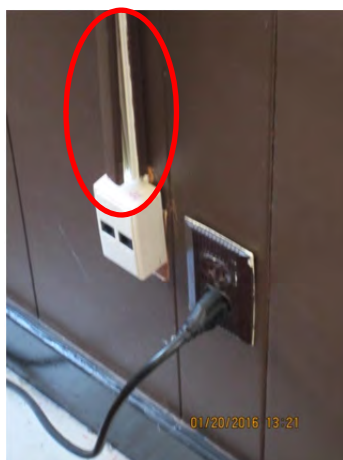
Photo 4.5.29 – Unsecured wire mold in Principal's office

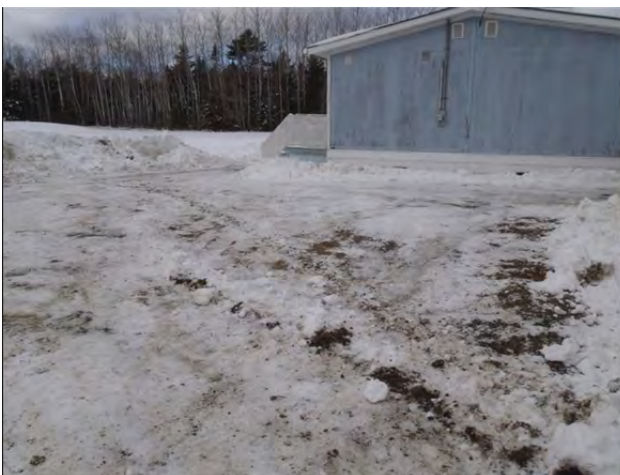
The presence of snow made the assessment of the parking areas and school perimeter difficult. The only areas that were fully visible were the asphalt bus loop and the asphalt areas on the east side of the school. The asphalt in the bus loop area was in poor condition (Photos 4.6.1 and 4.6.2) and showed significant areas of deterioration. It is recommended that this areas be resurfaced. The asphalt on the east side was uneven and should also be resurfaced (Photos 4.6.3 and 4.6.4), however due to the lack of vehicle traffic this is not a critical of an area as the bus loop. The gravel/dirt areas on the east side of the building should also be considered to be paved allowing for easier snow removal in the area (Photo 4.6.5). No costing allowance has been provided for this area.

Photo 4.6.5 – Unpaved area on east side of school

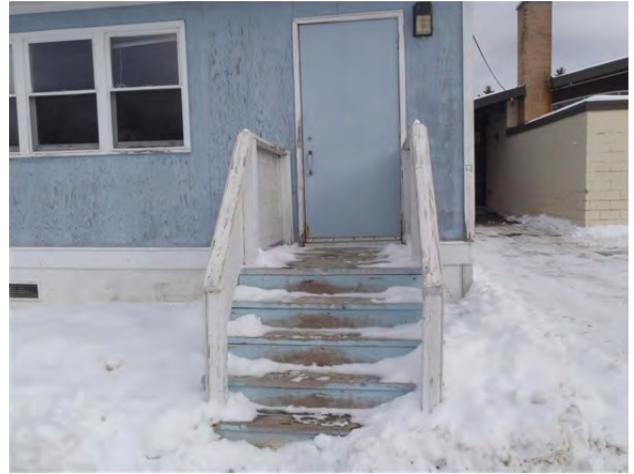
The wooden landing at the top of the ramp/stairs on the west side of the Classroom Portable has some areas of rot (Photo 4.6.6) and should be repaired immediately. The wooden steps on the west (Photo 4.6.7) and east sides (4.6.8) of the portable classroom have varying rises and runs between steps which can be a tripping hazard and as a result these should be replaced. The bottom concrete step on the east side is also damaged and requires replacement.

Photo 4.6.8 – Stair on east side of portable classroom

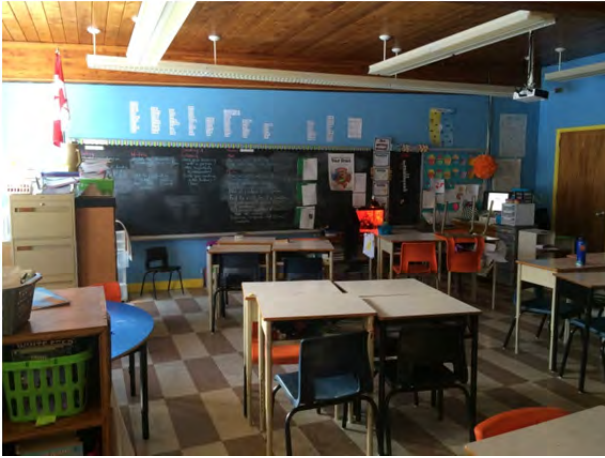
Photo 4.8.1 – Typical classroom finishes. Linoleum tile floor, painted walls, wood finished ceiling.

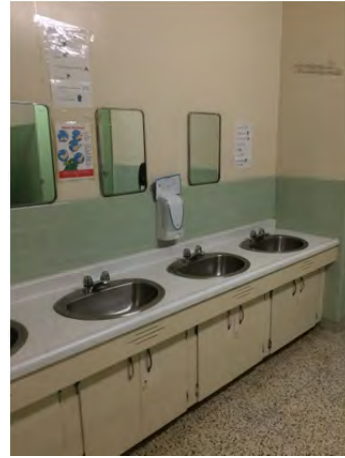
Photo 4.8.2 – Typical washroom finishes, terrazzo floor, tile backsplash at counter, painted walls with suspended ceiling tile.

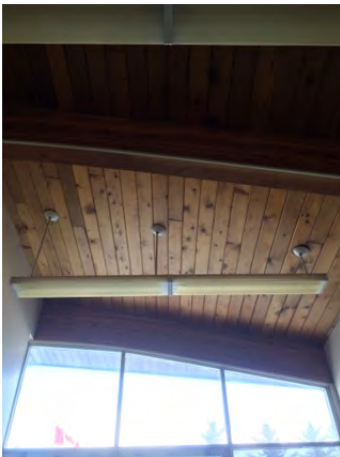
Photo 4.8.5 – Ceiling finish typical throughout

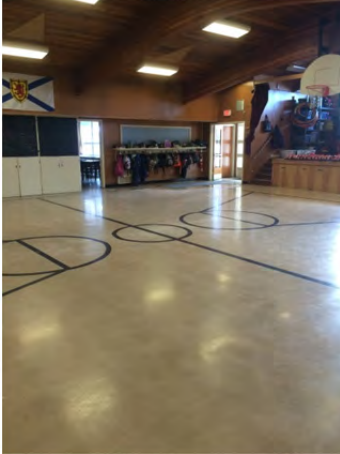
Photo 4.8.7 – Gymnasium finishes. vinyl tile floor, wood panel walls, wood finish ceiling.

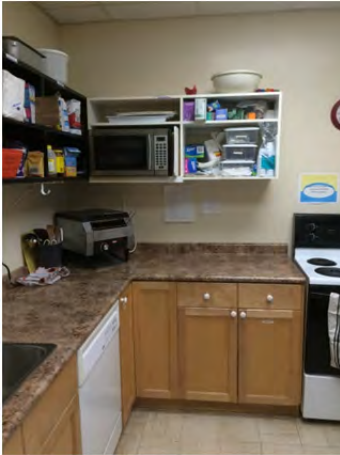
Photo 4.8.9 – Kitchen finishes.
