**Property Condition Assessment  
(PCA) For Petite Riviere Elementary  
School, 123 Wentzell Rd,  
Lunenburg, NS**

**FINAL REPORT**

Project No: 133430692

February 23, 2016

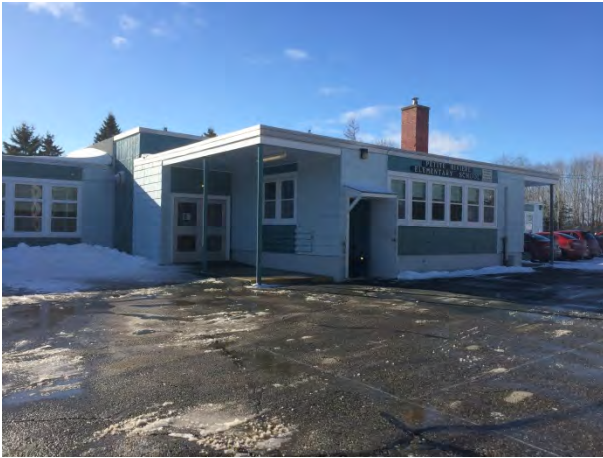
Photo 4.2.1 – West elevation. Front entry

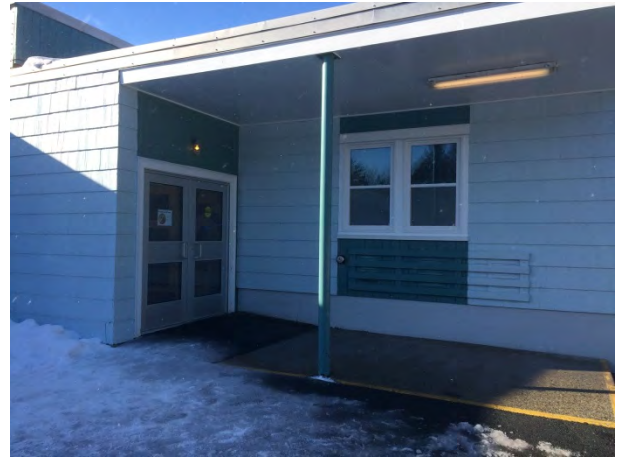
Photo 4.2.2 – North-west entrance

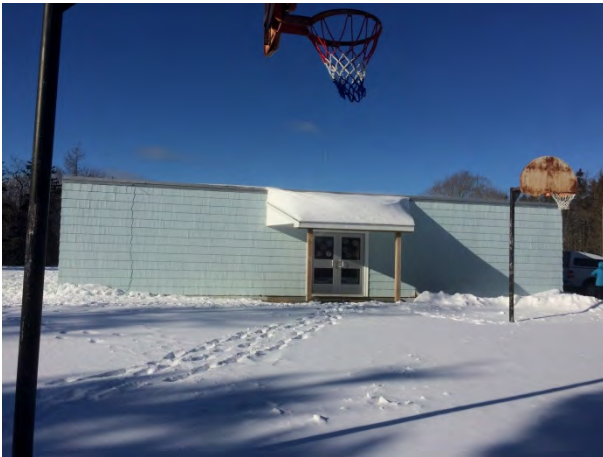
Photo 4.2.3 – North elevation

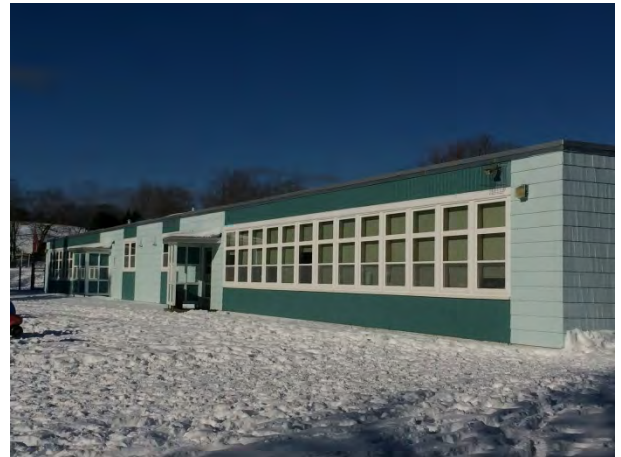
Photo 4.2.4 – East elevation

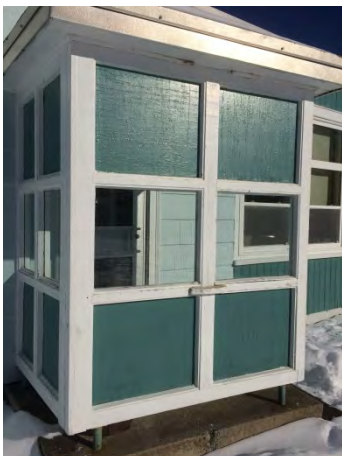
Photo 4.2.5 – North-east primary classroom sheltered exit

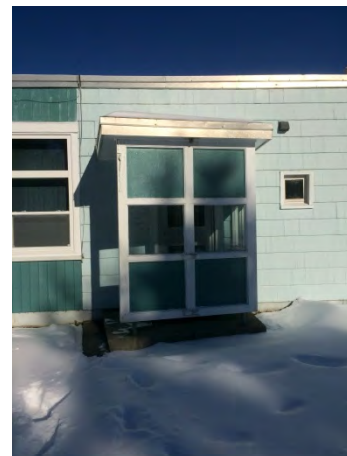
Photo 4.2.6 – South-east teacher's room sheltered exit

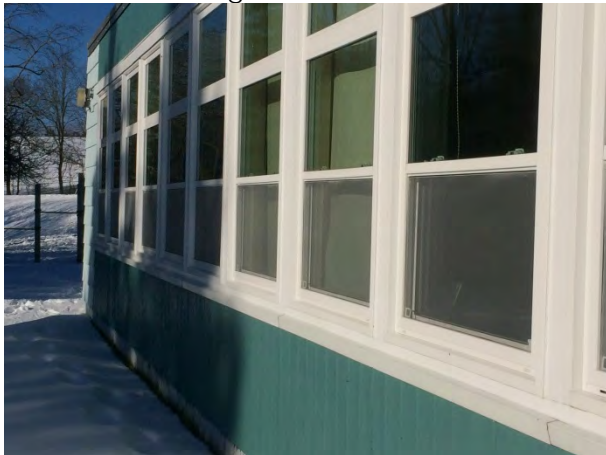
Photo 4.2.9 – Typical window construction.

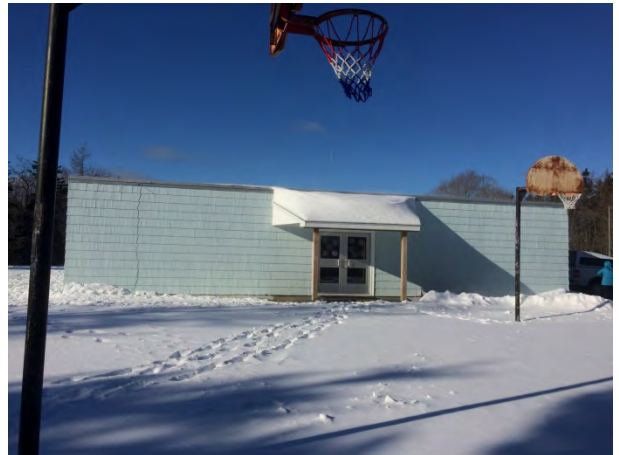
Photo 4.2.10 – North elevation

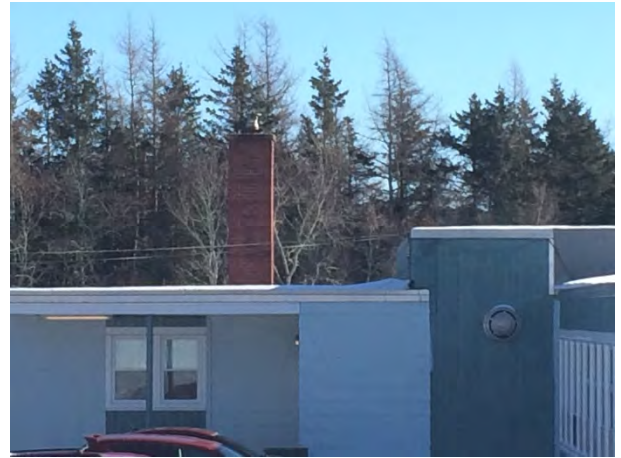
Photo 4.3.2 – View of chimney looking north.  
Located above offices at west of school.

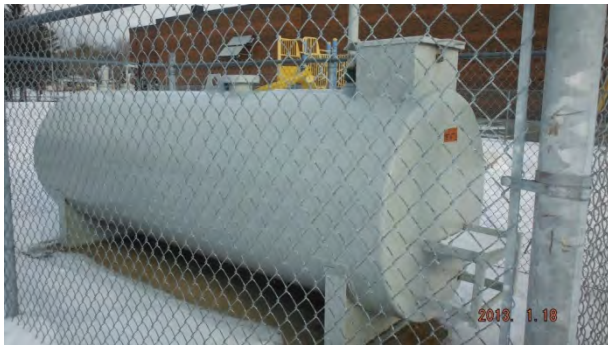
Photo 4.4.1 – The fuel storage tank for the building's heating system.

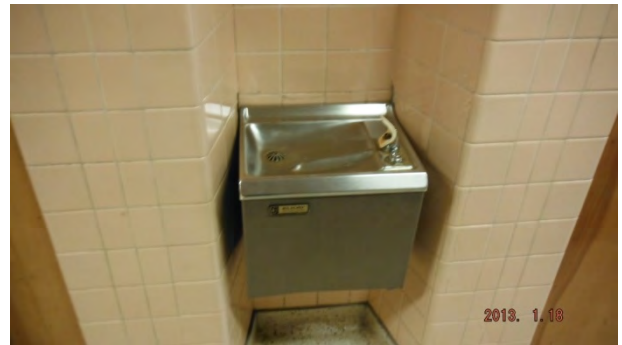
Photo 4.4.2 – Elkay refrigerated water fountain found in the hallways

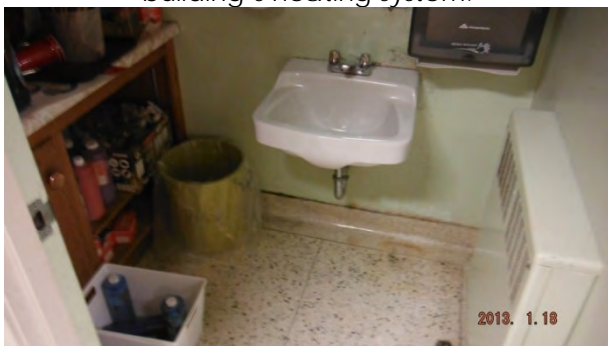
Photo 4.4.3 – Typical original sink

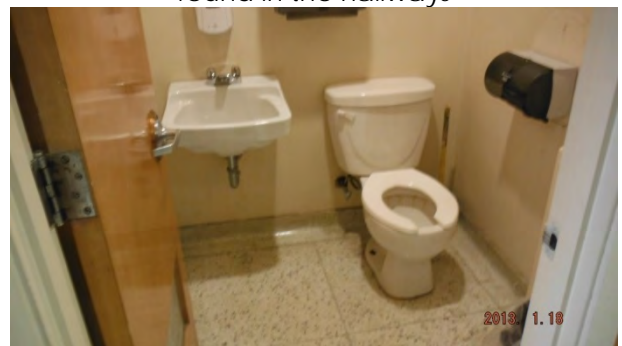
Photo 4.4.4 – Typical of water closet

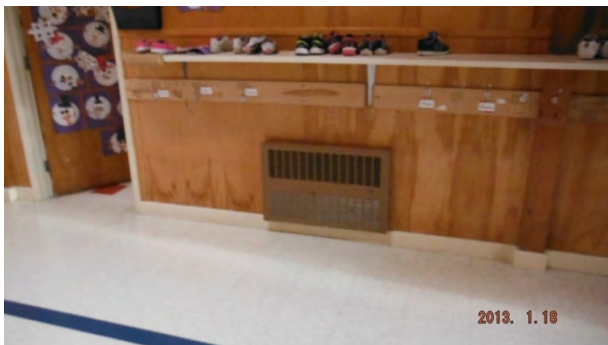
Photo 4.4.5 – Typical cabinet heater

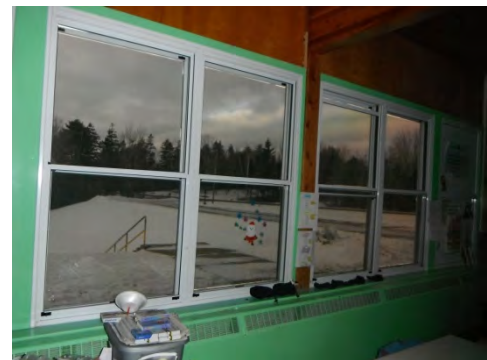
Photo 4.4.6 – Typical hot water baseboard heaters

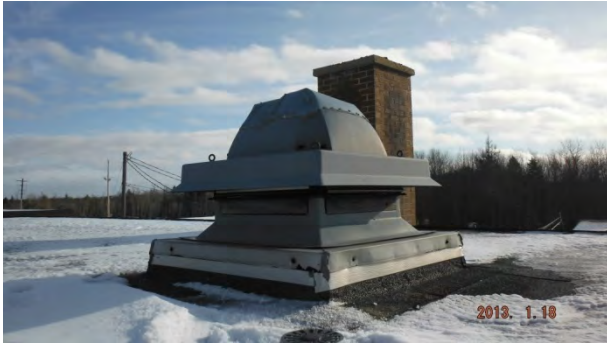
Photo 4.4.7 – Typical exhaust fan with original housing

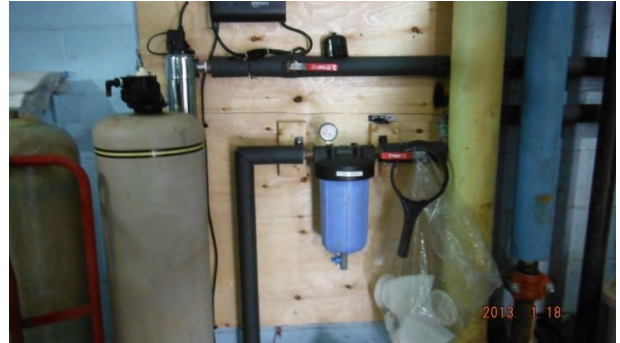
Photo 4.4.8 – Water treatment, filter and disinfecting equipment

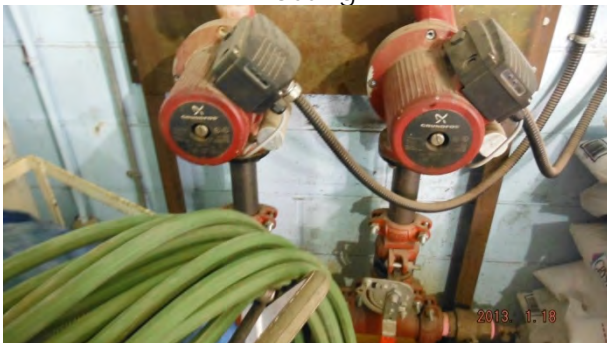
Photo 4.4.9 – Heating circulation pumps

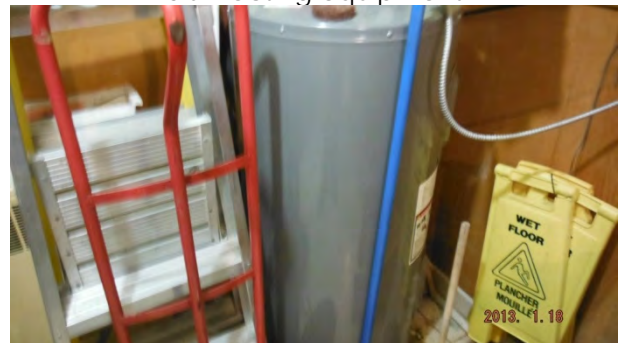
Photo 4.4.10 – Electric domestic hot water tank

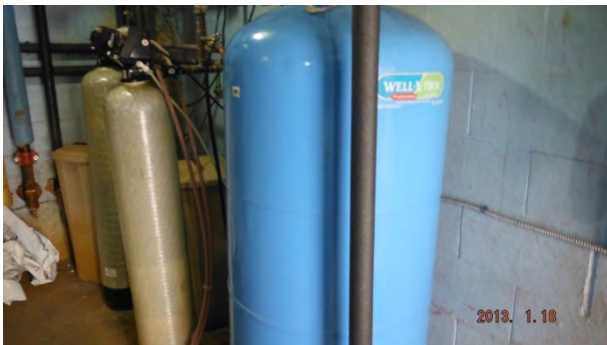
Photo 4.4.11 – Well Pressure Tank

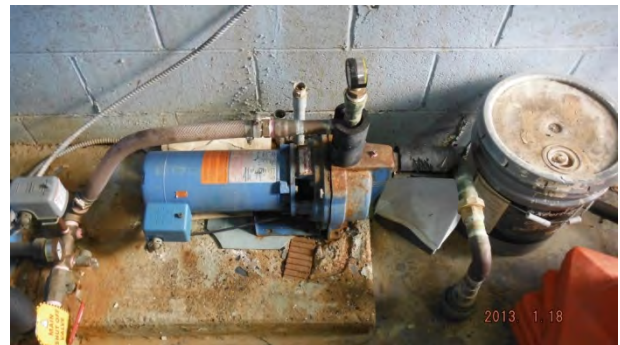
Photo 4.4.12 – Well pump

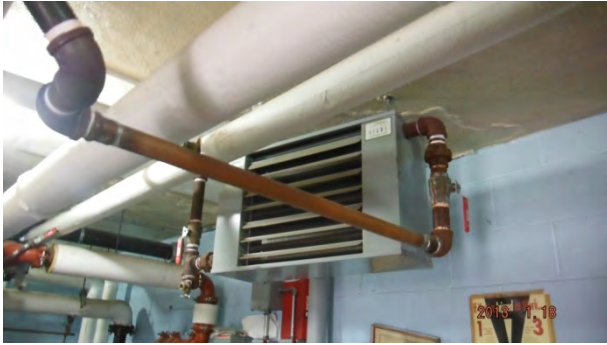
Photo 4.4.13 – Unit heater within the boiler room

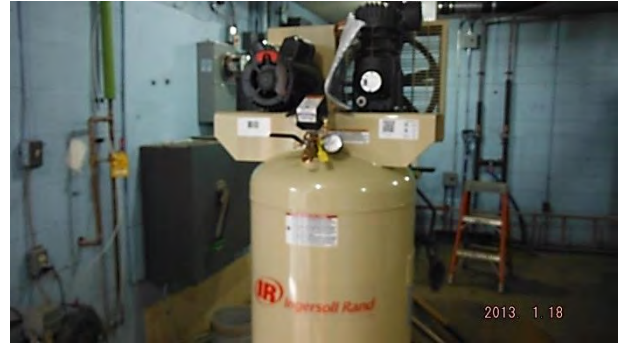
Photo 4.4.14 – New compressor for controls

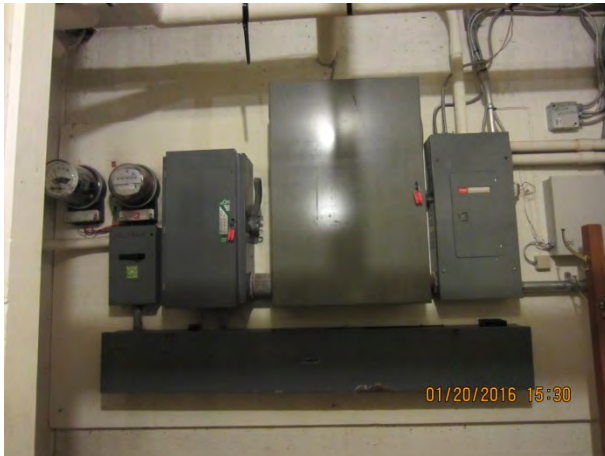
Photo 4.5.1 – Main Electrical Service and Distribution

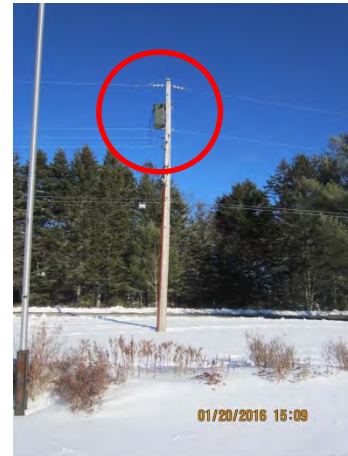
Photo 4.5.2 – Pole-mounted utility transformer

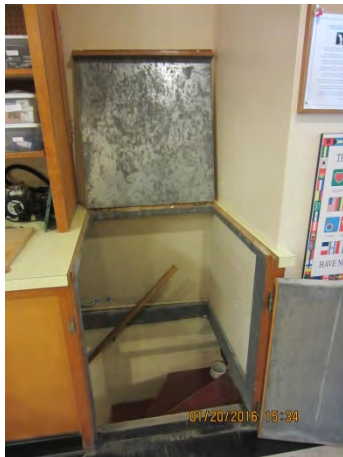
Photo 4.5.3 – Access to Electrical Room Located under stage

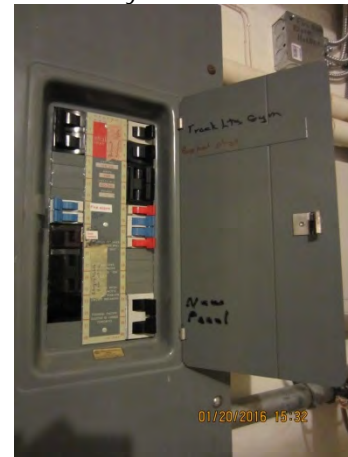
Photo 4.5.4 – 200A, 120/240V Distribution Panel

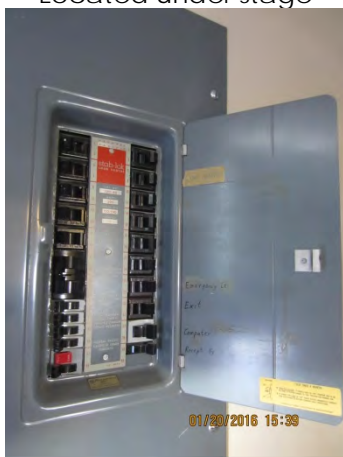
Photo 4.5.5 – 100A, 120/240V panel in the Principal's Office

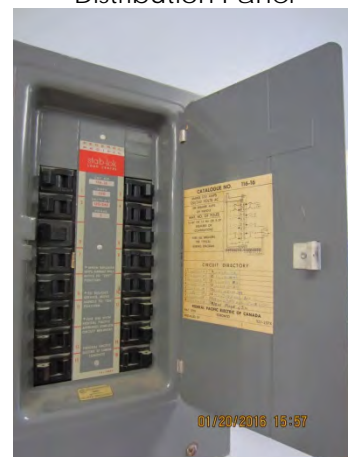
Photo 4.5.6 – 100A, 120/240V panel in Corridor 110

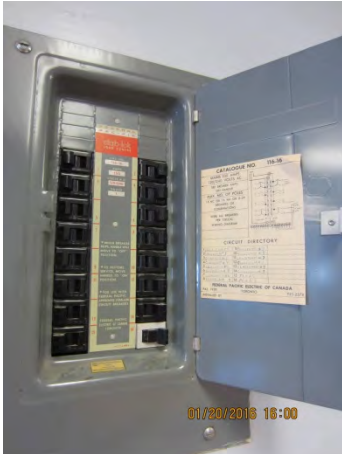
Photo 4.5.7 – 100A, 120/240V panel in Corridor 116

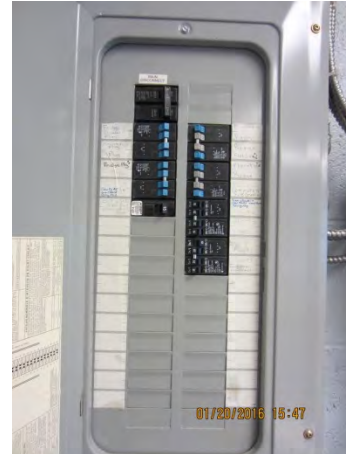
Photo 4.5.8 – 100A, 120/240V panel in the Kitchen

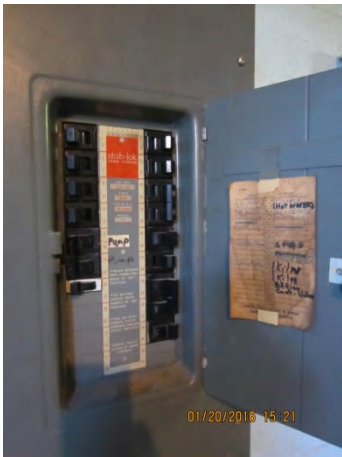
Photo 4.5.9 – 200A, 120/240V panel in the Boiler Room

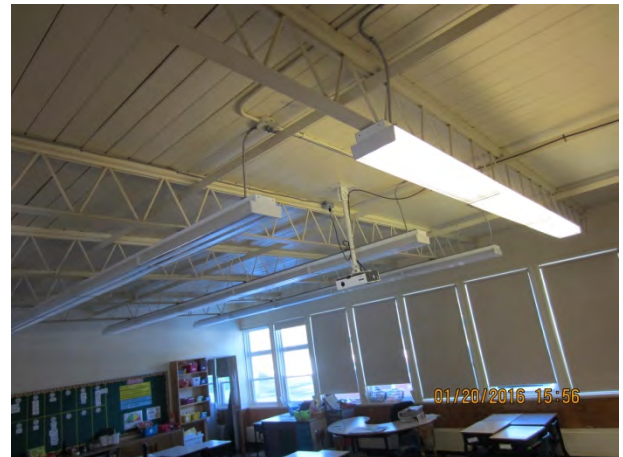
Photo 4.5.10 – Typical wiring strapped to ceiling of classroom for projector

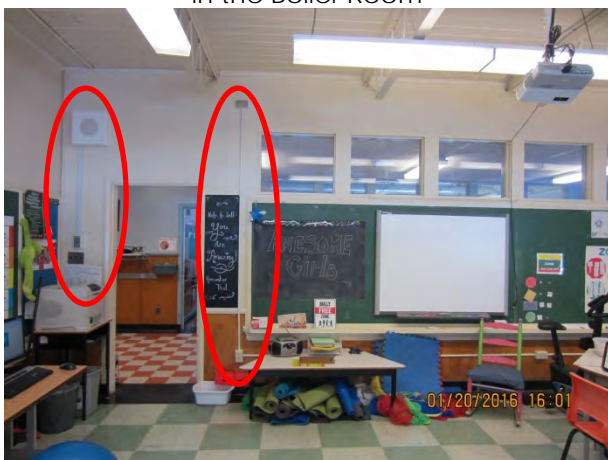
Photo 4.5.11 – Typical wiremold installation

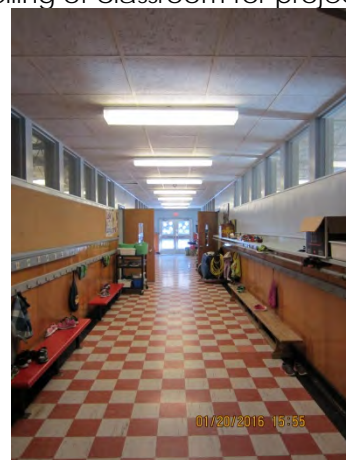
Photo 4.5.12 – Typical 1'x4' surface mounted fluorescent luminaires in corridors

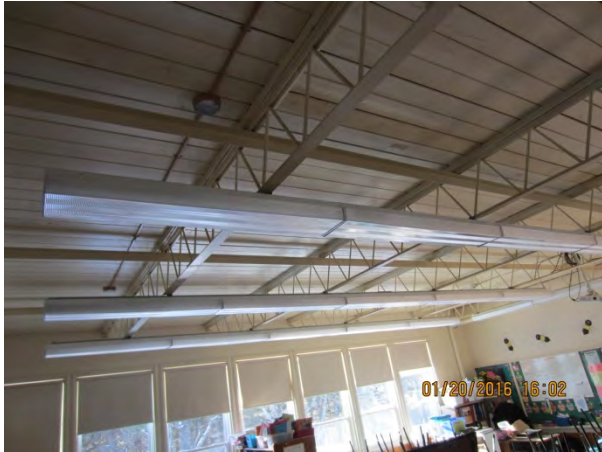
Photo 4.5.13 – Typical 1'x4' surface-mounted fluorescent luminaires in Classrooms

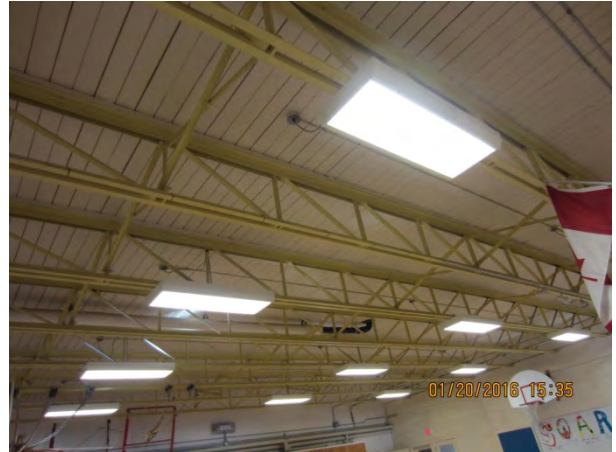
Photo 4.5.14 – 2'x4' surface-mounted fluorescent luminaires in the gymnasium

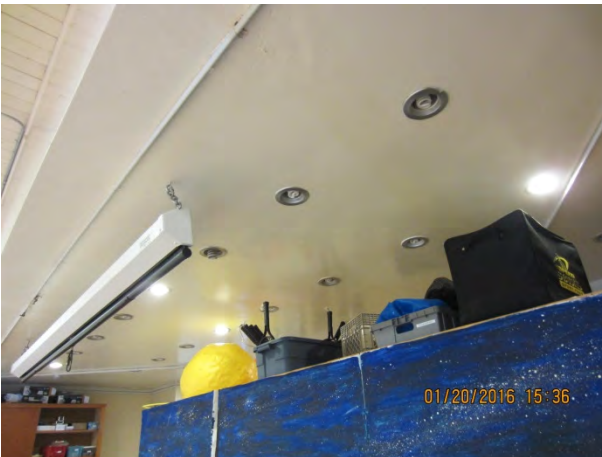
Photo 4.5.15 – Recessed pot lights at the stage

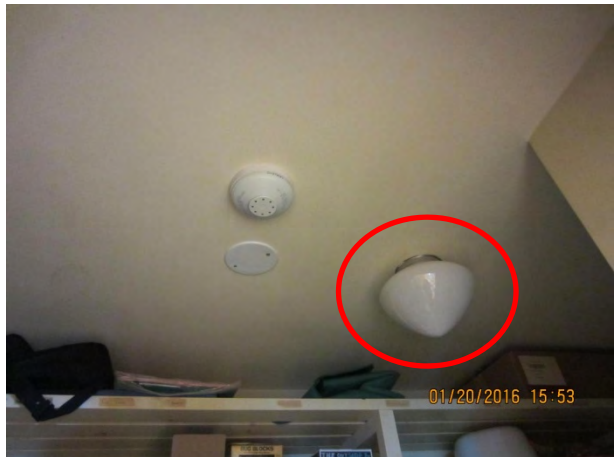
Photo 4.5.16 – Incandescent lighting in the storage room

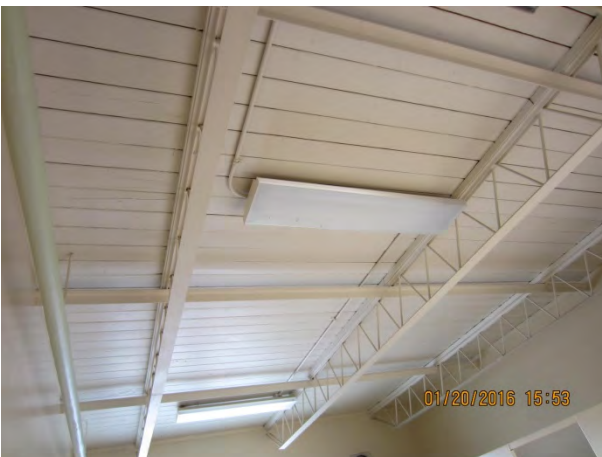
Photo 4.5.17 – Typical 1'x4' surface-mounted fluorescent washroom luminaires

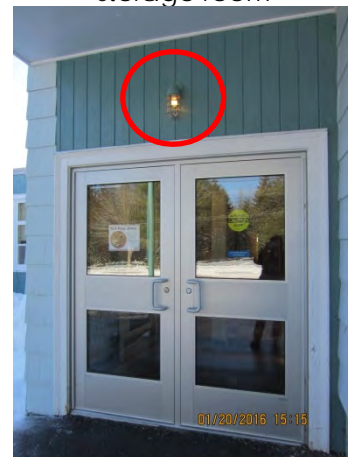
Photo 4.5.18 – Exterior wall-mounted luminaires over front entrance doors

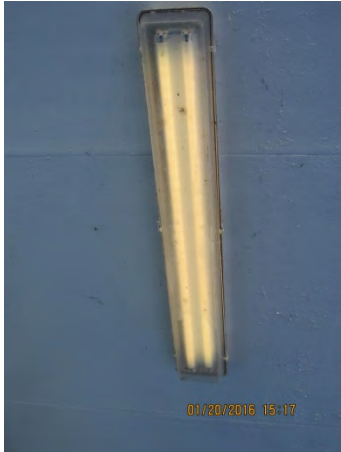
Photo 4.5.19 – 1'x4' vaportight luminaires at front entrances

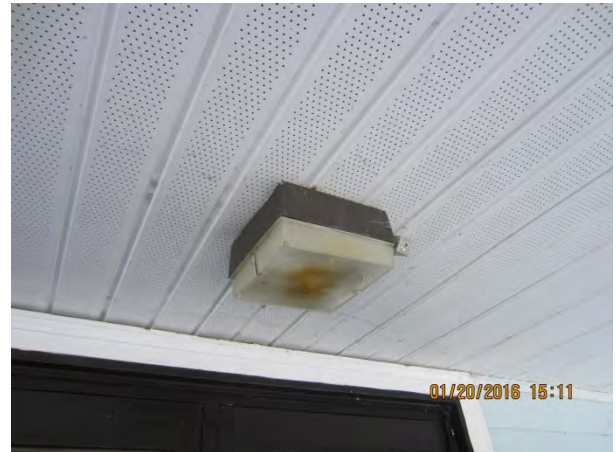
Photo 4.5.20 – Surface-mounted HID luminaire at west entrance

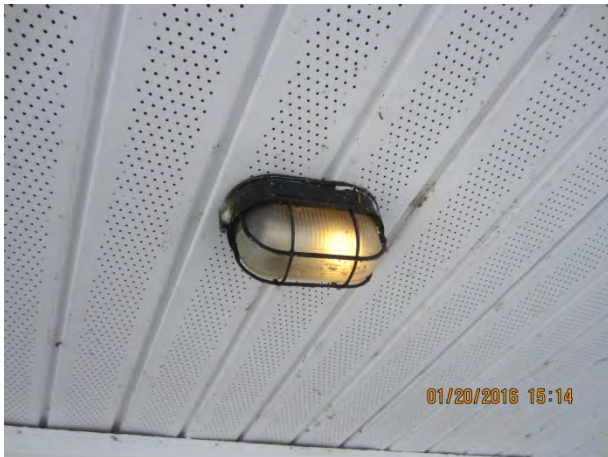
Photo 4.5.21 – Surface-mounted compact fluorescent luminaire at east entrance

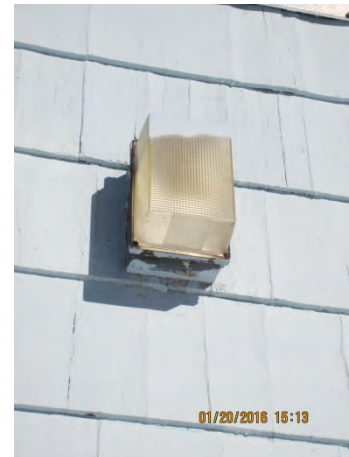
Photo 4.5.22 – Wall-mounted HID luminaire for perimeter lighting

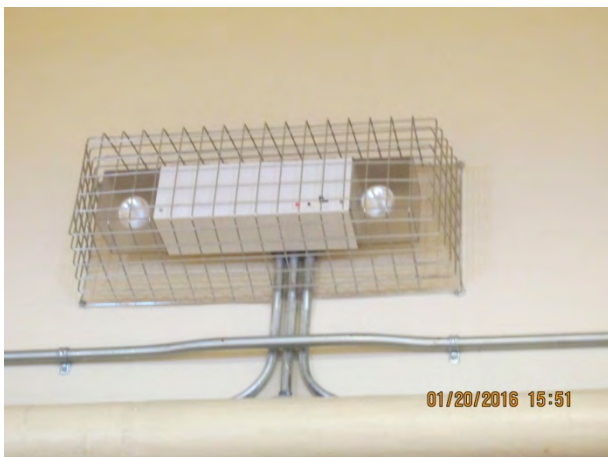
Photo 4.5.23 – Emergency lighting unit complete with wireguard

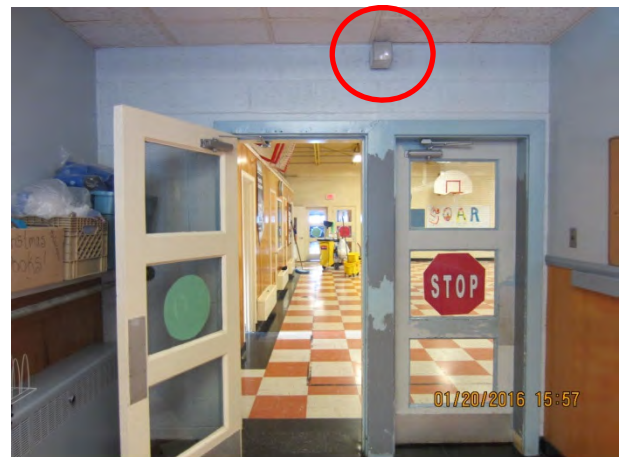
Photo 4.5.24 – Single remote head emergency lighting

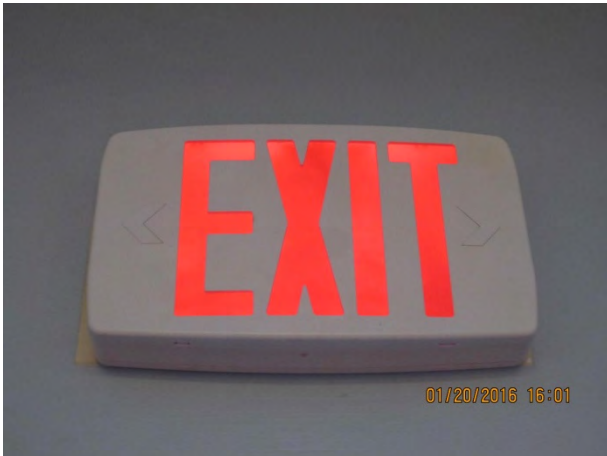
Photo 4.5.25 – Typical exit sign

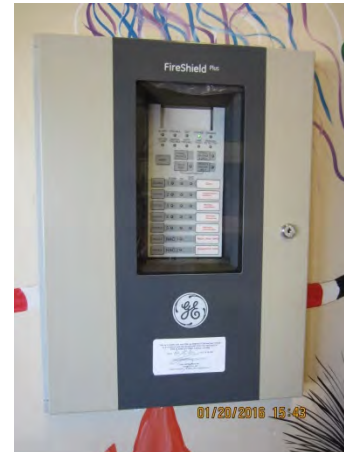
Photo 4.5.26 – GE- FireShield Main Fire Alarm control panel

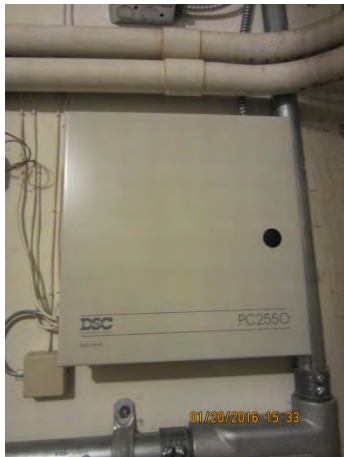
Photo 4.5.27 – Security system control panel in electrical room

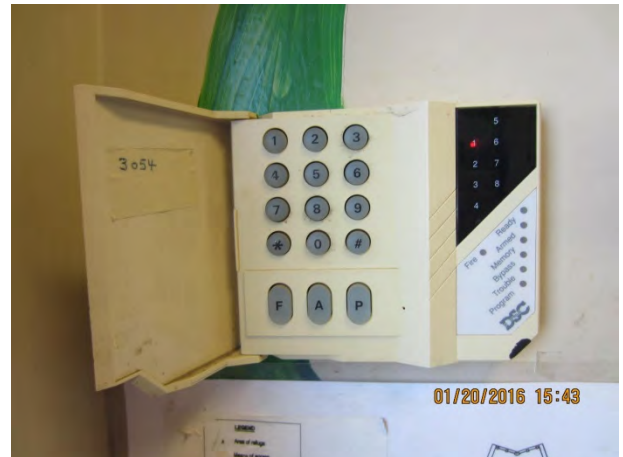
Photo 4.5.28 – Security keypad at main entrance

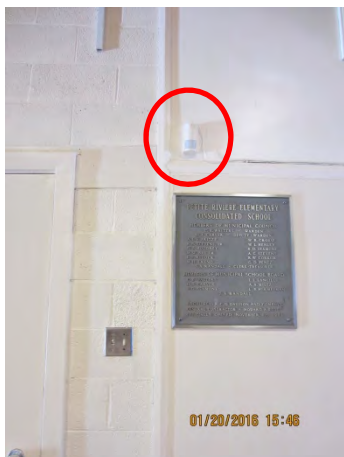
Photo 4.5.29 – Typical wall-mounted security motion sensor

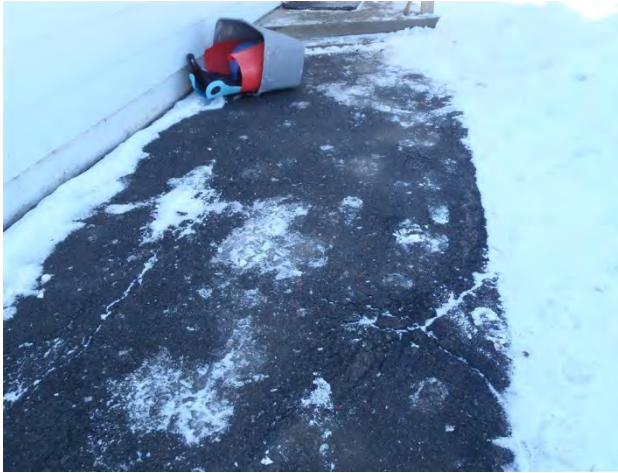
Both asphalt walkways, north of the school and south of the school, are showing signs of deterioration and should be repaired as they could be tripping hazards (Photos 4.6.1). The driveway on the east side of the school is also deteriorating and showing signs of cracking/deterioration and should be resurfaced within the next three years (Photo 4.6.2 and 4.6.3). An alternative would be to implement a plan to patch and repair the existing asphalt, where it could be assumed that 20% is required to be replaced each year in order to spread out the costs.

Photo 4.6.1 – Walkway on south side of school

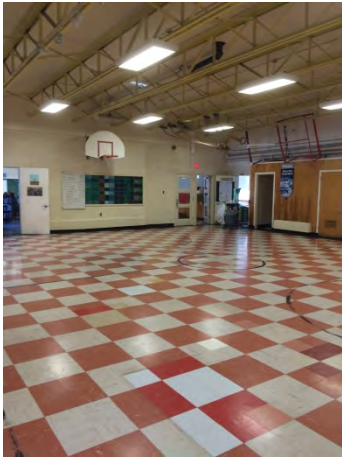
Photo 4.8.1 – View of assembly hall. Vinyl tile floor, painted concrete block walls

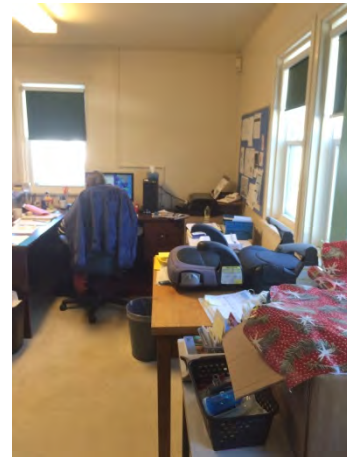
Photo 4.8.4 – Office typical finishes

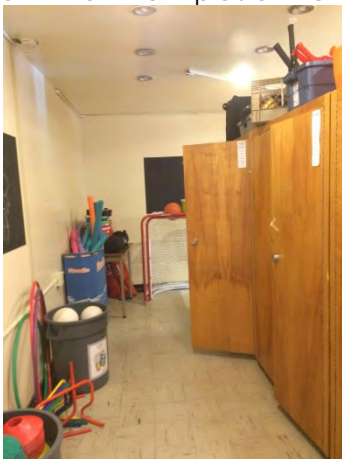
Photo 4.8.5 – Platform area, looking north.

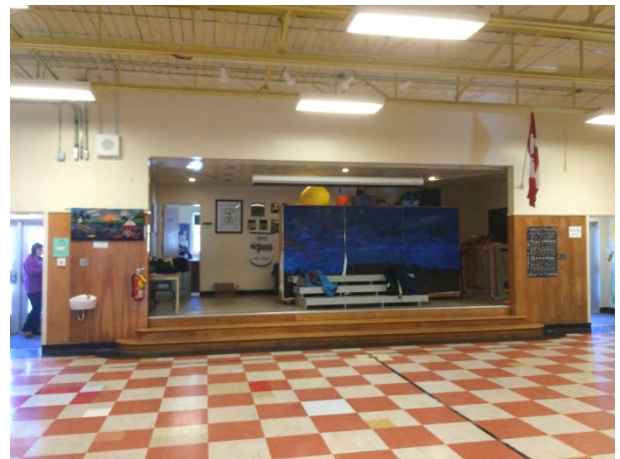
Photo 4.8.6 – View of platform area, looking west

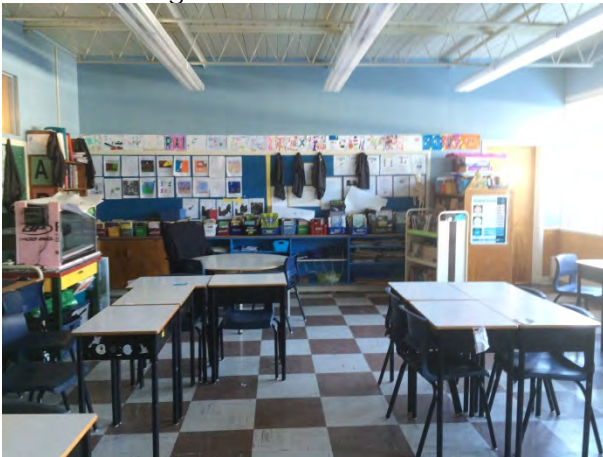
Photo 4.8.9 – View of typical classroom finishes

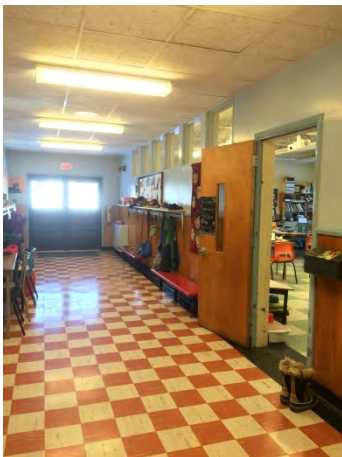
Photo 4.8.11 – View of corridor with painted gypsum walls, suspended ceiling tiles, vinyl tile flooring

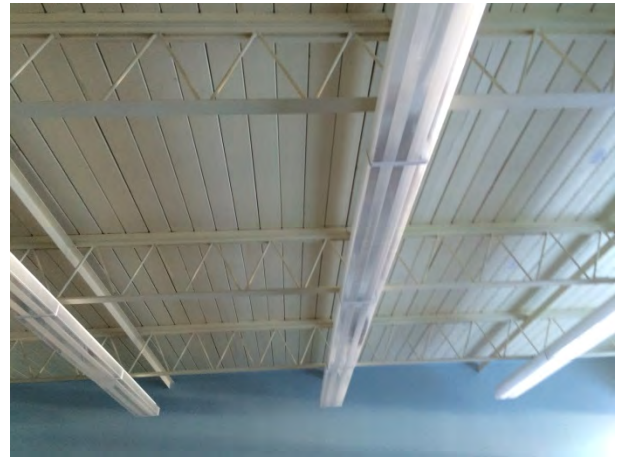
Photo 4.8.10 – Open to underside of roof in classroom areas. Painted wood
